Oregon Department of Transportation Culvert Repair Programmatic Agreement Pilot Project Final Report 2018-2022

Final ODFW Report

Prepared by Pete Baki – ODFW-ODOT Fish Passage Liaison

June 30 2023

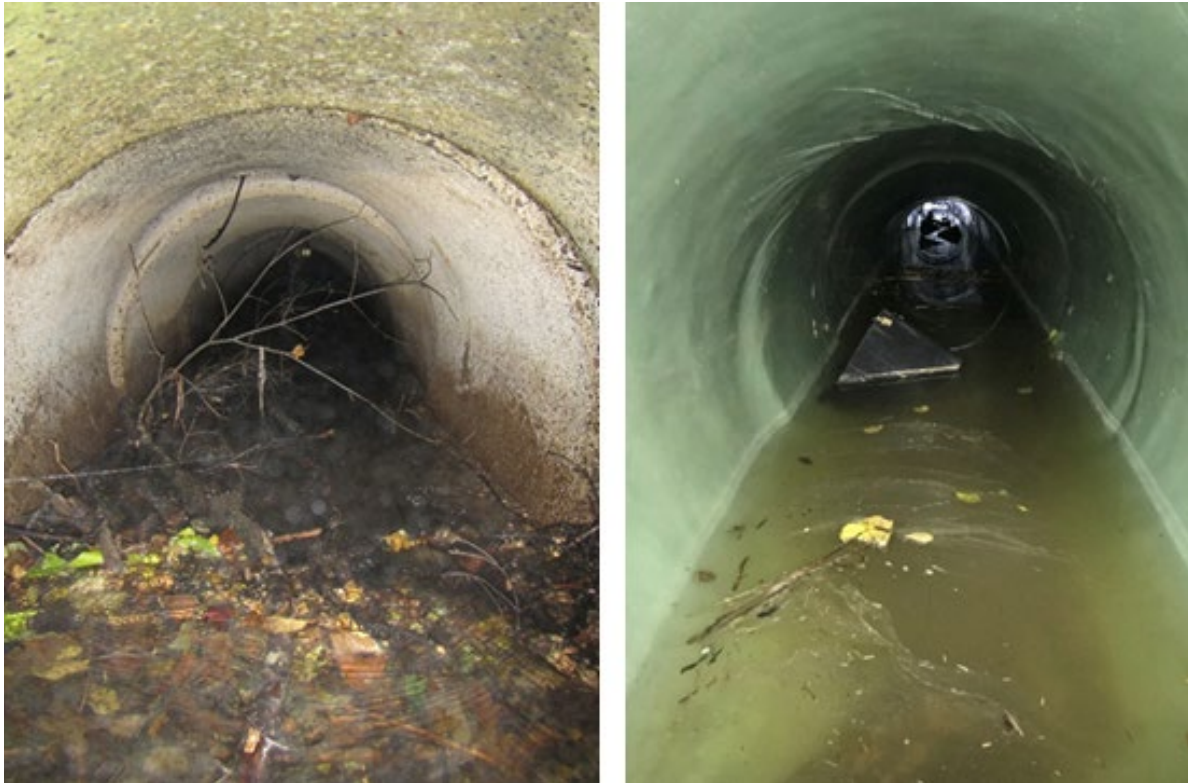
Figure 1: Unnamed Tributary to Pheasant Creek Culvert Repair Before and After

This 80-foot long culvert is a 36" diameter corrugated metal pipe (CMP), passing a stream with an estimated active channel width of 14 feet. The culvert's structural condition was considered poor, due to severe settlement and open joint issues. If left untreated, these issues could allow water to escape the culvert and erode the soil arch under the roadway, ultimately leaving the highway unsupported and unsafe. Hydraulic calculations show flow conditions at the culvert had velocities of 2.44 fps and flow depths as low as 1.5 inches (flows ranging between 5 percent and 95 percent of the daily exceedance

The degraded culvert was repaired with a cast-in-place pipe liner that sealed the joints and alleviated the settlement issues, keeping the water flowing inside the culvert. Fish passage was improved with the addition of staggered one-piece polymer baffles with rounded edges. These baffles were placed to decrease the velocities within the culvert and offer ample hydraulic variation for NMF. The rounded edges of the baffles were an important fish passage detail due to the possibility of adult Pacific lamprey in the system. Post-treatment conditions were estimated to have velocities of 1.03 fps and flow depths of 6.7 inches, thus improving access to the approximate 0.2 miles of upstream habitat.

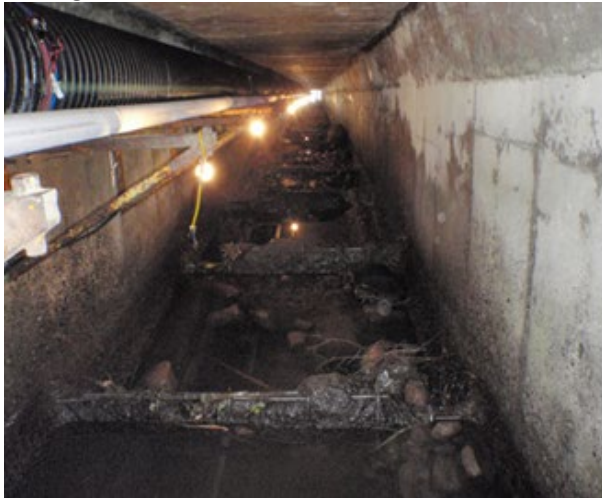
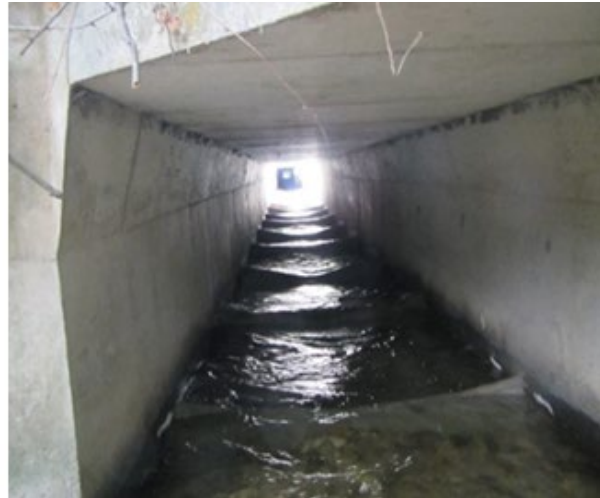
Figure 2: Neil Creek Culvert Repair Before and After

This concrete box culvert is 435 feet long, eight feet wide, and eight feet tall. The culvert's condition prior to repair was poor due to invert degradation. Invert degradation allows water to saturate the soil surrounding the culvert. It also erodes away the soil beneath the culvert and can lead to settling. If left untreated, these issues can lead to the roadway becoming unsupported and unsafe. The hydraulic conditions within the culvert presented numerous issues, including passage barriers of increased jump heights over the old concrete weirs and high velocities during high flow.

The culvert invert and concrete weirs were repaired, amending the invert degradation issue. The repair of the concrete weirs improved fish passage. These lowered the velocity in the culvert and allowed for variation of hydraulic conditions through the culvert to improve NMF passage conditions to the potential 8.9 miles of habitat upstream.

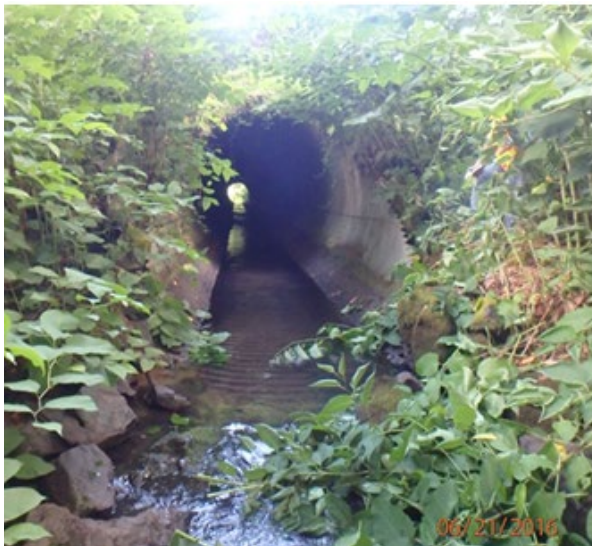
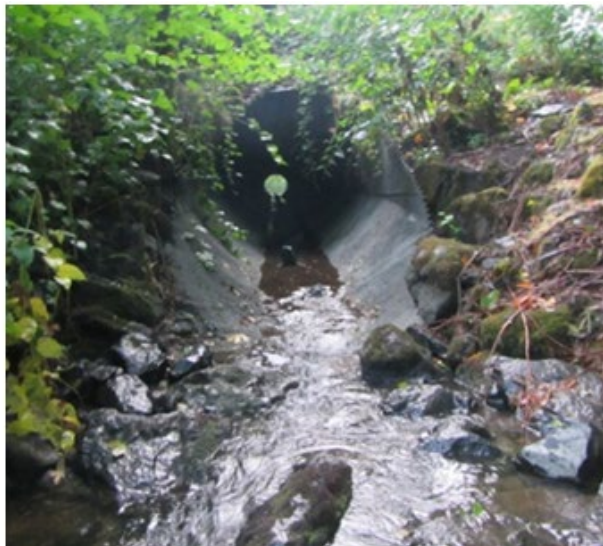
Figure 3: Pass Creek Culvert Repair Before and After

The 12-foot diameter CMP is 284 feet long and drains an area of 5.27 square miles. The culvert's surveyed condition was considered poor due to corrosion and a missing section of the invert. If left untreated, this could become a potential hazard to the traveling public due to water saturating and

The stream has an estimated active channel width of 15 feet. Water velocities during high flow conditions and shallow water depths during low flow conditions created a partial barrier for the upstream movement of fish through the culvert. Cutthroat trout, steelhead, rainbow trout, and ESA listed coho salmon were potentially blocked or delayed from accessing the approximately 4.89 miles of upstream habitat due to these conditions.

The culvert was repaired with a 6-inch paved invert treatment. This allowed for the degraded invert condition to be restored, keeping the water inside the barrel. Installing an 18-inch pre-cast concrete fish blocks at 10-foot intervals through the pipe improved fish passage. These blocks slow water velocities during high flow events, increase flow depth during low flow conditions, and create flow complexity within the culvert. The resulting conditions improve fish passage and increase access to the 4.89 miles of upstream habitat.

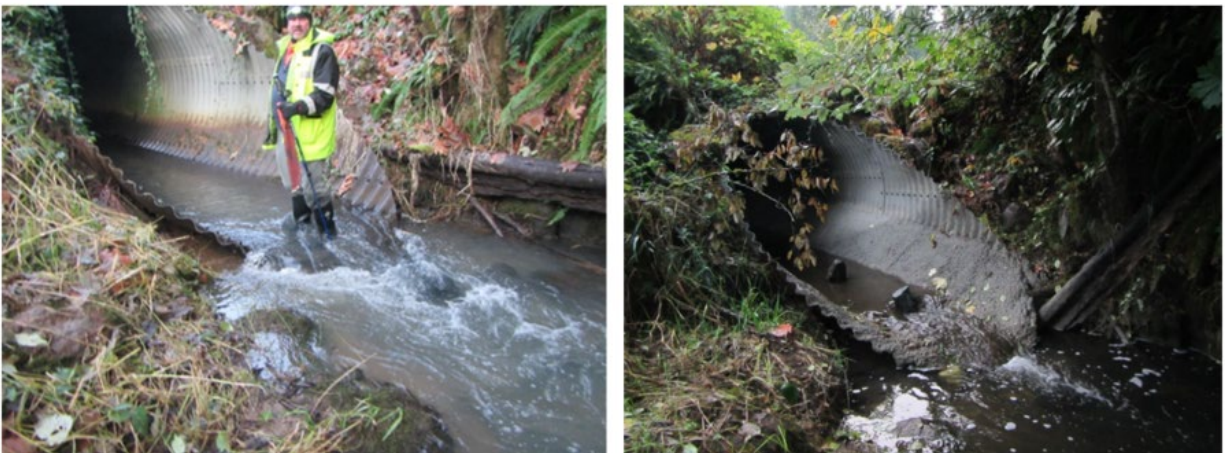
Figure 4: Pass Creek Culvert Repair Before and After

This culvert conveys Pass Creek under I-5 approximately 6.0 miles south-west of Cottage Grove in Douglas County, Oregon. Pass Creek is a tributary to Elk Creek in the Umpqua River basin. This culvert is an 8-foot circular CMP and is 234 feet long. In this location, Pass creek has an estimated active channel width of 15 feet. The culvert was considered to be in critical condition, mainly due to invert damage, water piping (water flowing on and around the outside or damaged sections of the pipe), and some end

treatment issues that, if left untreated, could allow water to saturate the soil surrounding the culvert. This could cause the culvert to settle and the soil to erode, ultimately leaving the roadway unsupported.

Post-construction monitoring of the project documented that the specified rocks in the downstream weir were undersized, was not embedded into the channel, and not fully sealed, allowing water to flow through the rocks rather than maintaining surface flow. The following winter, a high water event displaced the rocks of the weir. Although subsequent high flow events recruited natural streambed material in the proximity of the original weir location, the ultimate backwater condition at the culvert outlet does not improve fish passage to the extent designed. Monitoring of the project continues to see how the natural recruitment of sediment will ultimately backwater the site. If the site does not backwater to the extent designed, a modification will be made during the applicable IWWP.

The culvert was repaired with a 6-inch paved invert. This restored the invert integrity, resolved the water piping issues, and improved the end treatment to help keep the water flowing through the culvert and not around it and in the surrounding soil. Installing 10- inch pre-cast concrete fish blocks at 5-foot intervals throughout the culvert improved fish passage. The fish blocks increase flow depths during low flow, create eddies and flow complexities within the culvert, and reduce velocities during high flow. A weir was constructed downstream of the culvert outlet to increase the outlet pool elevation and reduce the 6-inch perch, allowing for improved access to the 3.67 miles of habitat upstream.

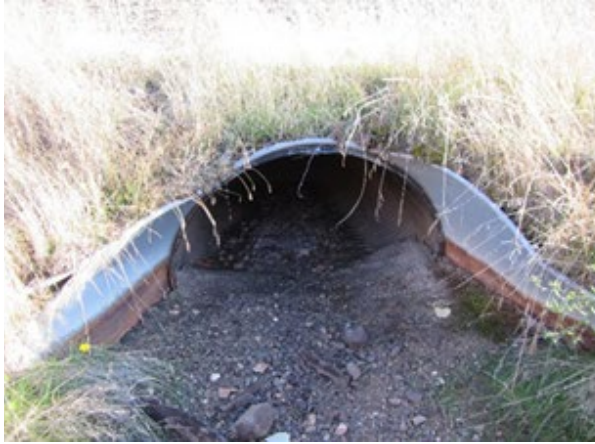
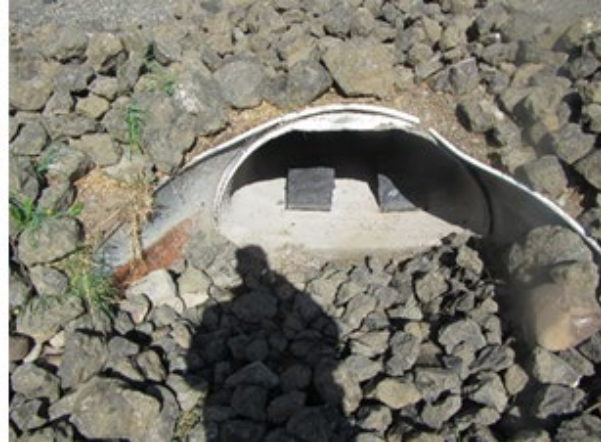
Figure 5: Unnamed Tributary to Cow Creek Culvert Repair Before and After

The culvert is an arch culvert 244 feet long and 36 tall and 54 inches wide with an estimated active channel width of six feet. The culvert was in critical condition due to severe distortion creating a structural blockage of the pipe and open joints. These issues, if left untreated, could compromise the safety of the roadway due to the surrounding soil arch eroding away through the open joints caused by the distortion, ultimately leaving the above roadway unsupported.

The intermittent tributary goes dry during the summer low flow period but provides refuge for cutthroat trout during winter higher flows. ODFW predicts the velocity through the culvert to be over 2 fps during much of the high flow season and would prevent or impede passage upstream. There are 0.2 miles of upstream habitat for cutthroat trout that was possibly inaccessible due to these conditions.

This critical condition culvert was repaired with a cured in place pipe liner, which realigned the distortion, closed the joints, and allowed for removal of the structural blockage. Through this repair, the surrounding soil arch is no longer exposed to the flowing water and, in turn, at risk of erosion. Installation of plastic baffles to provide hydraulic complexity and flow variations through the culvert improved fish passage. This aims to slow the water velocity during higher flow periods and improves access to the upstream 0.2 miles of high water refuge habitat.

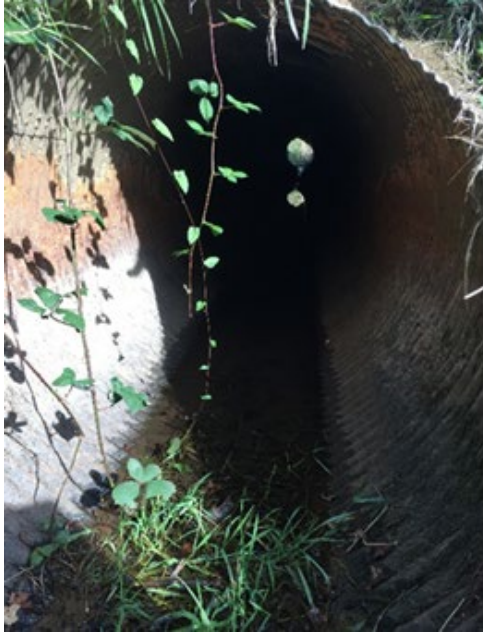
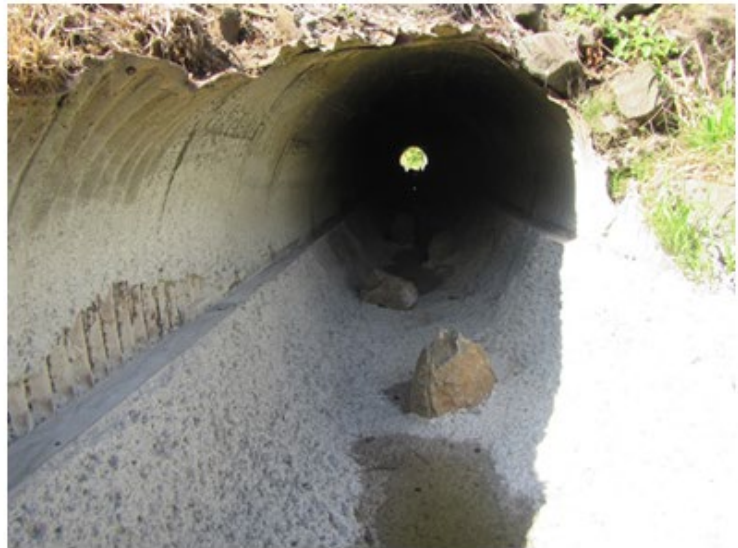
Figure 6: Unnamed Tributary to the Tillamook River Culvert Repair

The corrugated metal culvert is five feet wide and 98 feet long, with an estimated 11-foot wide active channel width. It was considered to be in critical condition due to a rusted invert condition. If left untreated, the soil below the culvert could erode allowing the culvert to settle into that open space. Ultimately then allowing water to flow around the culvert, saturating and eroding the above soil and roadbed to leave the roadway unsupported.

An invert pave was used to repair the culvert, allowing the bottom of the culvert to be resurfaced and hold the water inside the culvert. Adding 20-inch fish rocks to create flow variations and to slow water velocities improved fish passage. The modeled water velocity after construction was 1.77 fps at a depth of 7.3 inches. This lowered velocity and increased hydraulic variation within the culvert, improving access to the 1.74 miles of habitat upstream for juvenile rearing of salmon and steelhead and spawning and rearing for coastal cutthroat trout.

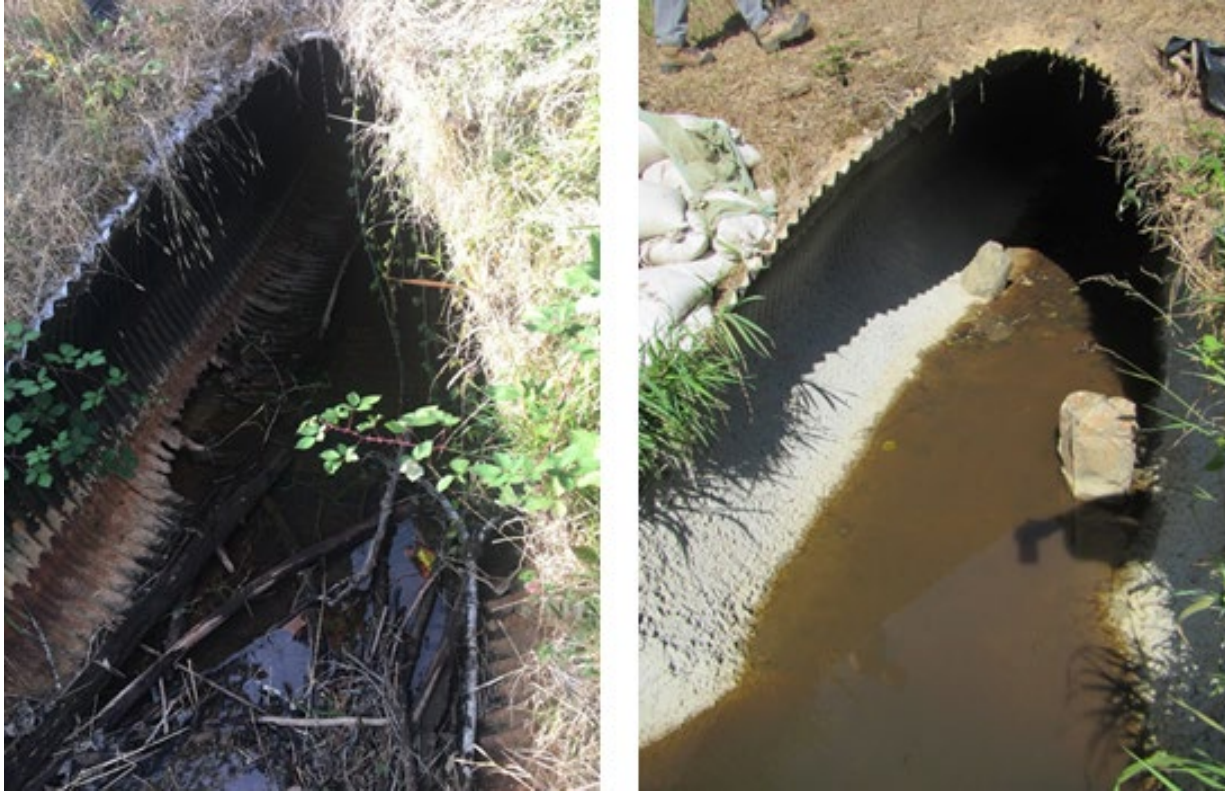
Figure 7: Unnamed Tributary to the Tillamook River Culvert Repair

Description: Two images, the first is looking down at the mitered slope end treatment pre-repair. The second is looking down at the mitered slope end treatment post repair.

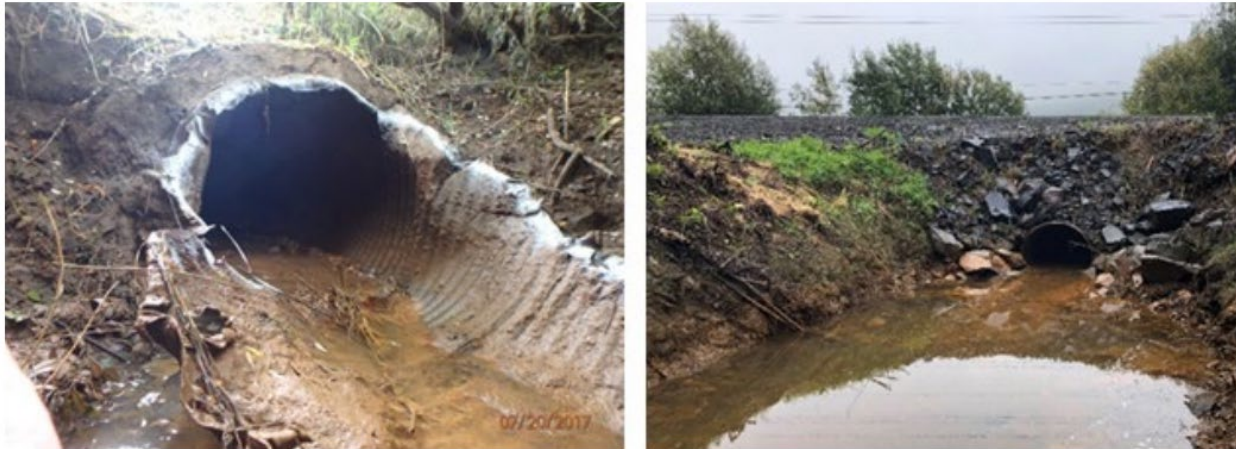
Figure 8: Tandy Creek Culvert Repair Description: Two photos, the first shows the outlet end of the culvert recently dug out of the mud pre-repair, with water running through it. The second photo shows standing water at the post repaired outlet of the culvert.

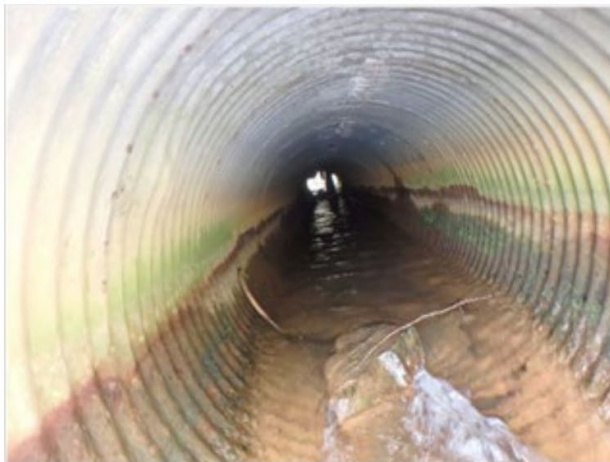
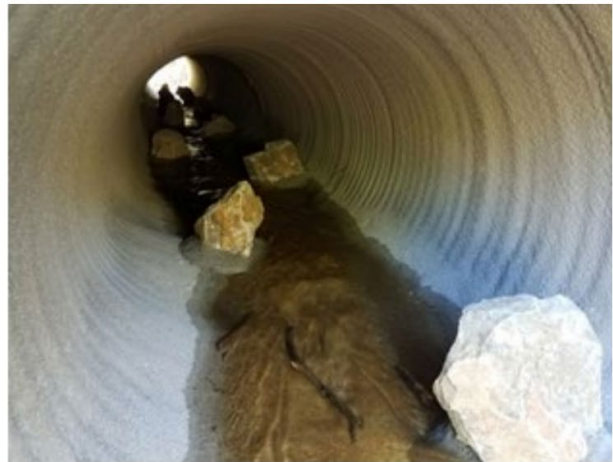
Description: Two images, the first shows water running through the inside of the culvert pre-repair. The second image shows water running through the culvert with fish rocks post-repair.

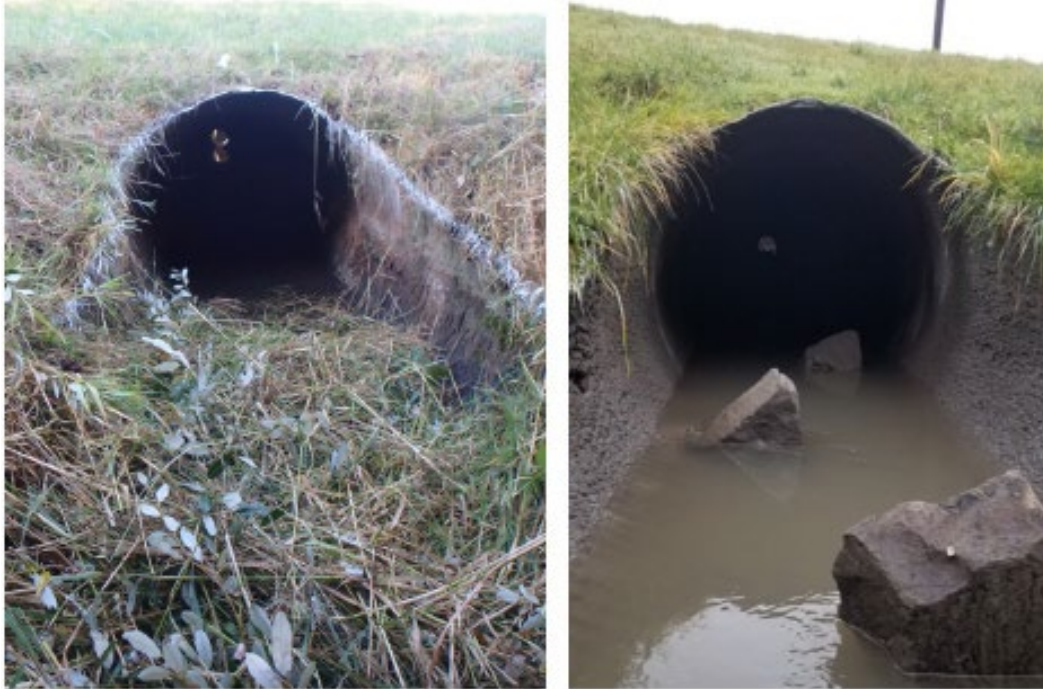
Figure 11: Unnamed Tributary to Mud Slough Culvert Repair, Before and After
Description: Two images, the first is the pre-repair view inside the culvert. The second image is of fish rocks inside of the culvert post-repair with water running through it.

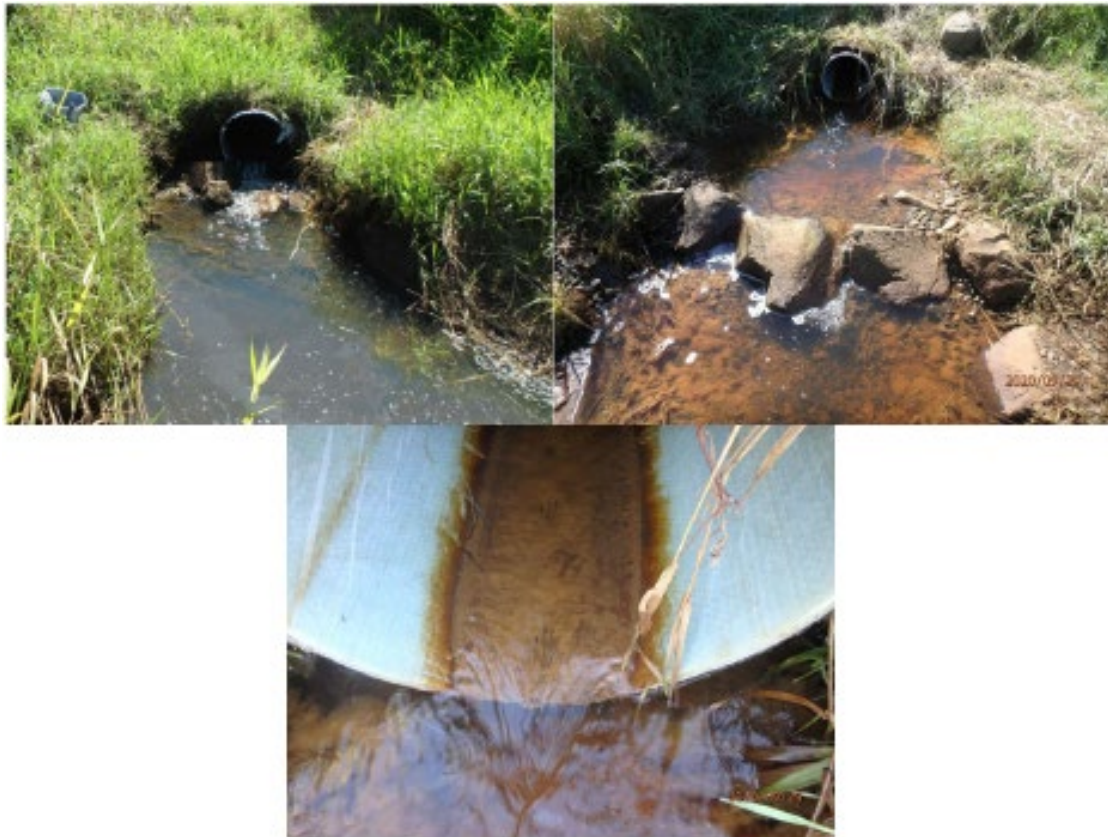
Description: Three images, the first shows the outlet end of the culvert pre-repair with water running through it, the culvert is perched ~4 inches. The second image shows the outlet of the culvert post-repair with water running through it, the perch at the outlet of the culvert has been improved. The third photo shows the conditions at the outlet following adaptive management work in 2020, where there is no longer a perch.

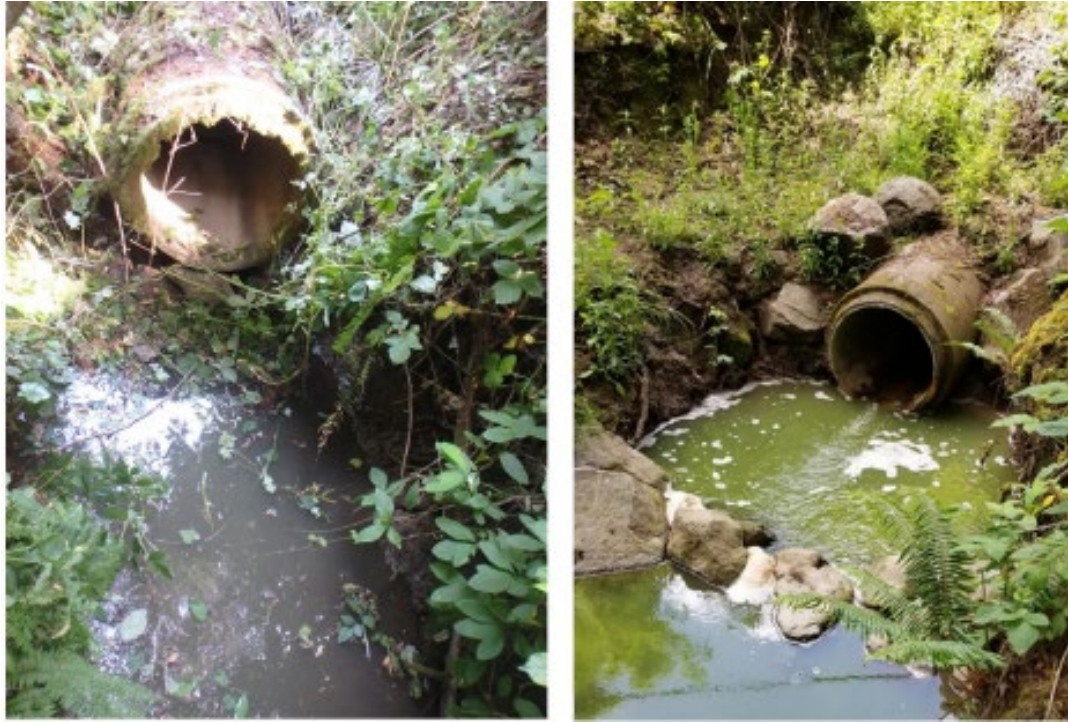
Description: Two images, the first shows the outlet end of the culvert pre-repair illustrating the perched condition. The second image shows the outlet of the culvert post-repair with one downstream boulder weir. The boulder weir has backed up water and reduced the perched condition.

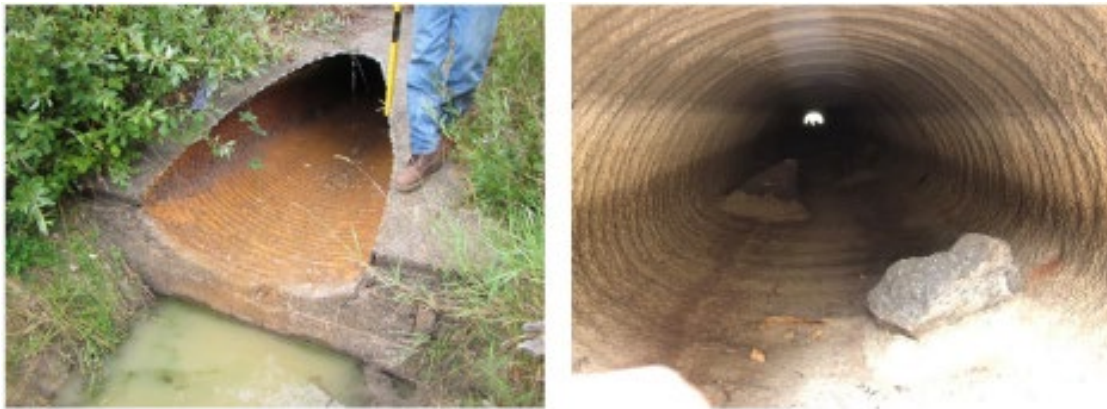
Description: Two images, the first looks at the end of an arch culvert pre-construction, where the culvert invert is showing signs of rust and deterioration. The second image is post-repair, and looks in the end of the arch culvert. The interior of the culvert shows new concrete around the perimeter, and fish rocks placed on the inlet.

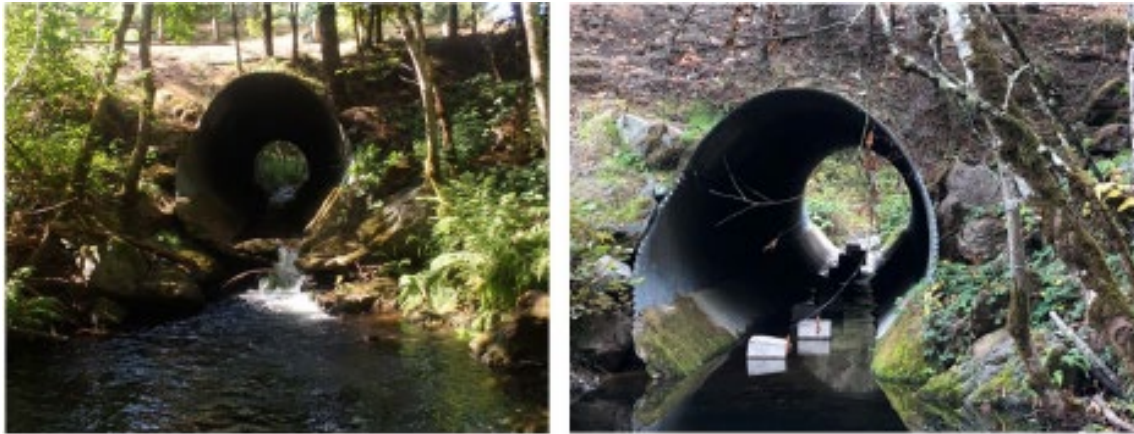
Description: Two photos, the first shows the outlet end of the culvert with water running through it, this clearly illustrates the perched condition of the culvert. The second photo shows standing water at the post-repaired outlet of the culvert, and fish blocks placed through the culvert.

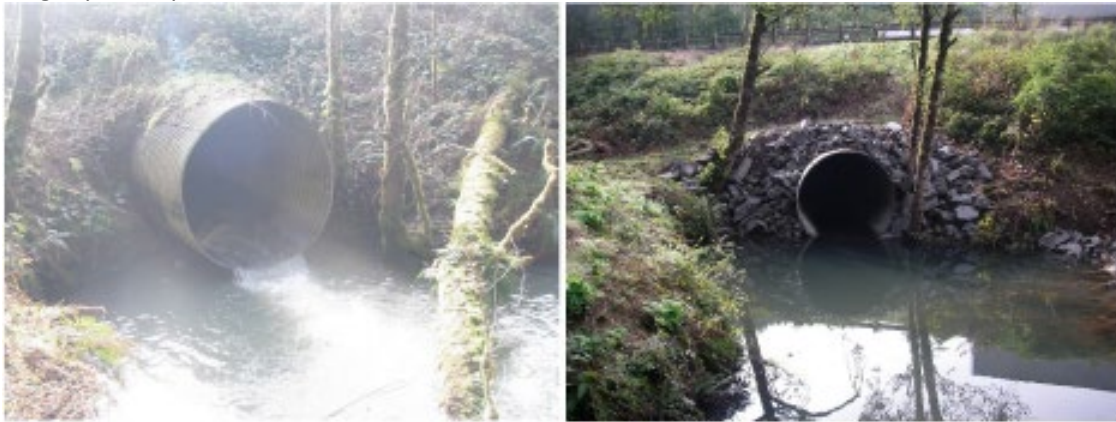
Description: Two images, the first shows the outlet of the culvert and a perch creating a jump height pre-repair. The second image shows water running through the culvert backwatered with no jump height post-repair.

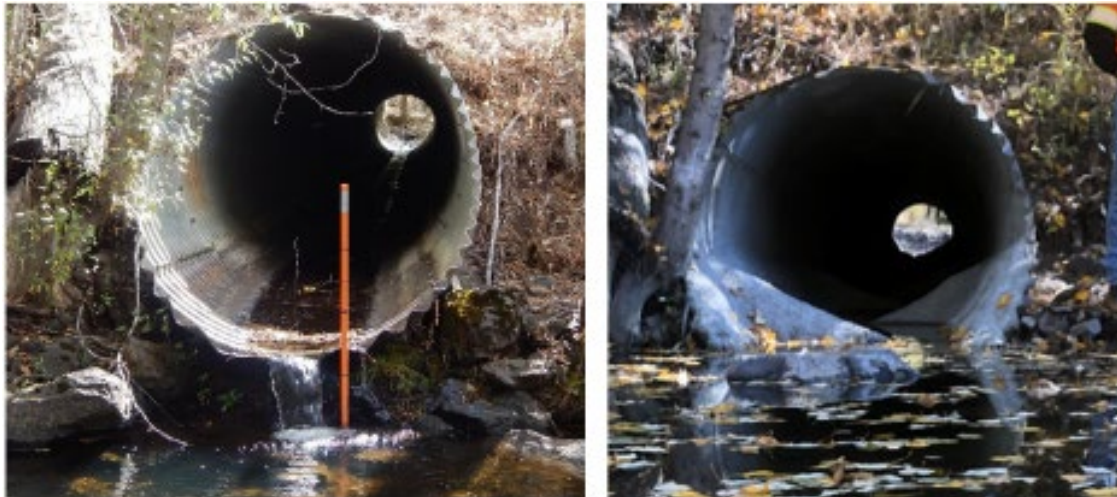
Description: Two images, the first shows water running through the perched culvert pre-repair. The second image shows water backwatered to the culvert outlet with alternating baffles post repair.

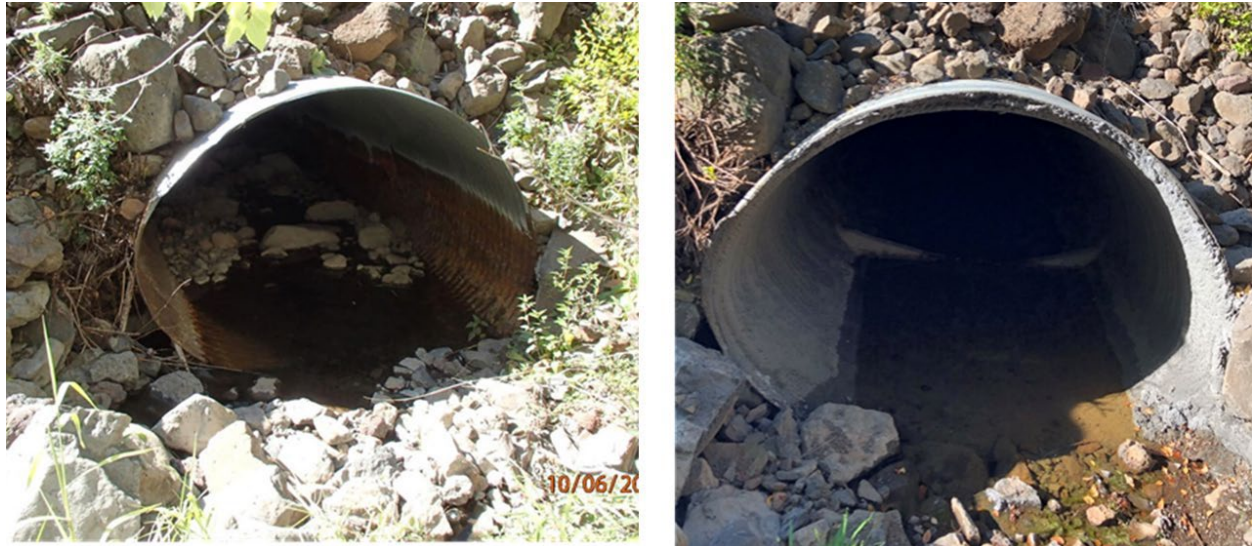
Description: Two images, the first shows the outlet end of the culvert pre-repair with water running through it and accumulated large cobbles. The second image shows the outlet end of the culvert post-repair with water running through it and concrete weirs.

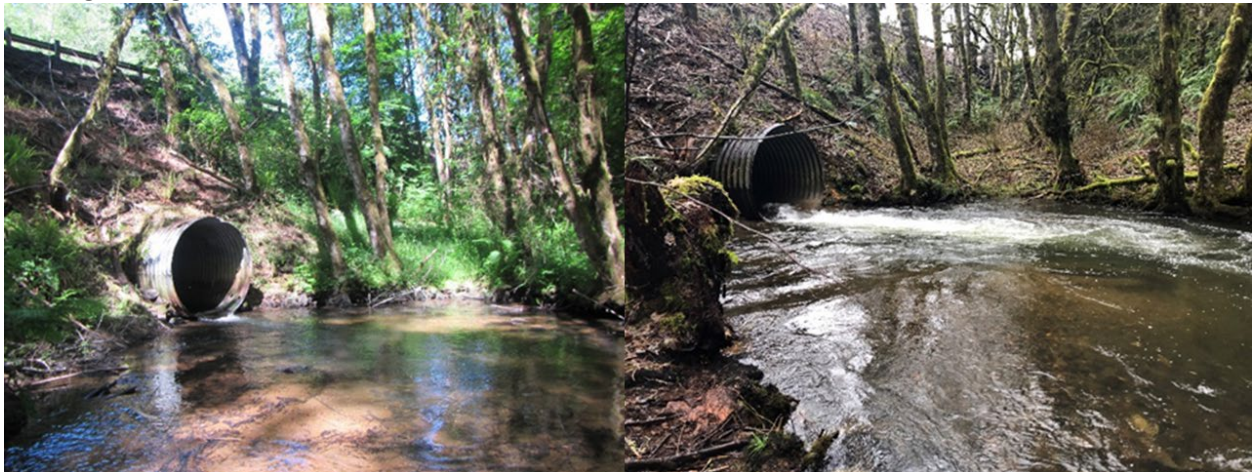
Description: Two images, the first image shows the perched outlet of the culvert pre-repair with water running through it. The second image shows the unperched outlet of the culvert post-repair with water running through it.

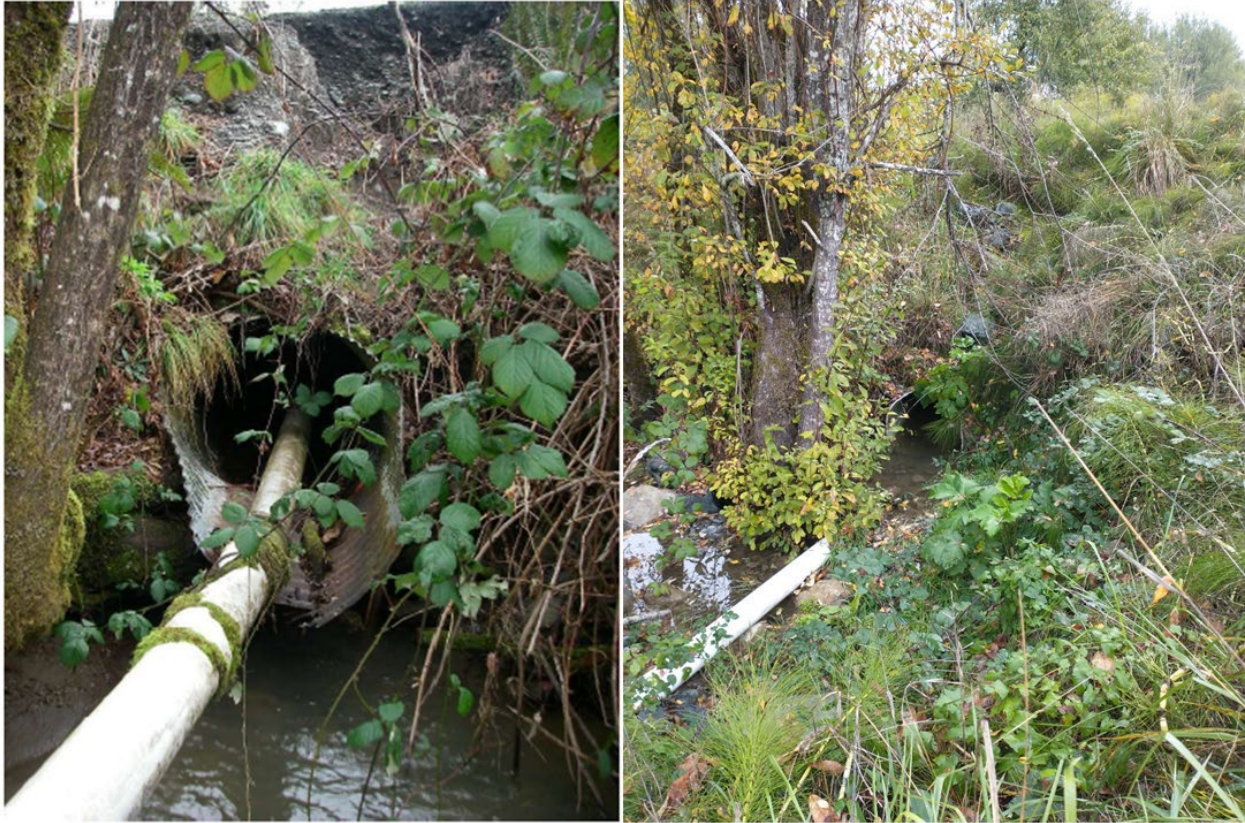
Description: Two photos, the first shows the pre-repair outlet end of the culvert with water present in the outlet pool and irrigation pipe running through the culvert. The second photo shows the post-repair outlet end of the culvert with water present in the outlet pool and irrigation pipe removed from the culvert.

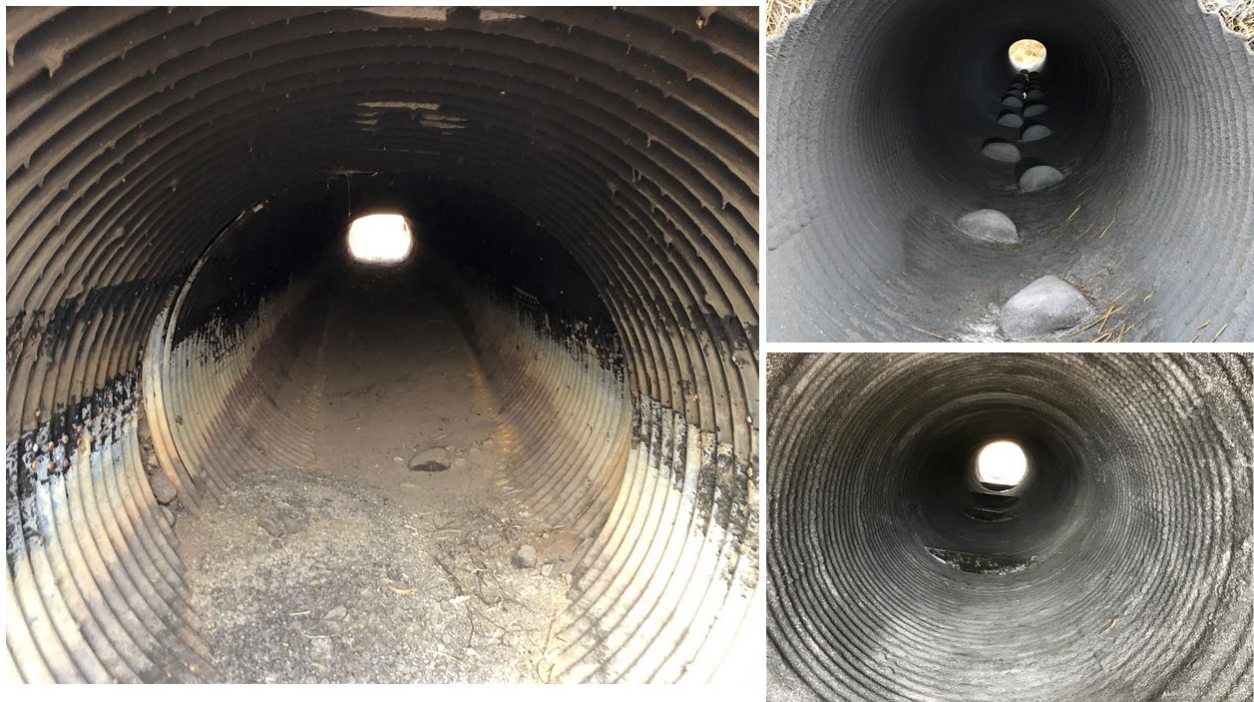
Description: Three images, the first shows inside a culvert pre-repair with a separated joint and accumulated sediment. The second shows inside a culvert post-repair with fish blocks and the third shows inside a culvert post-repair with fish baffles.

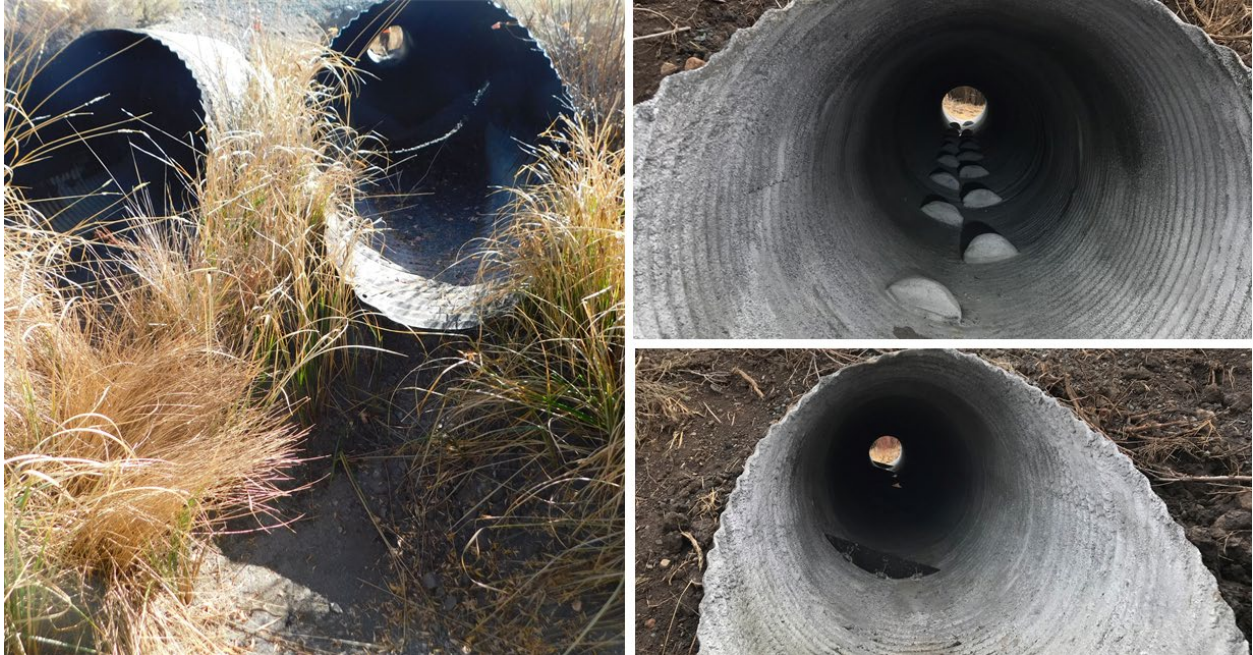
Description: Three images, the first shows the perched culvert outlets pre-repair. The second shows inside a culvert post-repair with fish blocks and the third shows inside a culvert post-repair with fish baffles.

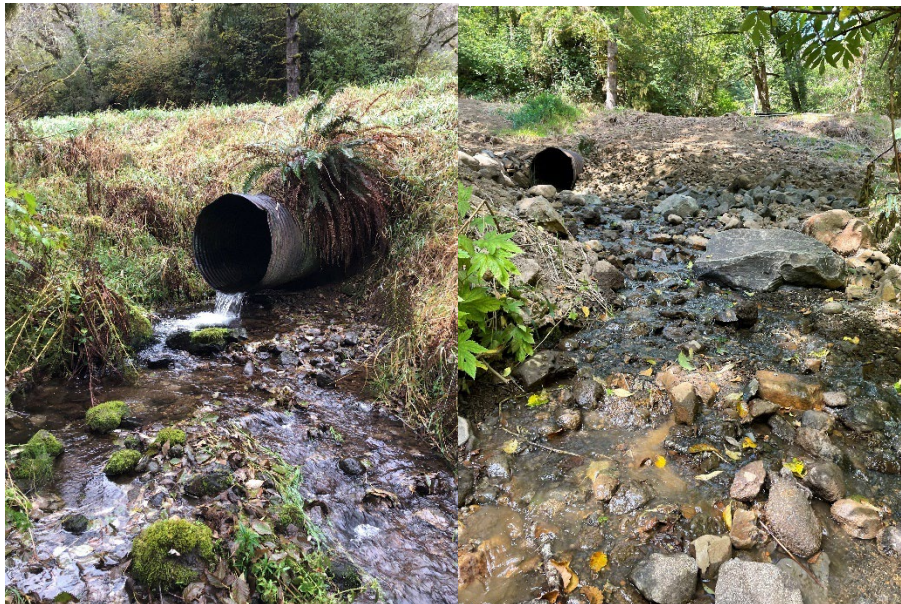
The first picture shows the perched culvert with no jump pool. The second picture shows the repair but using a roughened riffle to allow fish to swim through the culvert. The culvert also had weirs installed to increase the depth and reduce velocities.

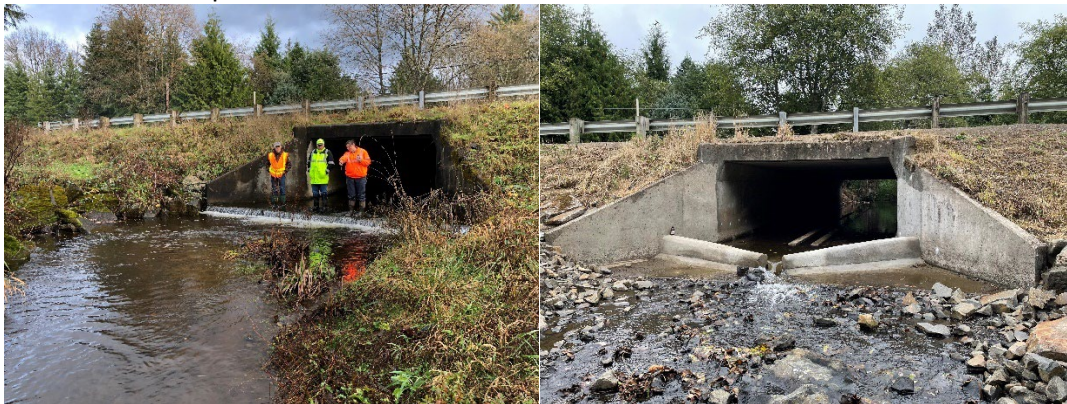
The first pictures shows the pre-project conditions, with shallow sheet flow through the culver and a perched outlet. The second picture shows the roughened riffle to address the perch and a notched weir to address the depth in the culvert.

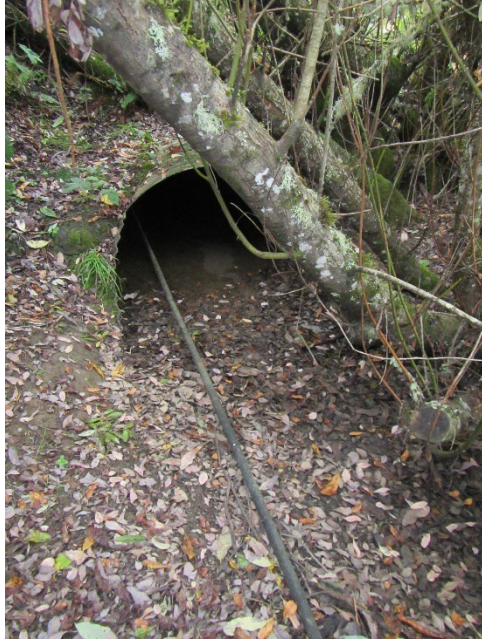
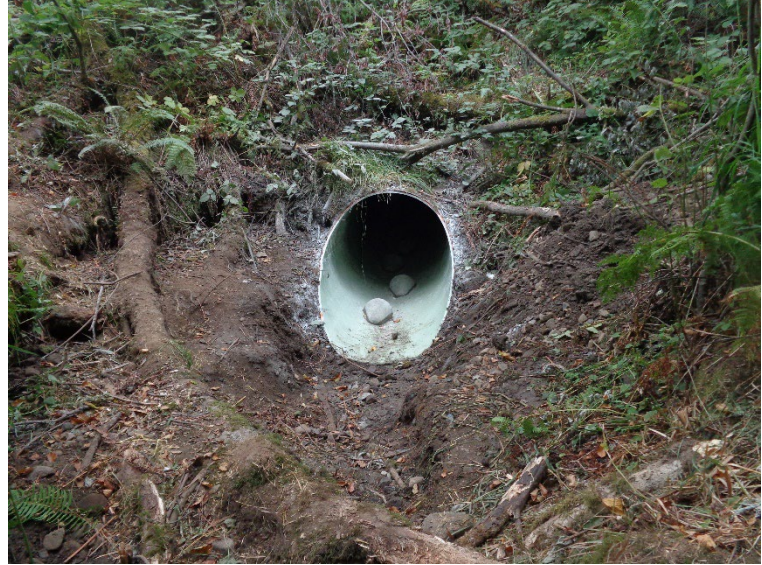
The first picture is the outlet at low flow conditions. The second picture is after a CIPP liner was installed and the placed fish rocks.
