# Culvert Repair Programmatic Agreement (CRPA) Annual Report 2016

**Report Prepared by**  
**William Warncke, ODOT**  
**Art Martin, ODFW**  
**February 3, 2017**

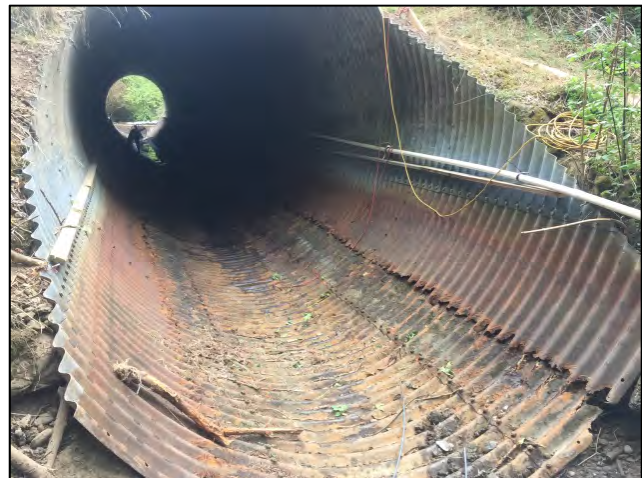
All of the 2016 culvert repair projects were repaired by invert paving. Invert paving adds a layer of reinforced concrete in the bottom of the culvert to both seal the bottom and keep water in the culvert barrel, and to provide a connection to complete the culvert circumference thereby repairing the structural capacity of the pipe. There are other repair techniques available under the CRPA but the 2016 repair locations were all metal pipes, either Corrugated Metal Pipe (CMP) or multi-plate culverts with significant invert rusting (see photo of Oakpoint Creek Culvert - to right). Several different types of fish passage improvements were included as part of these invert paving repairs (see below).

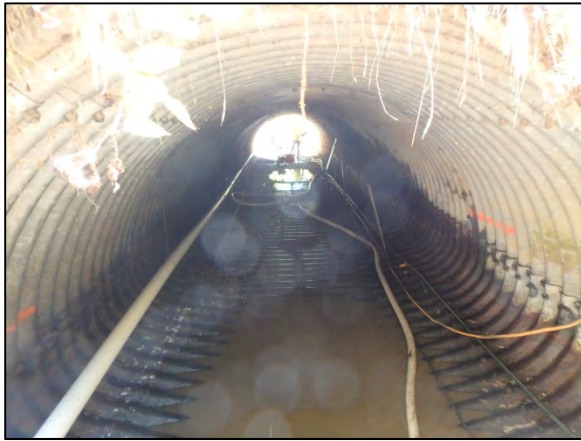
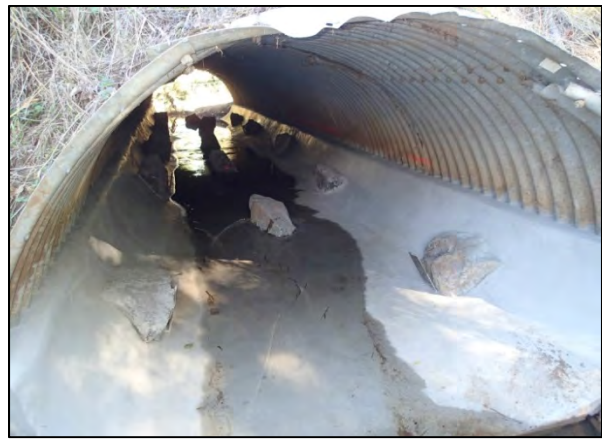
Potter Creek Culvert pre-treatment (left), post-treatment (right)

The pre-treatment culvert condition was a 10 foot by 7 foot arch pipe metal culvert, 55 feet in length and installed at an approximate slope of <1%. The approximate average active channel width in Potter Creek channel upstream and downstream was estimated at 17 feet in width. During project scoping, the culvert outlet was backwatered approximately 12 inches above the culvert invert. Substrate ranging from cobbles to fines in size had accumulated along the length of the culvert invert. Pre-treatment hydraulic condition likely resulted in flow depths less than 6 inches at the culvert inlet during some portions of the juvenile salmonid migration periods and likely velocities in excess of 2 feet per second during some portions of juvenile salmonid migration periods. Therefore the pre-treatment conditions likely resulted in a partial upstream barrier for both adult and juvenile salmonids and other NMF species during a portion of the range of stream flows when NMF need to migrate (flows ranging from the 5% to 95% of the daily exceedance stream discharge). Biological implications from these pre-treatment passage impediments likely included the delay of upstream fish passage during portions of most years and the possibility of underutilization of upstream reaches during periods when NMF would use habitats available upstream of the culvert.

Post-treatment Fish Passage Condition. The Potter Creek culvert repair included a concrete invert pave and the placement of large (~ 20" diameter) offset fish rocks throughout the length of the culvert invert. The anticipated hydraulic performance of these offset fish rocks is to increase post-treatment water depth conditions at low flow conditions and to slow post-treatment water velocities conditions across the range of stream discharges (flows ranging from the 5% to 95% of the daily exceedance stream discharge). The anticipated biological implications are to increase the window of hydraulic conditions necessary for successful upstream migration for both adult and juvenile NMF. This will likely result in better utilization of habitats found in the upper reaches of Potter Creek.

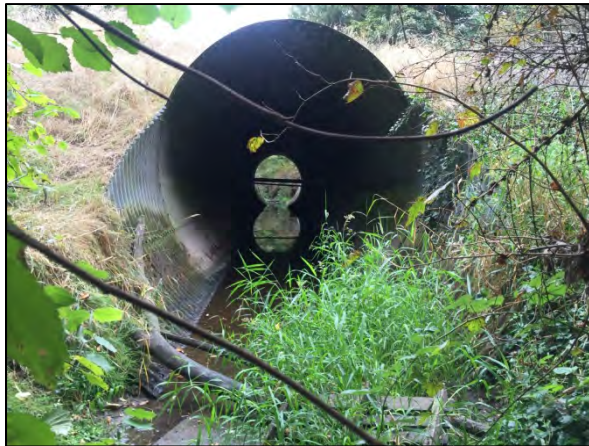
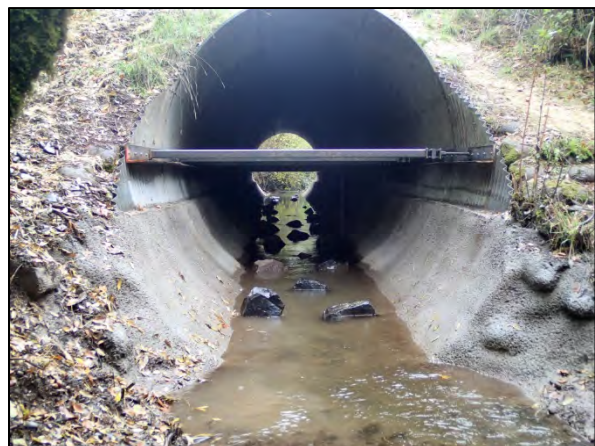
Oakpoint Creek Culvert pre-treatment (left), post-treatment (right)

Pre-treatment Fish Passage Condition. Oakpoint Creek is a tributary to Rickreall Creek in the Willamette River Basin north of Independence, Oregon. Oakpoint Creek is seasonal in nature and typically becomes intermittent during the summer low flow period in the reach where the OR 51 MP 2.92 culvert crossing is located. It is utilized by cutthroat trout, steelhead, juvenile Chinook salmon, largescale suckers and norther pikeminnow during periods of the year they are able to successfully access it and adequate water quality persists. The pre-treatment culvert condition was a 14 foot diameter multi-plate round metal culvert, 132 feet in length and installed at an approximate slope of <1%. The approximate average active channel width in Oakpoint Creek channel upstream and downstream was estimated at 17 feet in width. During project scoping, the culvert outlet was backwatered approximately 12 inches above the culvert invert. A slight volume of substrate ranging in size from cobbles to fines had accumulated along the culvert invert. Pre-treatment hydraulic condition likely resulted in flow depths less than 6 inches at the culvert inlet during some portions of the juvenile salmonid migration periods and likely velocities in excess of 2 feet per second during some portions of juvenile salmonid migration periods. Therefore the pre-treatment conditions likely resulted in a partial upstream barrier for both adult and juvenile salmonids and other NMF species during a portion of the range of stream flows when NMF need to migrate (flows ranging from the 5% to 95% of the daily exceedance stream discharge).

Post-treatment Fish Passage Condition. The Oakpoint Creek culvert repair included a concrete invert pave, instillation of a series of lateral supports above the ordinary high water flow line within the structure, and the placement of large (~ 24" diameter) offset fish rocks throughout the length of the culvert invert. The anticipated hydraulic performance of these offset fish rocks is to increase post-treatment water depth conditions at low flow conditions and to slow post-treatment water velocities conditions across the range of stream discharges (flows ranging from the 5% to 95% of the daily exceedance stream discharge). The anticipated biological implications are to increase the window of hydraulic conditions necessary for successful upstream migration for both adult and juvenile NMF. This will likely result in better utilization of rearing and refugia habitats found in the upper reaches of Oakpoint Creek.

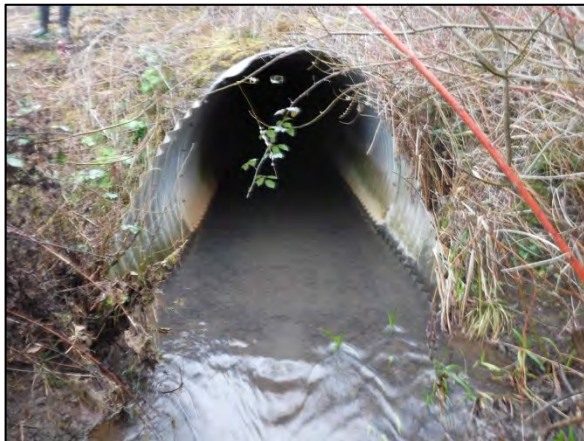
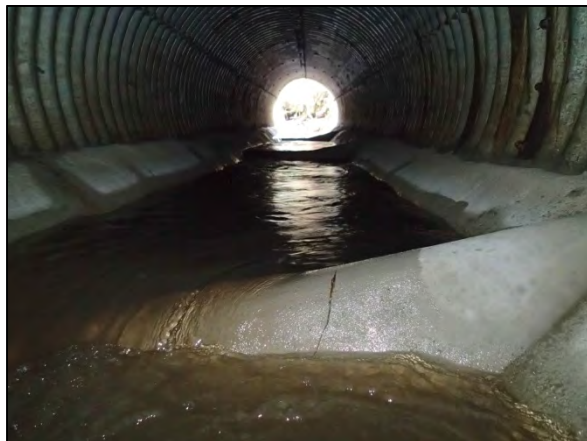
Wilson Creek Culvert pre-treatment (left), post-treatment (right)

Pre-treatment Fish Passage Condition. Wilson Creek is a tributary to Yoncalla Creek in the Umpqua Basin north of Rice Hill, Oregon. Wilson Creek is seasonal in nature and typically dries up during the summer low flow period in the reach where the I-5 MP 150.85 culvert crossing is located. It is used by cutthroat trout, steelhead, and Coho salmon during periods of the year they are able to successfully access it. Wilson Creek is also assumed to be current or historic habitat for Pacific lamprey. The pre-treatment culvert condition was a 7 foot diameter multi-plate round metal culvert, 270 feet in length and installed at an approximate slope of 1 to 2%. The approximate average active channel width in Wilson Creek channel upstream and downstream was estimated at 10 feet in width. During project scoping, the culvert outlet was backwatered approximately 20 inches above the culvert invert. A significant volume (>1-2 feet deep) of substrate ranging from gravels to fines in size had accumulated throughout the

culvert invert. Pre-treatment hydraulic condition likely resulted in flow depths less than 6 inches during some portions of the juvenile salmonid migration periods and likely velocities well in excess of 2 feet per second during some portions of juvenile salmonid migration periods. Therefore the pre-treatment conditions likely resulted in a partial upstream barrier for both adult and juvenile salmonids during a portion of the range of stream flows when NMF need to migrate (flows ranging from the 5% to 95% of the daily exceedance stream discharge). Biological implications from these pre-treatment passage impediments likely included the delay of upstream fish passage during portions of most years and the possibility of under seeding of upper reaches with adults salmonids in low water years.

Post-treatment Fish Passage Condition. The Wilson Creek culvert repair included the instillation of 16, corner baffles, ranging from 27 inches in height at the high side and 6 inches in height at the low side relative to the culvert invert. The anticipated hydraulic performance of these corner baffles is to increase post-treatment water depth conditions by a minimum of 6 inches at low flow conditions and to slow post-treatment water velocities conditions across the range of stream discharges (flows ranging from the 5% to 95% of the daily exceedance stream discharge). The anticipated biological implications are to increase the window of hydraulic conditions necessary for successful upstream migration for both adult and juvenile NMF. This will likely result in improved seeding of the upper reaches of Wilson Creek, particularly during low water years.

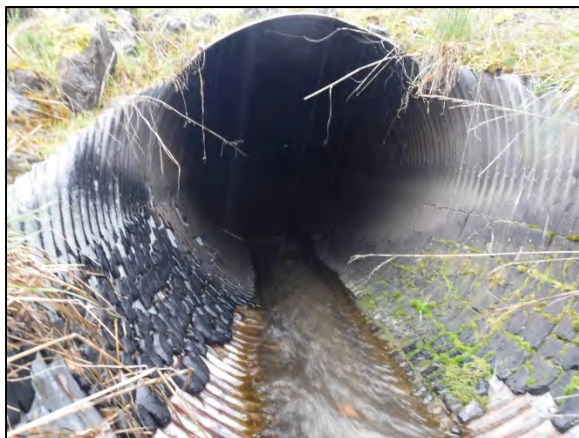
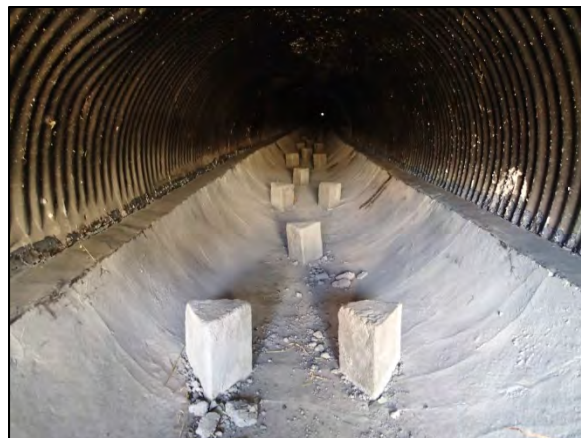
“Fairgrounds Creek” Culvert pre-treatment (left), post-treatment (right)

Pre-treatment Fish Passage Condition. “Fairgrounds Creek” is technically an unnamed tributary to the South Umpqua River south of Roseburg, Oregon. Fairgrounds Creek is seasonal in nature along the reach where the I-5, MP 122.53 culvert crossing is located. It is used by cutthroat trout, steelhead, and Coho salmon during years they are able to successfully access it. Fairgrounds Creek is also assumed to be current or historic habitat for Pacific lamprey. The pre-treatment culvert condition was a 5 foot diameter round corrugated metal culvert, 450 feet in length and installed at an approximate slope of 2 to 3%. The Fairgrounds Creek culvert has dual ownership with ODOT owning and maintain the inlet end

of the culvert (under Interstate 5) for the first 250 ft. and Douglas County owning and maintaining the outlet end (under the county fairgrounds infrastructure). The approximate average active channel width in Fairgrounds Creek upstream was estimated at 6 feet. During project scoping, only the inlet end of the culvert was assessed and no stream substrate was observed in the inlet or barrel of the culvert. Pre-treatment hydraulic condition likely resulted in flow depths less than 12 inches during most portions of the adult salmonid migration periods and likely velocities in excess of 2 feet per second during most portions of juvenile salmonid migration periods. Therefore the pre-treatment conditions likely resulted in a partial upstream barrier for both adult and juvenile salmonids during most of the range of stream flows used for migration (flows ranging from the 5% to 95% of the daily exceedance stream discharge). Biological implications from these pre-treatment conditions likely included prevention or delay of upstream fish passage during most portions of the year and the possibility of under seeding of the upper reaches of Fairgrounds Creek with adults salmonids in low water years.

Post-treatment Fish Passage Condition. The Fairgrounds Creek culvert repair included the instillation of precast concrete roughness features throughout the ODOT owned portion of the culvert. Roughness features were comprised of 8 inch equilaterally triangular columns. The anticipated hydraulic performance of these roughness features is to increase post-treatment low flow water depth conditions and to slow water post-treatment water velocity conditions across the range of stream discharges (flows ranging from the 5% to 95% of the daily exceedance stream discharge). The reason pre-cast roughness features were selected over weirs or baffles was because the proposed treatment was only to be applied in the ODOT owned portion of the culvert barrel. It was anticipated that any NMF entering the culvert outlet would already be sprinting the untreated county owned portion of the culvert barrel and any additional hydraulic jump at the transition point into the treated portion of the culvert barrel could be an impediment to successful upstream passage. ODOT and ODFW staff agreed that these precast roughness features would be the best experimental design treatment likely to create the desired hydraulic outcome while minimizing the likelihood of an unanticipated detrimental hydraulic outcome at the transition point of culvert ownership. The anticipated biological implications are to increase the window of hydraulic conditions necessary for successful upstream migration for both adult and juvenile NMF. This will likely result in improved seeding of the upper reaches of Fairgrounds Creek.

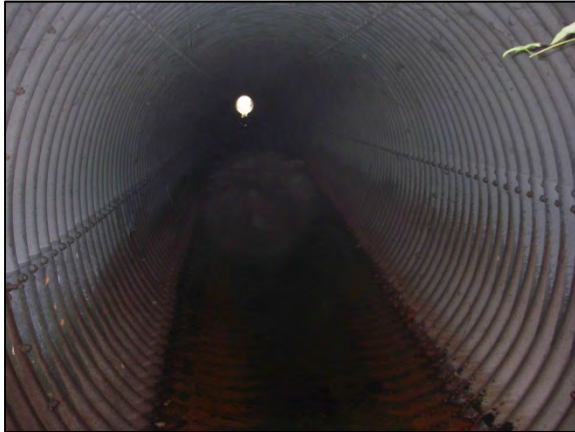
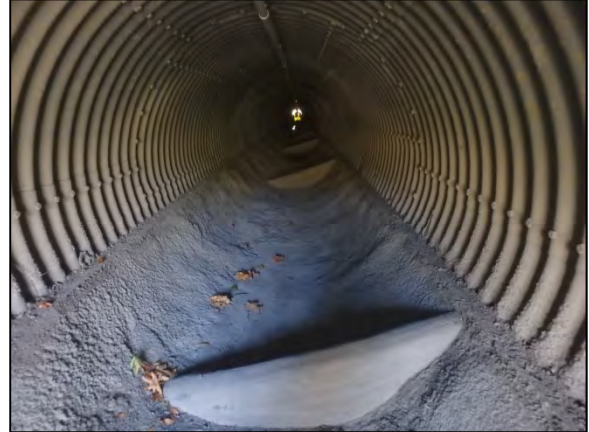
I-5 MP 110.31 Vandine Creek Culvert pre-treatment (left), post-treatment (right)

Pre-treatment Fish Passage Condition. Vandine Creek is a tributary to the South Umpqua River north of Myrtle Creek, Oregon. Vandine Creek is seasonal in nature and typically dries up during the summer low flow period in the reach where the I-5, MP 110.31 culvert crossing is located. It is used by cutthroat trout, steelhead, and Coho salmon during periods of the year they are able to successfully access it. Vandine Creek is also assumed to be current or historic habitat for Pacific lamprey. The pre-treatment culvert condition was an 8 foot diameter multi-plate round metal culvert, 327 feet in length and installed at an approximate slope of 3 to 4%. The approximate average active channel width in Vandine Creek channel upstream and downstream was estimated at 13 feet in width. During project scoping, a culvert outlet perch was observed of approximately 10 feet. The culvert outlet is located on bedrock, so that even without the culvert there would be a significant natural step or falls at this location. Significant volume (>1-2 feet deep) of substrate ranging from boulders to fines in size had accumulated throughout the culvert invert.

The Vandine Creek culvert is located at confluence of Vandine Creek and the South Umpqua River. The extreme annual variance in the river height of the South Umpqua River causes the jump height into the culvert outlet to vary between approximately 10 feet at low flow to a backwatered condition during the high flow events. Pre-treatment hydraulic condition likely resulted in flow depths less than 12 inches during some portions of the adult salmonid migration periods and likely velocities well in excess of 2 feet per second during some portions of juvenile salmonid migration periods. It is theorized that by the time the South Umpqua River reaches a discharge approaching the 5% daily exceedance stream flows allowing NMF fish to access the culvert outlet, the flow in Vandine Creek has already crested and is likely much less than the 5% daily exceedance flow. Therefore the pre-treatment condition likely resulted in a nearly complete upstream barrier for both adult and juvenile salmonids except during this short coincidental time period when discharges were near 5% daily exceedance flow in the South Umpqua River and discharges in Vandine Creek are still high enough to allow for adequate water depth for upstream migration of adult or juvenile NMF. Biological implications from these pre-treatment conditions likely included significant delay or complete barrier of upstream fish passage during most portions of the year and the frequent possibility of under seeding or no seeding in the upper reaches of Vandine Creek by adult NMF most water years.

Post-treatment Fish Passage Condition. The Vandine Creek culvert repair included the instillation of 15, corner baffles, ranging from inches in 30 inches in height at the high side and 6 inches in height at the low side relative to the culvert invert. The anticipated hydraulic performance of these corner baffles is to increase post-treatment water depth conditions by a minimum of 6 inches at low flow conditions and to slow post-treatment water velocities conditions across the range of stream discharges (flows ranging from the 5% to 95% of the daily exceedance stream discharge). The incremental fish passage benefit strategy is to increase the likelihood that the hydraulic conditions allow for greater upstream passability for both adult and juvenile NMF coincident to the times when the discharge in the South Umpqua River

allow NMF access to the culvert outlet. The anticipated biological implications are to increase the window of hydraulic conditions necessary for successful upstream migration for both adult and juvenile NMF. This will likely result in greater use of Vandine Creek's rearing and refugia habitats for both adult and juvenile NMF, particularly during high flow events in the South Umpqua Basin.

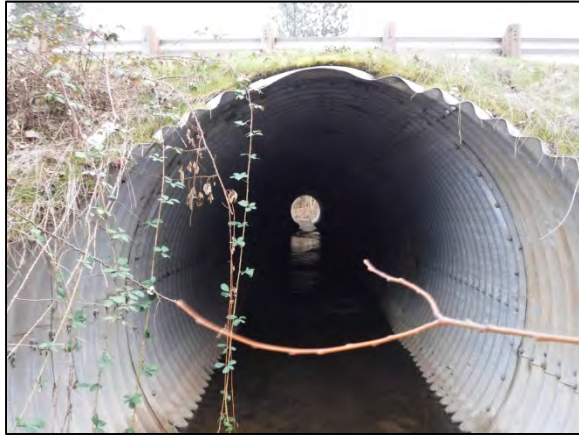
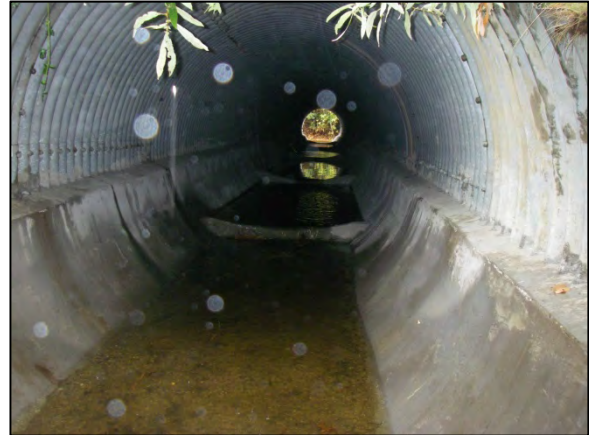
Blackwell Creek Culvert pre-treatment (left), post-treatment (right)

Pre-treatment Fish Passage Condition. Blackwell Creek is a tributary to the Upper Rogue River west of Medford, Oregon. Blackwell Creek is seasonal in nature along the reach where the I-5, MP 40.23 culvert crossing is located. It is used by cutthroat trout, steelhead, and Coho salmon. The pre-treatment culvert condition was a 9 foot diameter multi-plate round metal culvert, 136 feet in length and installed at an approximate slope of <1%. The approximate average active channel width in Blackwell Creek channel upstream and downstream was estimated at 6 feet in width. During project scoping, a backwatering of the culvert outlet was observed of approximately 12 inches of water depth and fine sediment had accumulated along the entire length of the culvert invert. Pre-treatment hydraulic conditions likely resulted in flow depths less than 12 inches during some portions of the adult salmonid migration periods and velocities in excess of 2 feet per second during some portions of juvenile salmonid migration periods. Therefore the pre-treatment conditions likely resulted in a partial upstream barrier for both adult and juvenile salmonids during a portion of the range of stream flows when NMF need to migrate (flows ranging from the 5% to 95% of the daily exceedance stream discharge). Biological implications from these pre-treatment passage impediments likely included the delay of upstream fish passage during portions of most years and the possibility of under seeding of upper reaches with adults salmonids in low water years.

Post-treatment Fish Passage Condition. The Blackwell Creek culvert repair included the installation of six weirs 15 inches in height with 6-inch low flow notches (height of notch relative to the culvert invert elevation). The anticipated hydraulic performance of these post-treatment weirs is to increase water depth conditions by a minimum of 6 inches at low flow conditions and to slow post-treatment water

velocities conditions across the range of stream discharges when NMF migrate (flows ranging from the 5% to 95% of the daily exceedance stream discharge). The anticipated biological implications are to increase the window of hydraulic conditions necessary for successful upstream migration for both adult and juvenile NMF. This will likely result in improved seeding of the upper reaches of Blackwell Creek, particularly during low water years.
