**SUBJECT:** Benefit Analysis for South Umpqua River Tributary, ODOT I-5 Roberts Mountain Fish Passage Exemption Request

# ODOT I-5 Crossing over South Umpqua Tributary

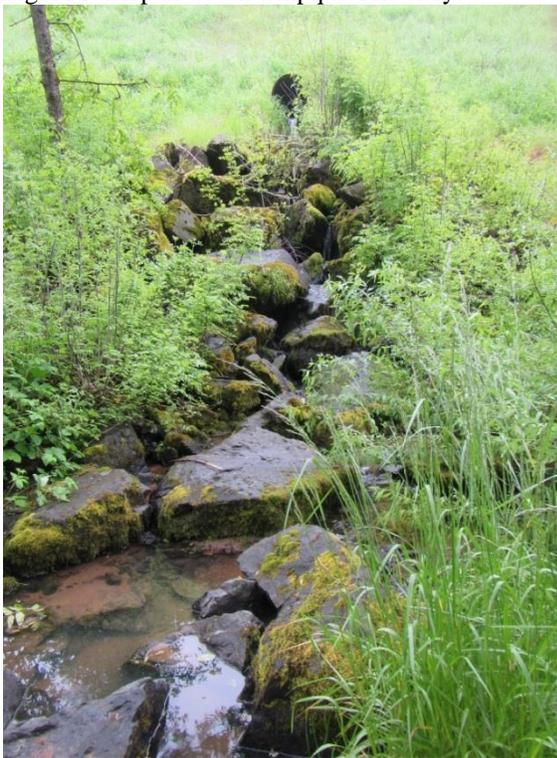
Figure 2. ODOT barrier culvert outlet at I-5 MP 115.95. (May 2017)

The small, unnamed tributary originates in the hills east of the highway, flows west through the 450-foot-long, 4-foot-diameter corrugated metal culvert, and exits 134 feet beneath the surface of the road fill (See map, Figure 1). The stream then follows along the western edge of the road fill 0.4 miles before entering private property, and then flows 1 mile through agricultural land to the South Fork Umpqua River. The existing culvert, at 28% slope and with a 4-foot high outfall drop, is a complete barrier to fish passage (Figure 2). Construction of the new lane would require lengthening the existing culvert 50 feet, widening the road fill to the west, and relocating 800 feet of the downstream channel west of its current location.

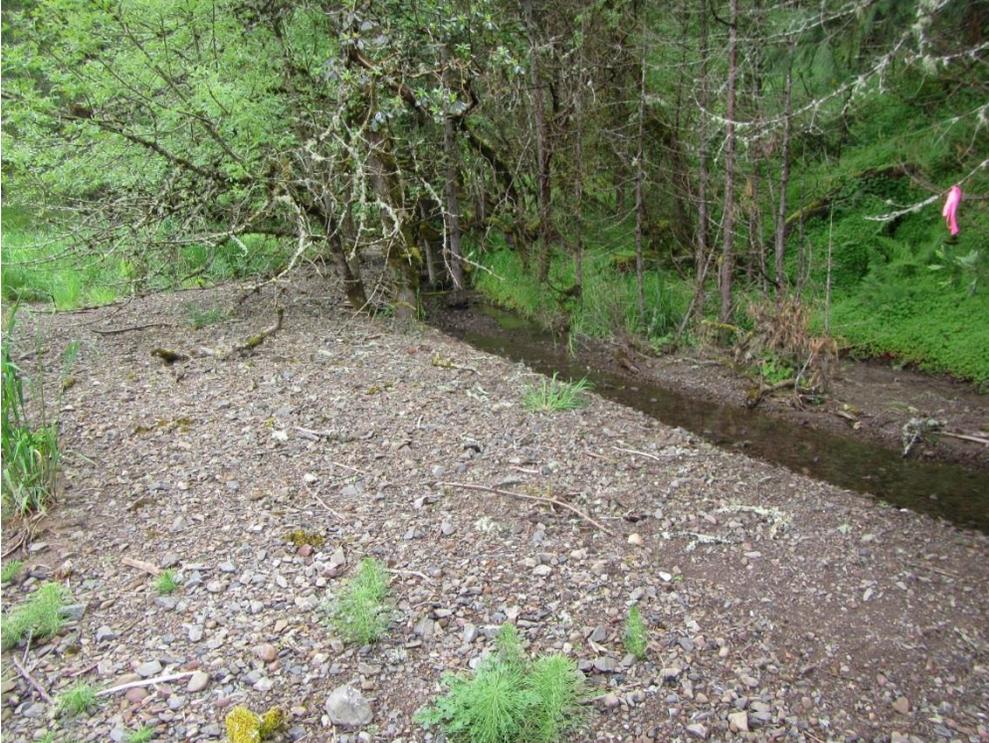
Immediately upstream of the crossing through the ODOT right of way 900 feet to the end of fish habitat, the stream cuts through a large deposit of streambed sediment impeded by the undersized culvert from transport downstream. (Figure 3). This reach of stream is prone to disturbance on a regular basis, as there is evidence of large episodic inputs of sediment, very little established vegetation (herbaceous or otherwise), and a shifting channel alignment, resulting in very poor fish habitat.

Figure 3. Upstream of the crossing in the ODOT right of way. (May 2017)

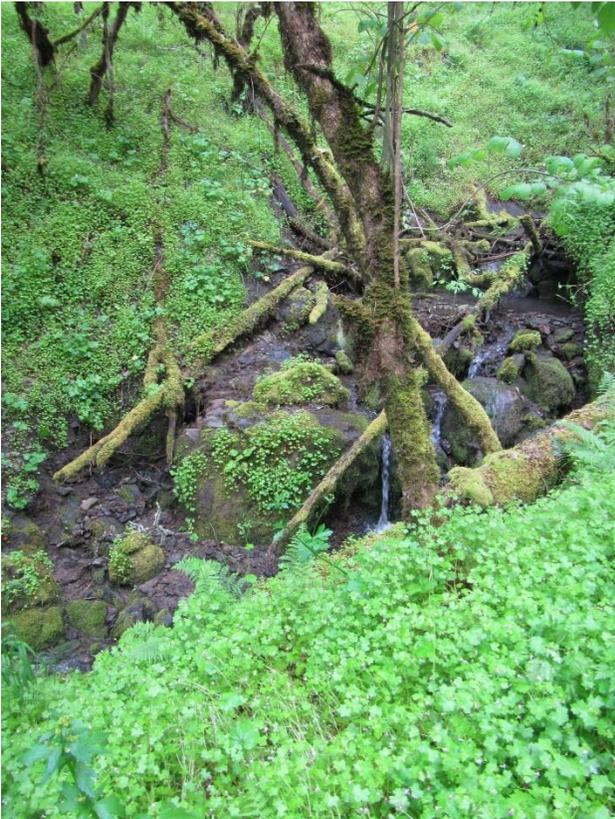
Figure 4. Steep channel upstream of ODOT right of way. (May 2017)

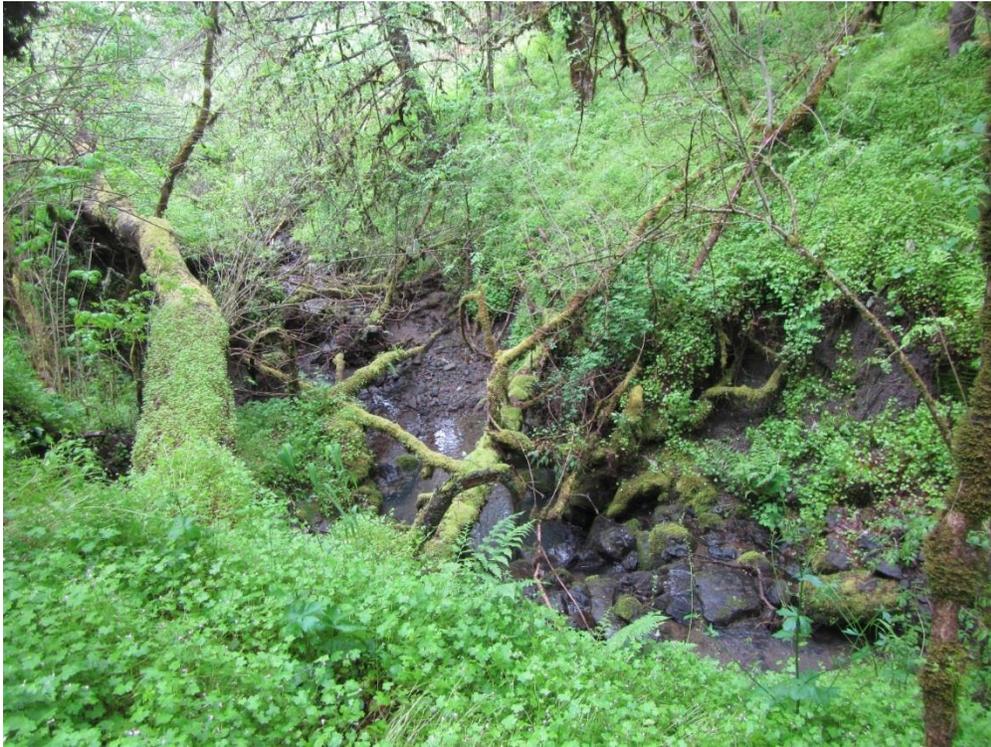
Figure 5. Steep channel upstream of ODOT right of way. (May 2017)

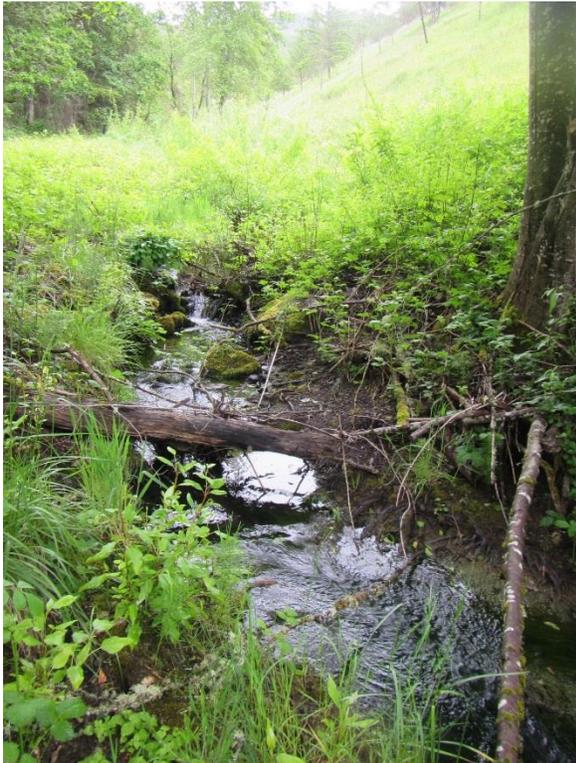
Figure 6. Downstream of the ODOT crossing within the ODOT right of way (this portion of the channel would be relocated to the west (left)). (May 2017)

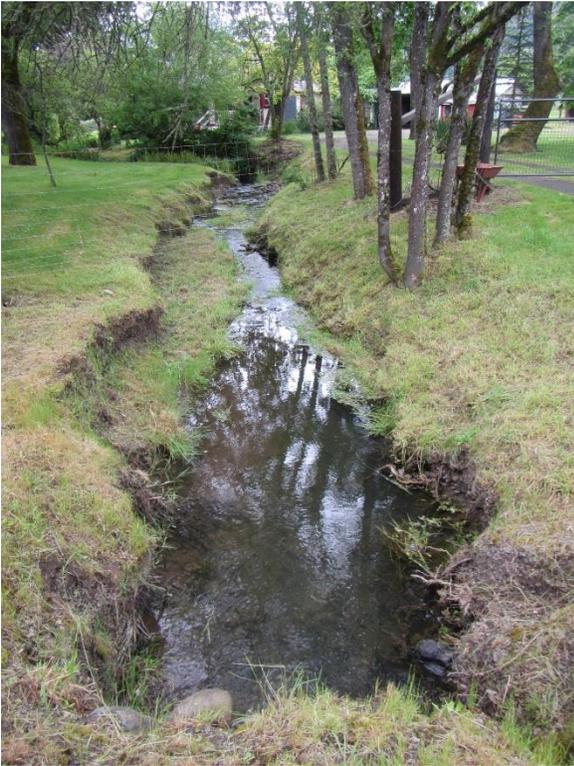
Figure 7. Downstream of the ODOT crossing as it enters private property. (May 2017)

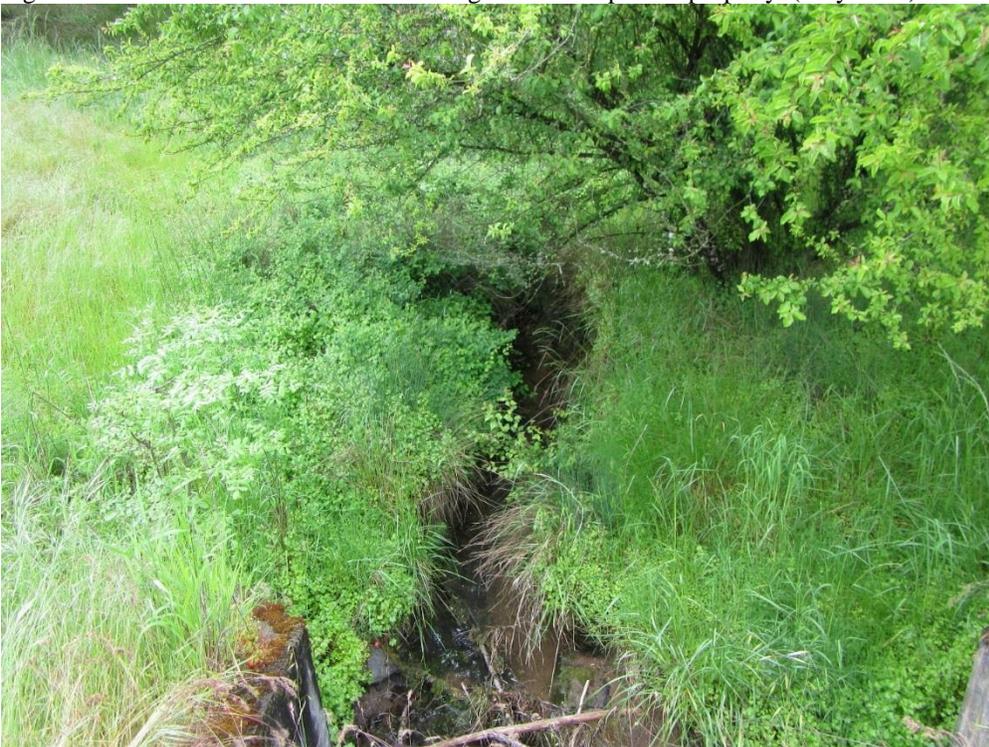
story vegetation, and is dominated with non-native blackberries (Figures 8, 9). Although the stream is perennial in the upper reaches, according to the ranch manager, it is known to go dry during the late summer through sections of this reach. This section of stream may be used by native migratory fish, but the habitat quality likely limits the amount of fish use in this basin.

Figure 8. Upstream of Roberts Mountain Road partial barrier culvert. (May 2017)

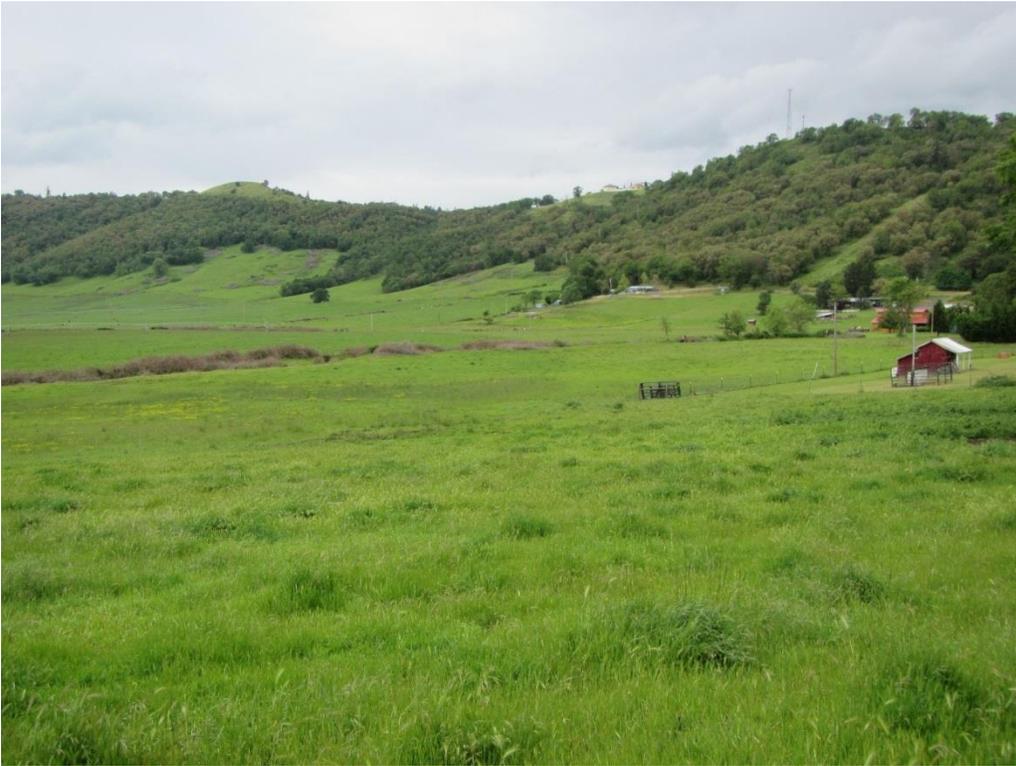
Figure 9. Stream flowing through the ranch near its confluence with South Umpqua River. (May 2017)
