Rick Demmer, Bureau of Land Management, Prineville, Oregon 97554

Robert L. Beschta¹, College of Forestry, Oregon State University, Corvallis, Oregon 97330

Recent History (1988-2004) of Beaver Dams along Bridge Creek in Central Oregon

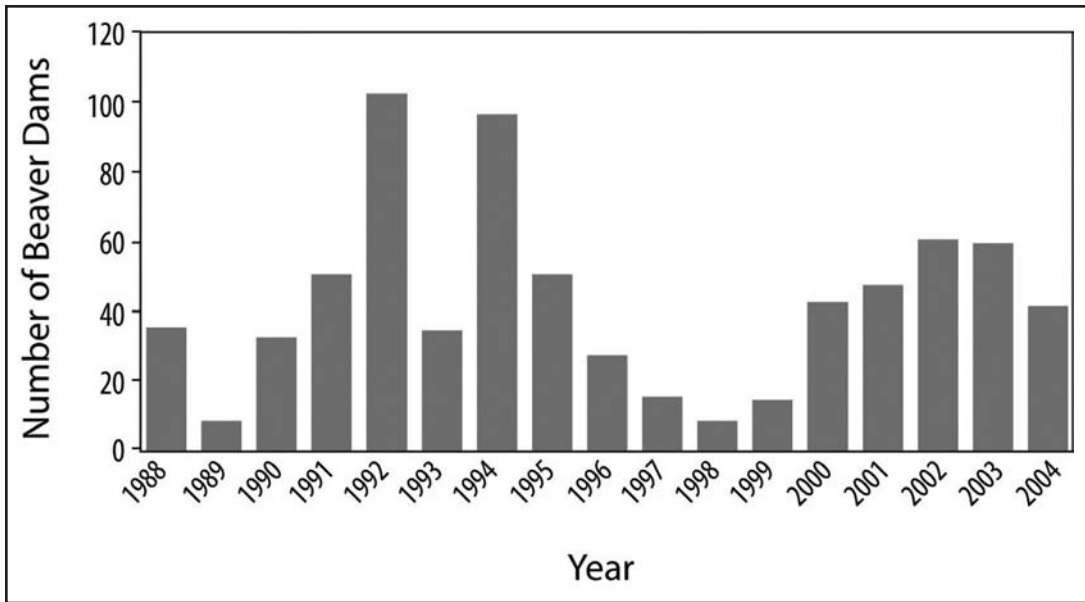
Figure 1. Total number of inventoried beaver dams, by year, along 25.4 km of Bridge Creek in central Oregon.

We inventoried 36 beaver dams along Bridge Creek in November of 1988, the 1st yr of the study. In subsequent years, the number of dams inventoried each fall ranged from 9 to 103 (Figure 1). Dams were built from locally obtained materials including stems of woody vegetation, driftwood, forbs, rocks, and mud. Average (\pm SD) dam and pond dimensions were: dam lengths = 8 m (\pm 6 m), maximum pond widths = 8 m (\pm 5 m), pond lengths = 26 m (\pm 18 m), maximum pond depths = 0.8 m (\pm 0.3 m), pond surface areas = 120 m² (\pm 150 m²), and pond volumes = 80 m³ (\pm 130 m³) (Figure 2). The length of time that dams remained in place varied from <1 to 7 yrs, with a high proportion of dams (i.e., 75%) lasting \leq 2 yrs.

and breached most dams in 1993, 1997, and 1998. Peakflows of the John Day River for these 3 yrs represented the 4th, 2nd, and 1st largest runoff events, respectively, during this study. Linear regression indicated a significant inverse relationship ($r = -0.49$, $P = 0.05$) between annual peakflow of the John Day River and number of beaver dams, supporting field observations that indicated fewer dams following the occurrence of high flows.

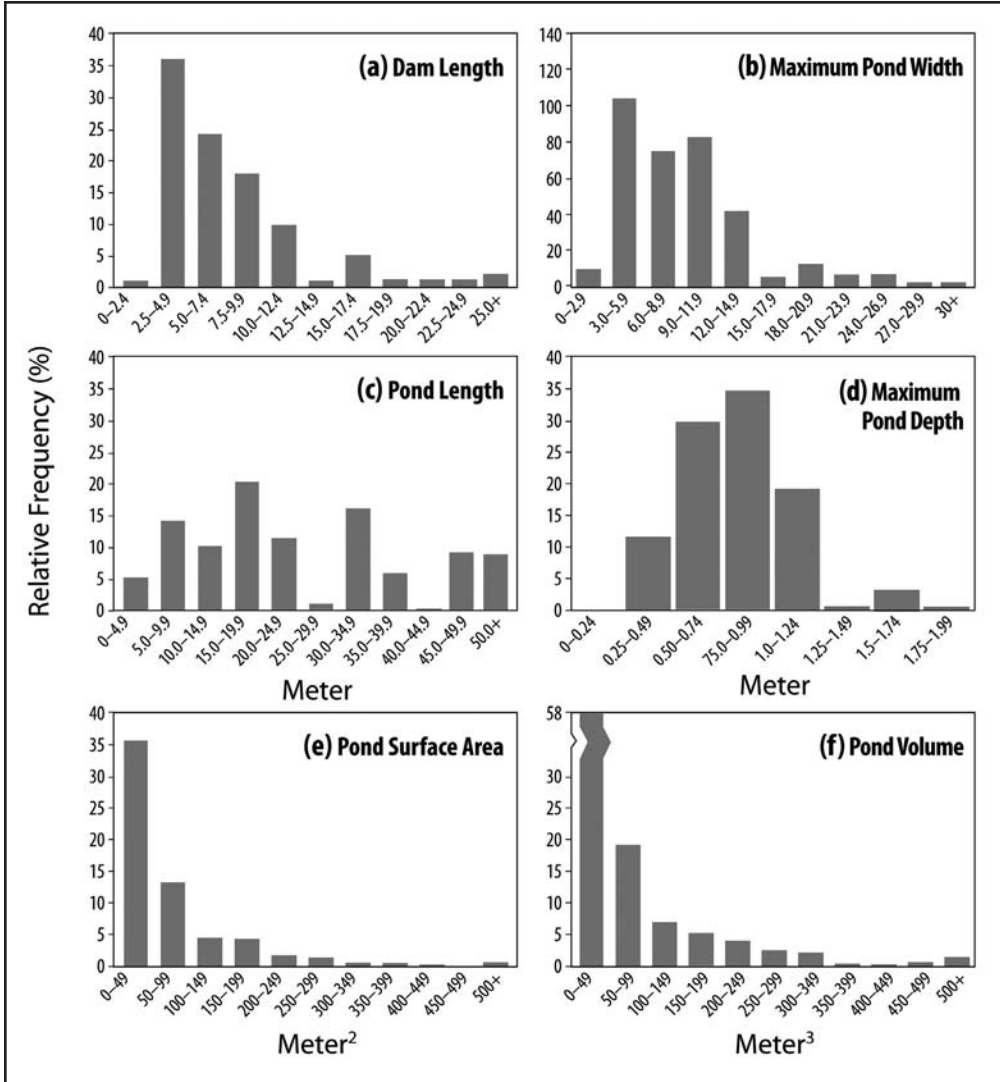
Figure 2. Frequency histograms of a) dam length (m), b) maximum pond width (m), c) pond length (m), d) maximum pond depth (m), e) pond surface area (m²), and f) pond volume (m³).

We visually estimated the following dimensions of each beaver dam and pond: dam length, pond length (l), maximum pond width (w), maximum pond depth (d). Since maximum pond widths and depths were typically greatest immediately upstream of a given dam, pond surface areas were calculated as $1/2 * l * w$ (area of a triangle) and pond volumes as $1/3 * l * w * d$ (volume of a pyramid). We located and dimensioned 476 dams over the 17 yrs of this study.

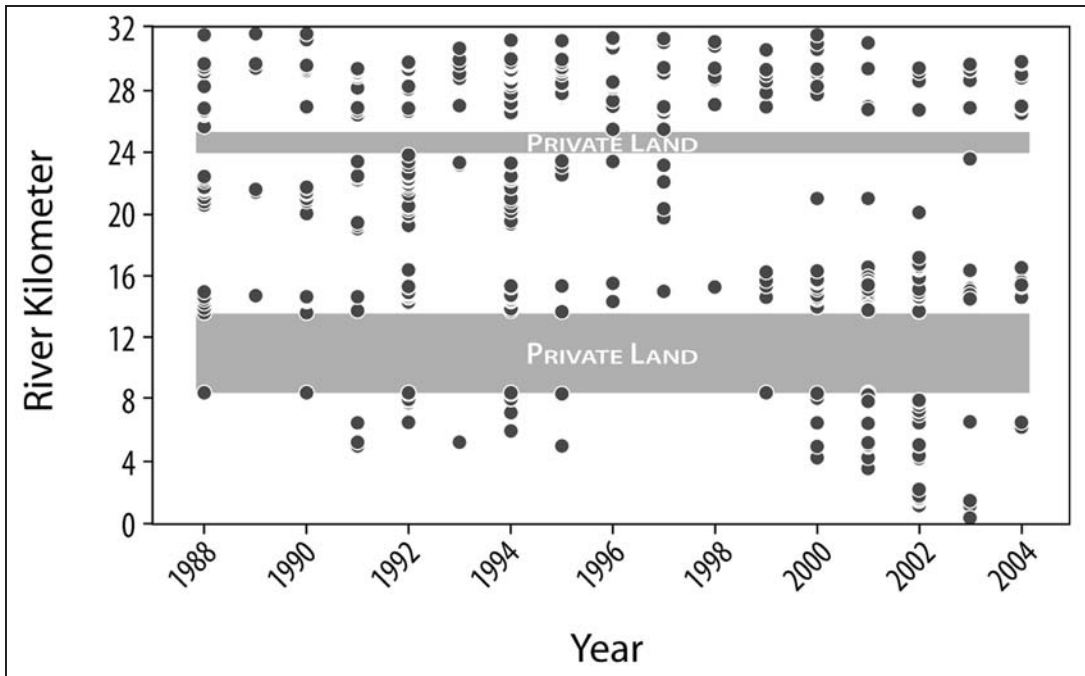
Figure 3. Occurrence of new beaver dams (closed circles) by year and river kilometer (rkm) along the Bridge Creek study reach. Private lands (from 8.5-13.7 rkm and 24.1-25.3 rkm) were not inventoried.

The spatial distribution of dams (Figure 3) was generally associated with the occurrence of improved riparian plant communities following reductions in livestock grazing and previously abandoned reaches. Thus, dams that had become breached or washed away by high flows were often not replaced if willows were more abundant at other locations. Once a site was abandoned, the previously utilized woody plant communities rapidly recovered within a few years. The germination of willow seeds that fell or washed onto newly exposed alluvial deposits following the loss of a dam typically formed a dense mat of seedlings. Species of the willow normally found along Bridge Creek generally require bare, wet soil within days of seed ripening in the spring (Brinkman 1974). In addition, willows that had been cut almost to the ground grew new stems and beaver-cut portions of willow stems that littered streambanks and alluvial deposits often sprouted.

(Figure 3) where habitat was initially marginal for their use.

The historical development and maintenance of irrigation systems along Bridge Creek had resulted in a management strategy that emphasized the removal of beaver and their dams. Before the change from private to public ownership along Bridge Creek, which occurred in stages between 1988 and 1992, beaver were routinely trapped. Trapping of beaver subsided as the transfer of land from private to public occurred and in 1992 such activities were banned along the entire stream and beaver dams were no longer removed on publicly acquired lands. In the fall of 1988 there were only 36 active beaver ponds along the Bridge Creek study reach, by 1992 the number had increased to 103 (Figure 3).

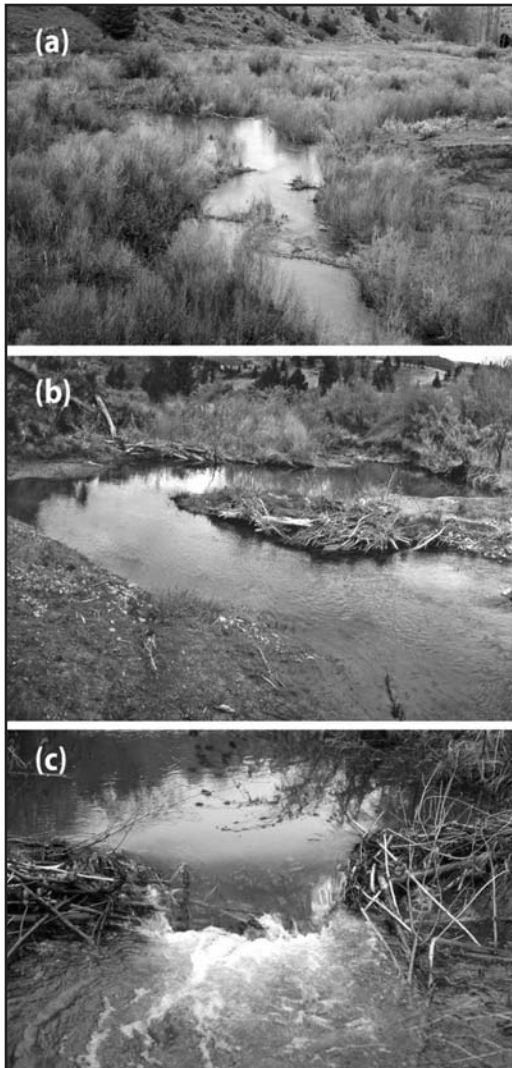
Figure 4. Examples of beaver dam effects: a) general ponding, overbank flows, and an expanded riparian plant community due to multiple dams, b) increased stream sinuosity as a result of a dam breaching on one end, and c) partial breach of dam contributing to pool formation (by scouring) immediately downstream of dam.

to be especially effective at spreading floodwaters (Figure 4a), often *via* beaver-made secondary channels, thus forming complex aquatic/riparian habitats. Dams were maintained and often enlarged during dry periods as long as riparian vegetation remained adequate for food.

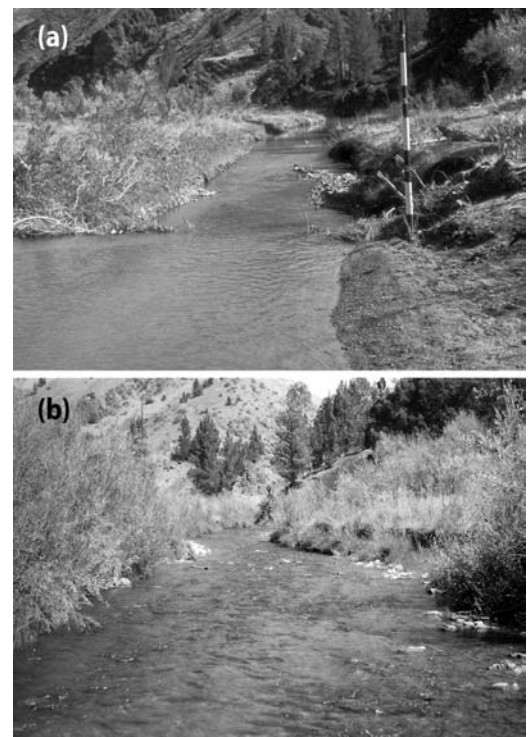
Figure 5. Chronosequence of photographs in a) 1987 and b) 1998 showing improved woody riparian plant communities along streambanks of Bridge Creek.

Along most of the study reach, observations indicated that riparian plant communities generally improved (e.g., increased numbers of woody species, height growth, and stem densities) during the course of this study (Figure 5). As these changes occurred beaver began to increasingly occupy the downstream portion of the study reach
