Fires in July 2018 and the Lower Deschutes Wildlife Area

SUBJECT: **Substation Fire (2018): Destroyed Historic Structures**
Lower Deschutes Wildlife Area
T1N, R15E, Sec 23, 25; T1S, R16E, Sec 4, 5
Emerson and Locust Grove Quads
Sherman County, Oregon

On the weekend of July 20, 2018, the Substation Fire burned over 7,000 acres in the Lower Deschutes Wildlife Area, owned by the Oregon Department of Fish and Wildlife (ODFW). Several historic structures previously documented with the Oregon SHPO were destroyed in the fire. These included two railroad cars associated with the Deschutes Railroad War, the Harris Ranch House, Harris Ranch Shearing Shed & Corrals, Harris Ranch Barn/Shed, and Harris Ranch Railroad Water Tower. Two other historic structures not previously documented, the Harris Ranch Bunkhouse and Rattlesnake Grade Bridge, were also destroyed. The only previously recorded historic structure in the area unaffected was the Freebridge over the Deschutes River (which only consists of concrete bridge pillars).

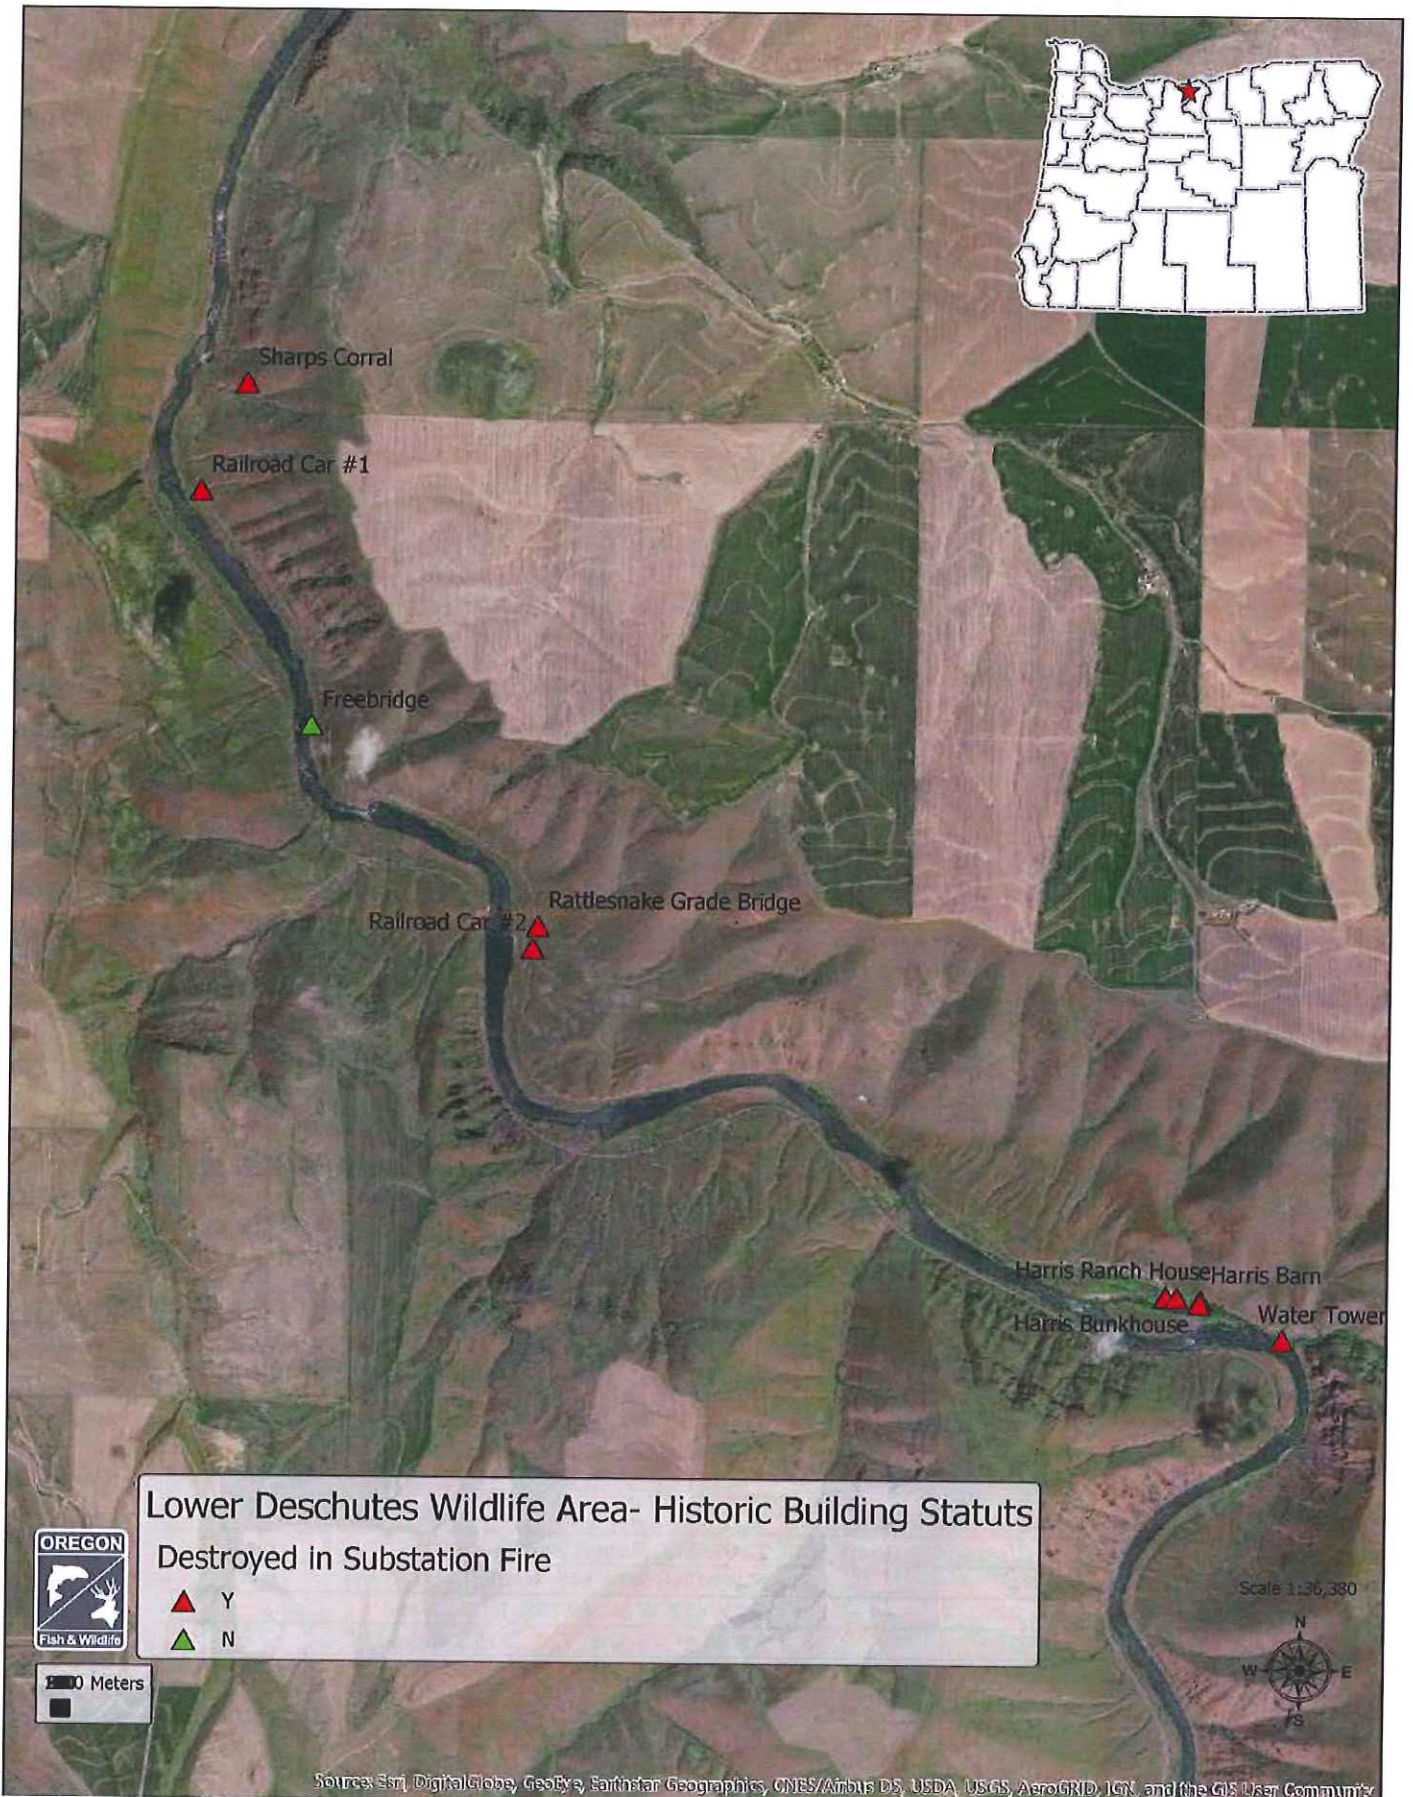
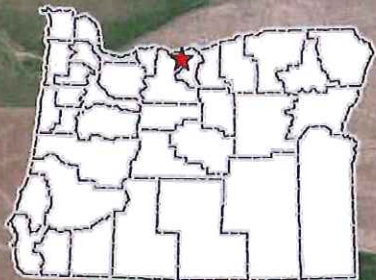
A site visit was made of each of the areas on July 30, 2018. Destruction of all of the aforementioned historic properties was near total. Legal locations are depicted below in Table 1. Maps of the locations are provided in Figures 1 and 2. Photos of the structures after the fire follow below along with a brief description of each resource. Note that each resource was recorded via GPS in the field with five meter accuracy. Some of the locations do not exactly match locations in the SHPO database that were recorded in 1995.

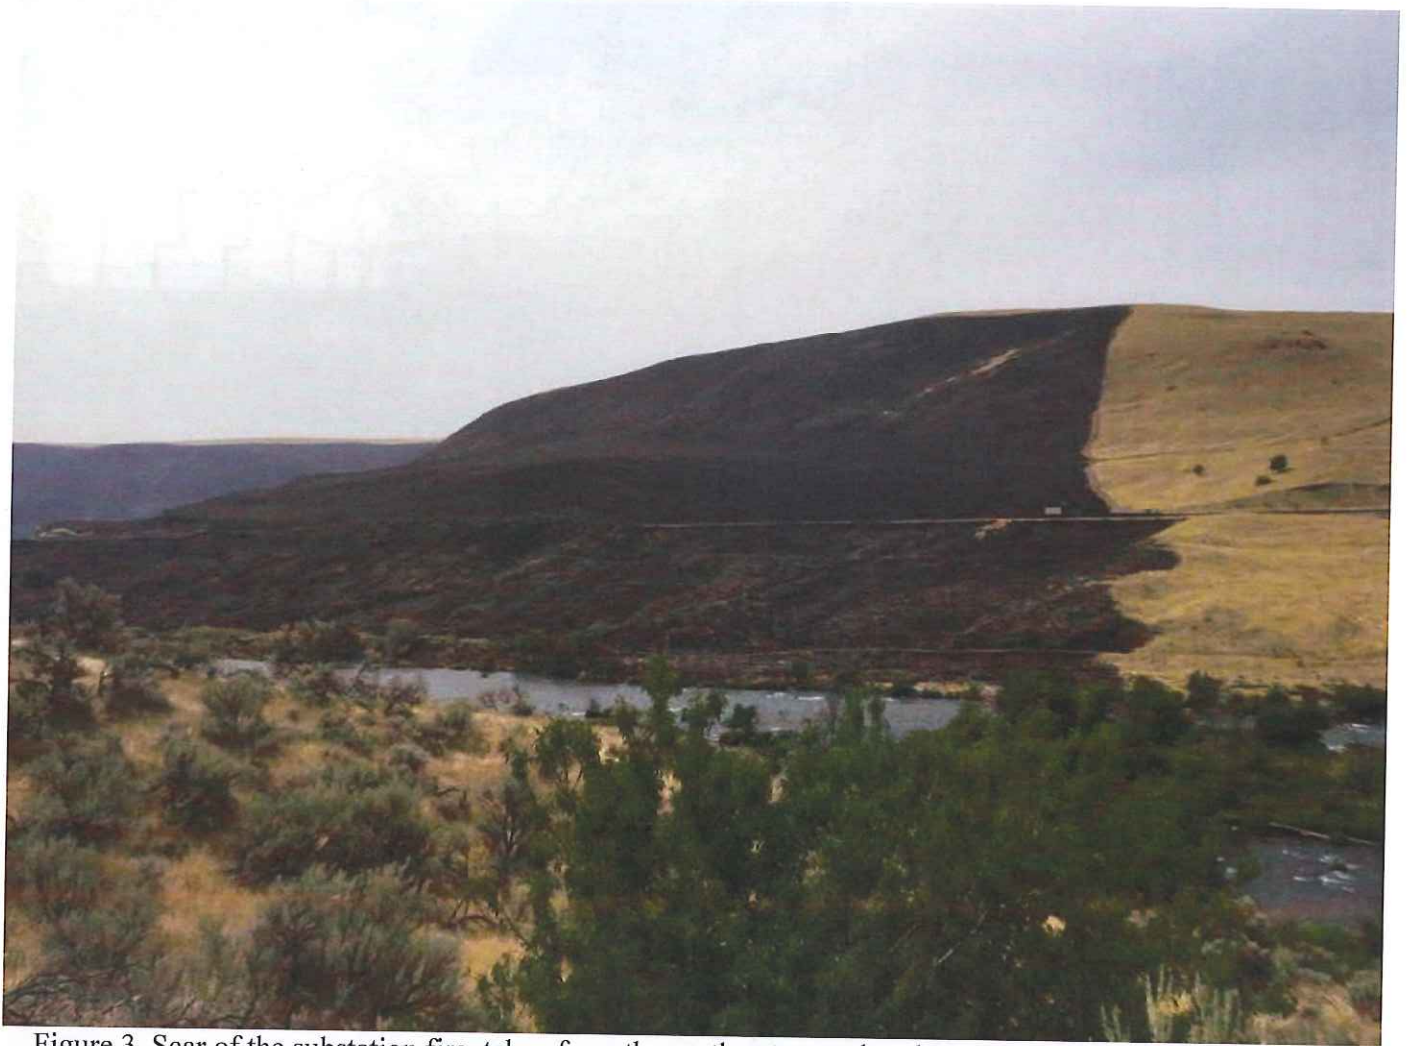
Figure 3. Scar of the substation fire, taken from the north entry road to the Lower Deschutes Wildlife Area, facing west-southwest.

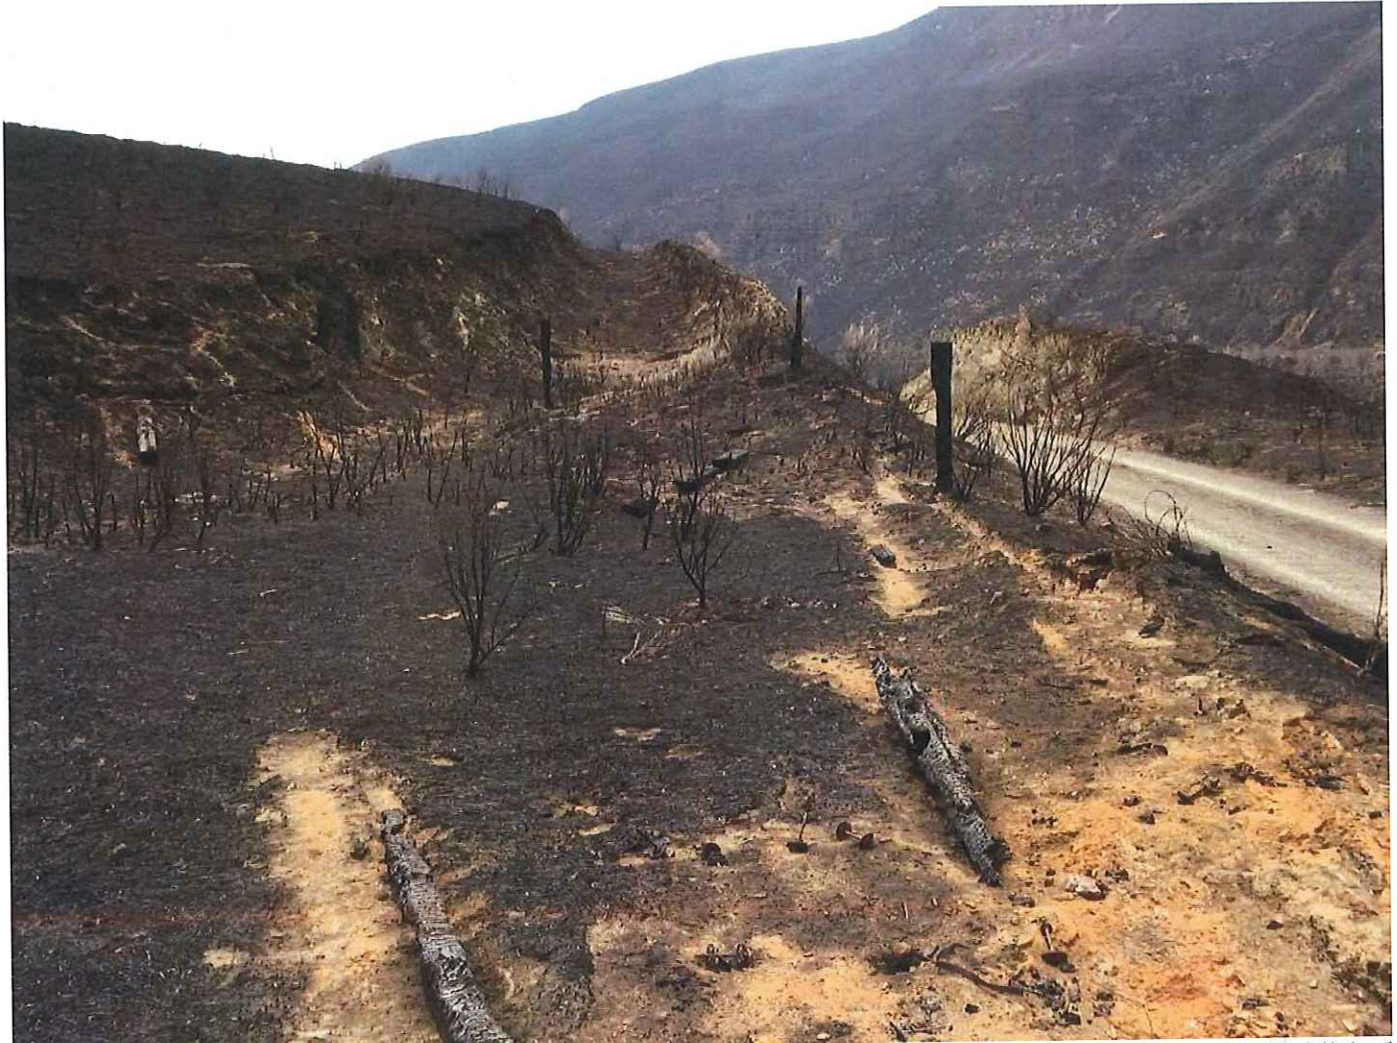
Figure 4. "Sharps Corral". This was a corral made of railroad ties near Sharps Bar. Sharps ranch was established after Harris Ranch, and was purchased by ODFW in 1983. The age of the resource is unknown- it may have been constructed by Sharps or as part of the earlier Harris Ranch. It was not previously recorded in the SHPO historic sites database. The only surviving features following the substation fire are six standing, heavily charred posts.

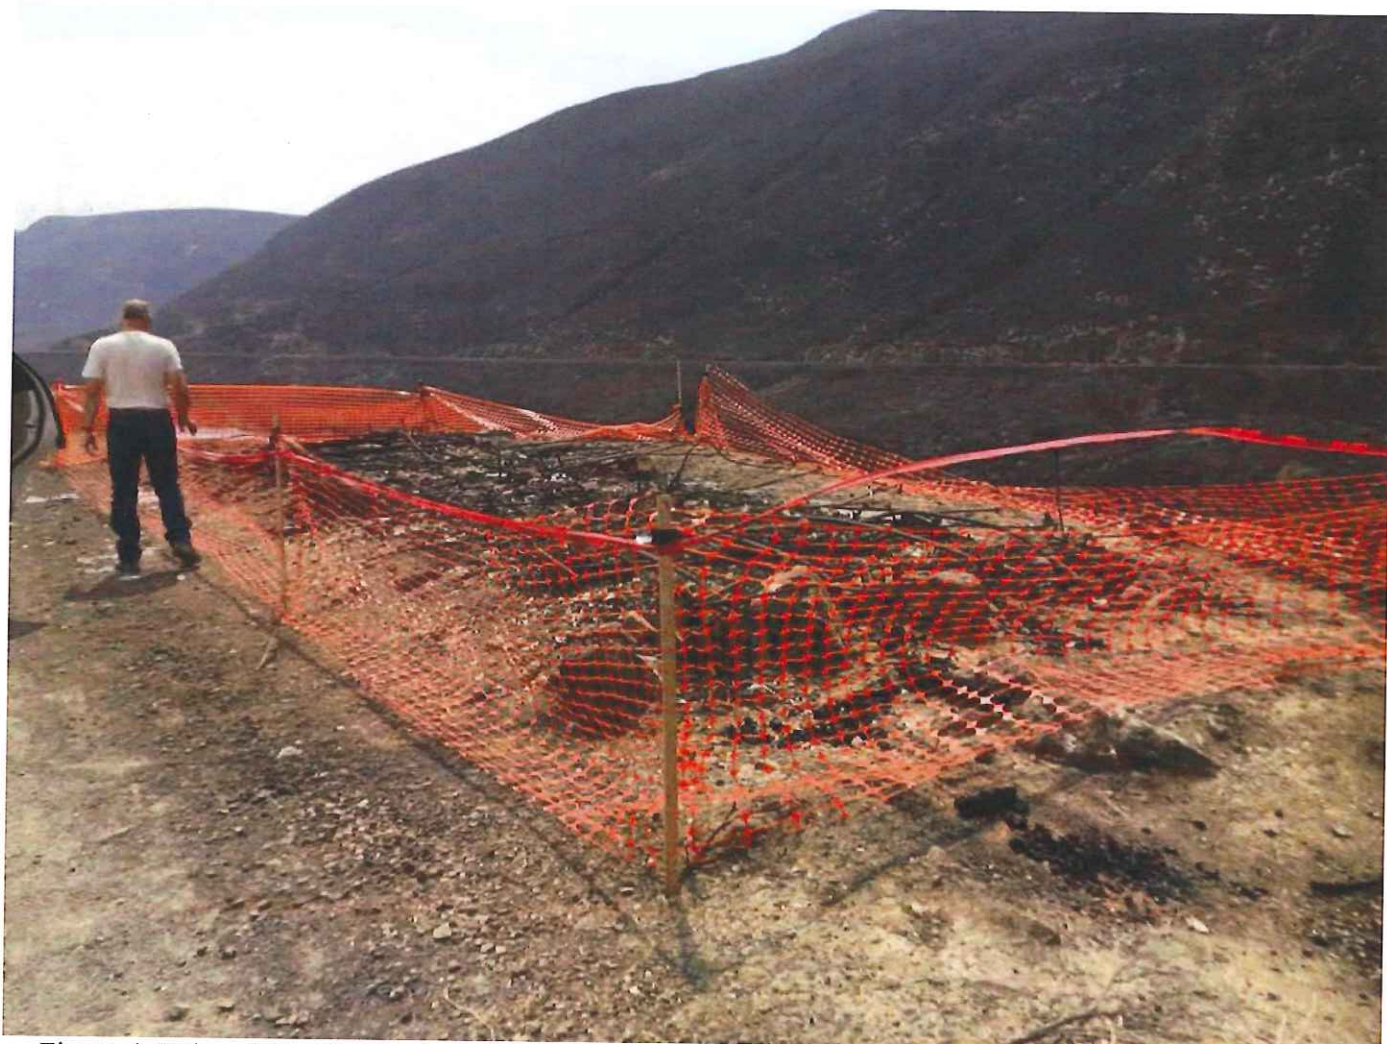
Figure 4. "River Mile 12: Deschutes River Harris Ranch Railroad Car #1". This was a historic railroad car presumed to be associated with the Deschutes Railroad Wars, circa 1908. There were no logos on the original train car. It was set alongside the main wildlife area road, which was the original railroad alignment on the east side of the Deschutes River. This was the railroad constructed by the Deschutes Railroad, a Union Pacific subsidiary owned by Edward H. Harriman. The car was completely destroyed, with only partially slagged metal remaining. Facing southwest.

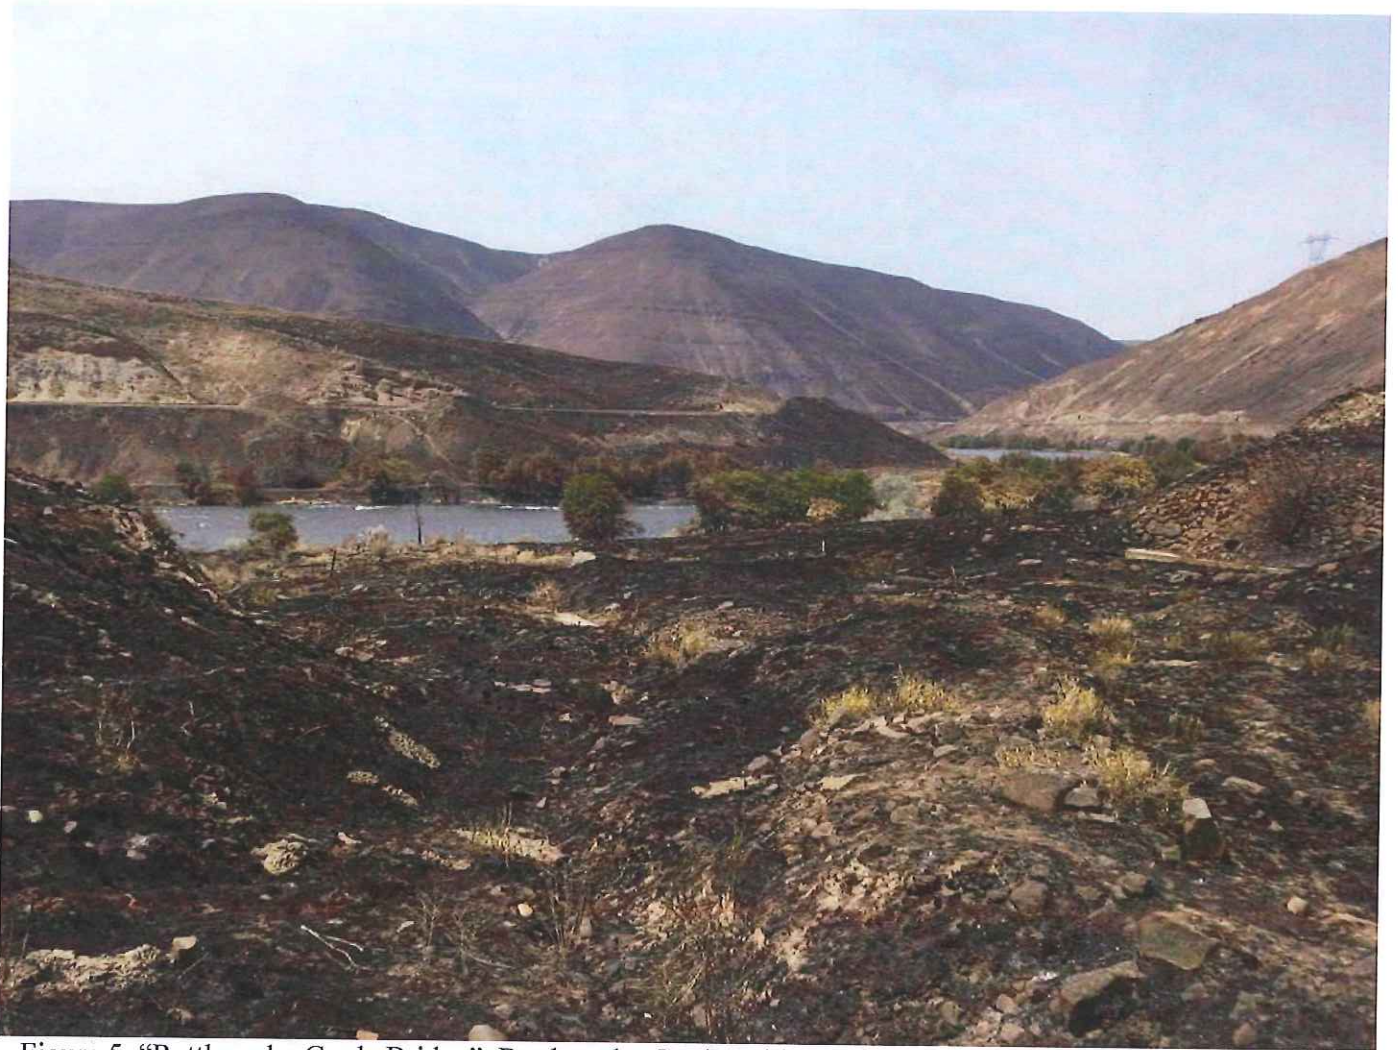
Figure 5. "Rattlesnake Grade Bridge". Rattlesnake Grade Bridge was not previously recorded in the Historic SHPO database, but is presumed to have been part of the historic Harriman railroad alignment. The only portion of the bridge that survived the fire are the earthen bridge approaches and rock rip-rapped abutments. Facing northwest.

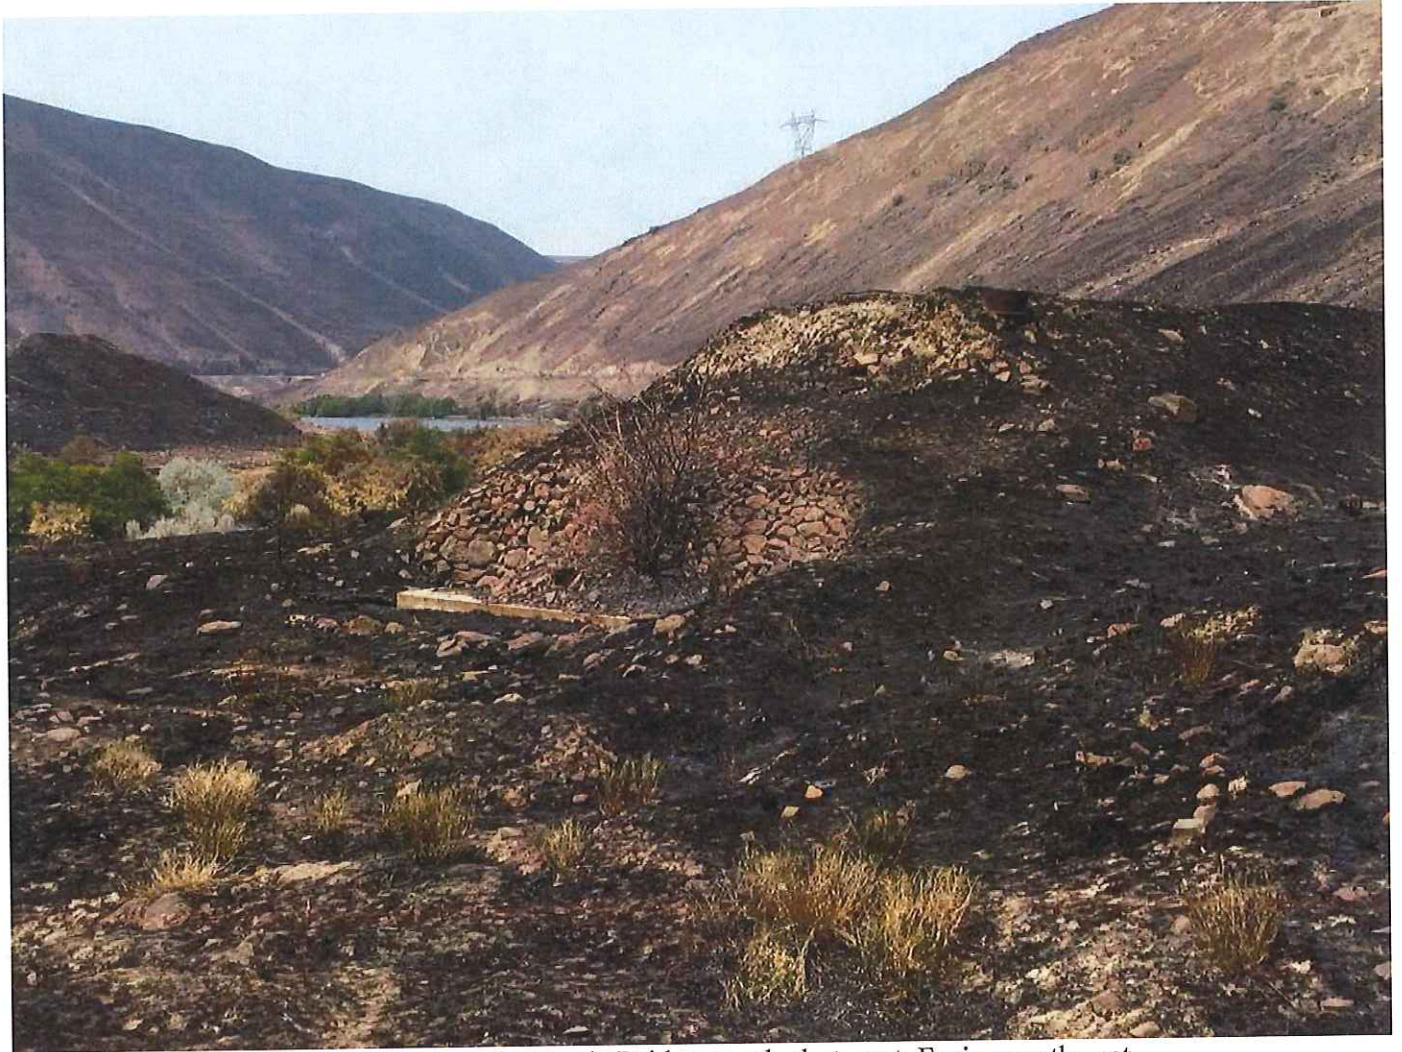
Figure 6. Rattlesnake Grade Bridge, north abutment. Facing northwest.

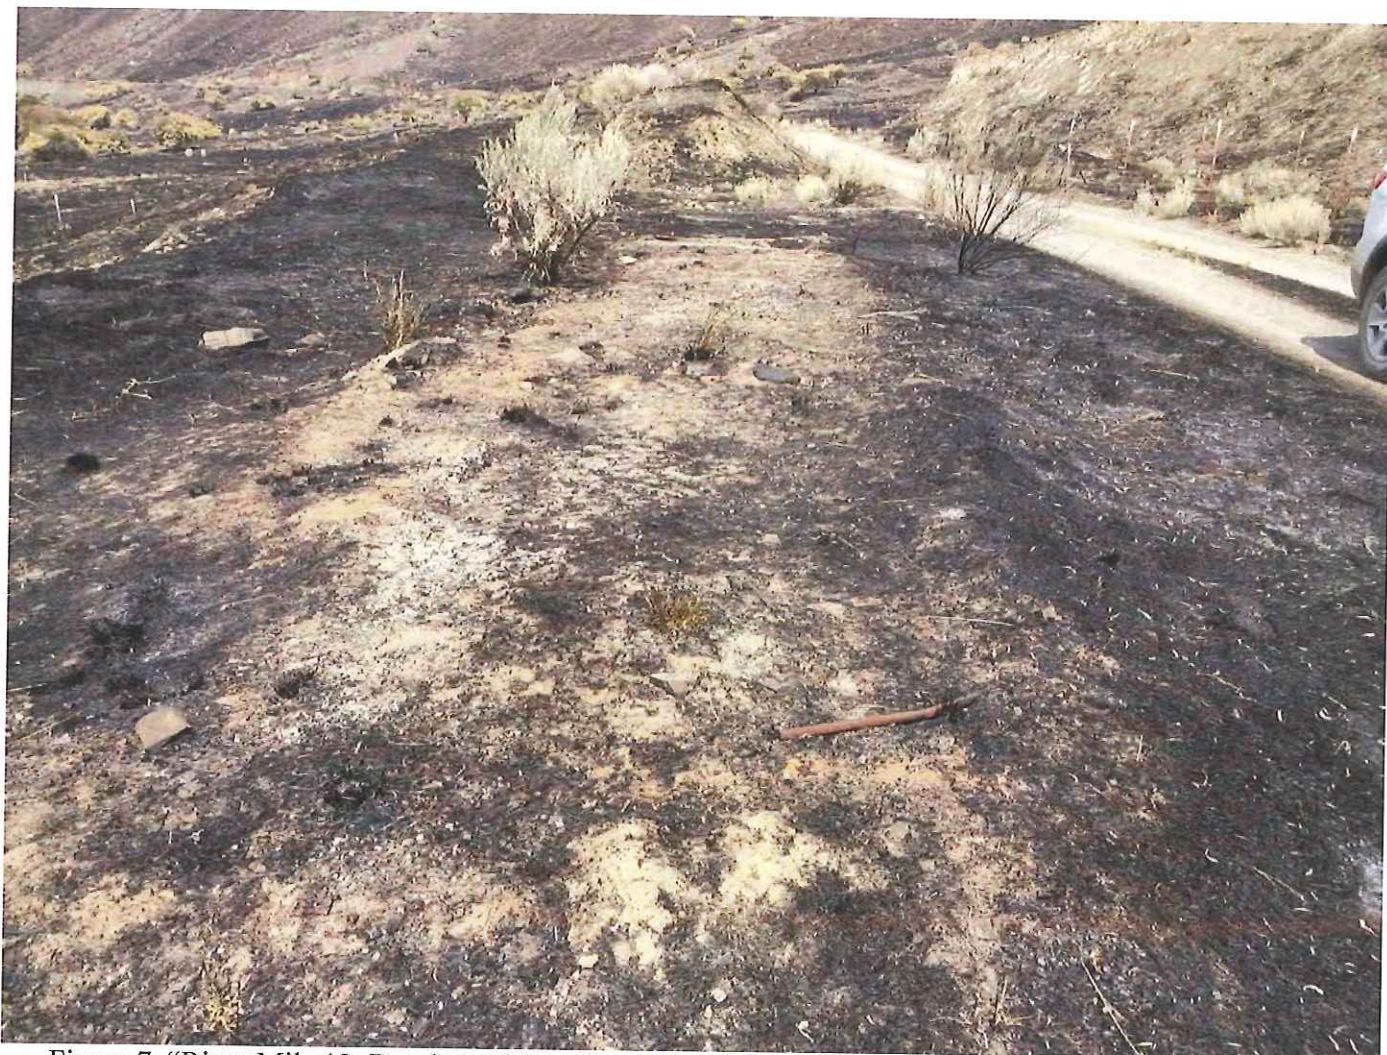
Figure 7. "River Mile 12: Deschutes River Harris Ranch Railroad Car #2". This historic railroad car was recorded in the Historic SHPO database. It was previously destroyed in a wildfire sparked by lightning circa 2008, and the metal remains were subsequently removed. The only evidence remaining of the railroad car is an earthen pad (built by ODFW after 1983) on which it was placed.

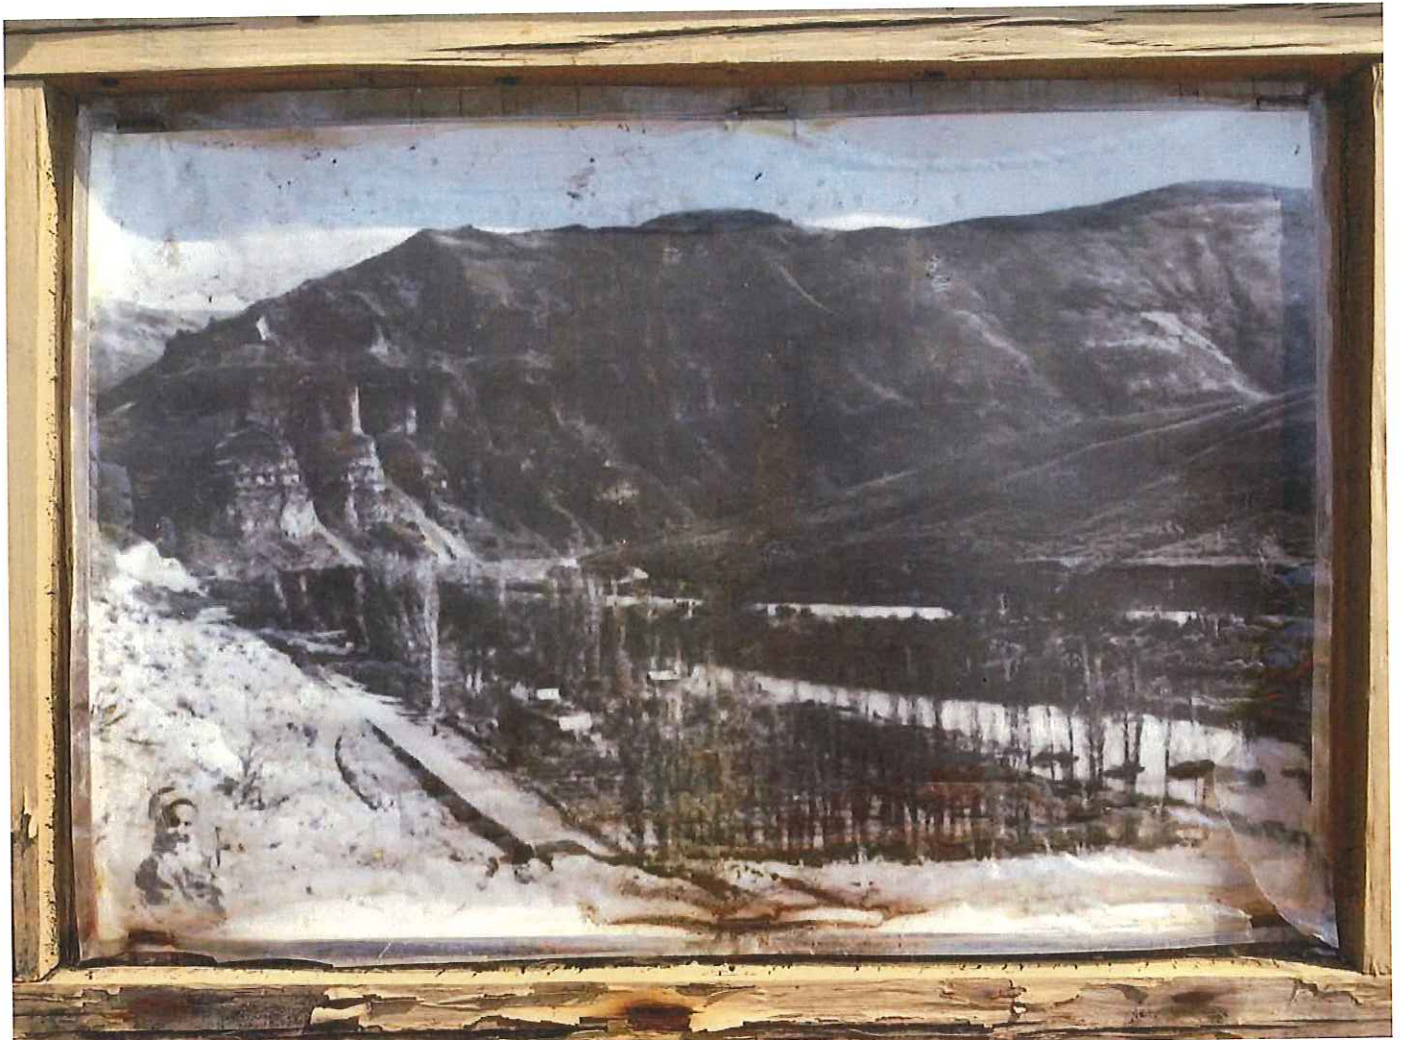
Figure 8. Historic Photo of the Harris Ranch Homestead on a display at the ranch. The photo and display sign was the only structure on the ranch that did not burn in the Substation Fire.

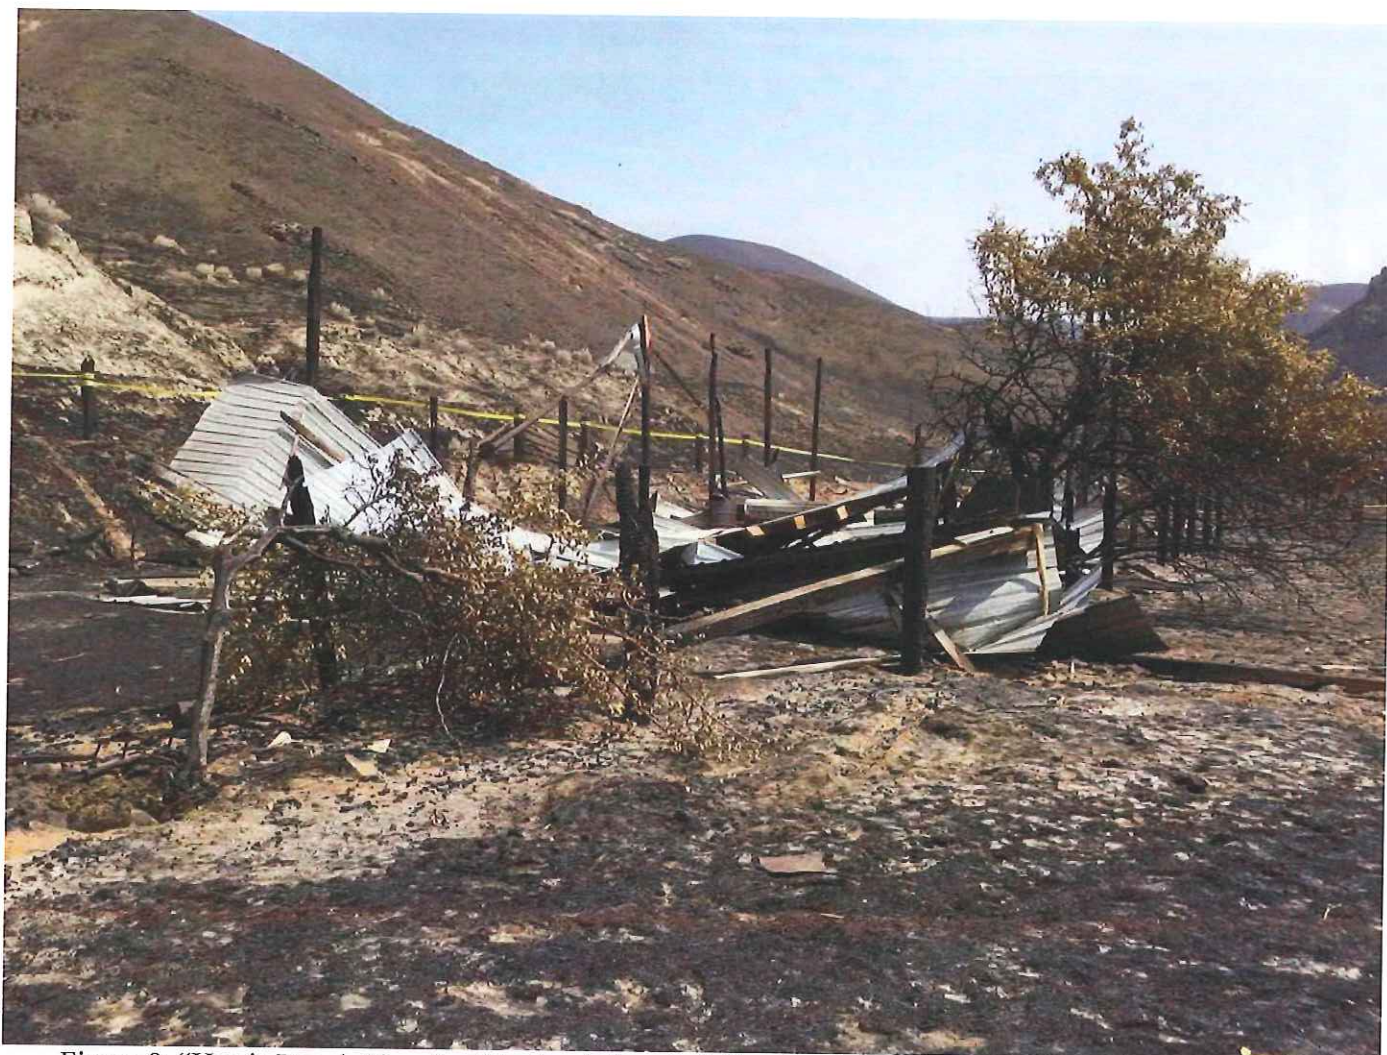
Figure 9. "Harris Ranch Shearing Shed and Corrals." The Harris Ranch shearing shed and corrals were destroyed in the fire, with only a handful of charred posts remaining of the corrals. Pictured is a hay barn that was attached to the north side of the shearing shed. The hay barn was built in 1954, and post-dated the shearing shed and corral. Facing south-southeast.

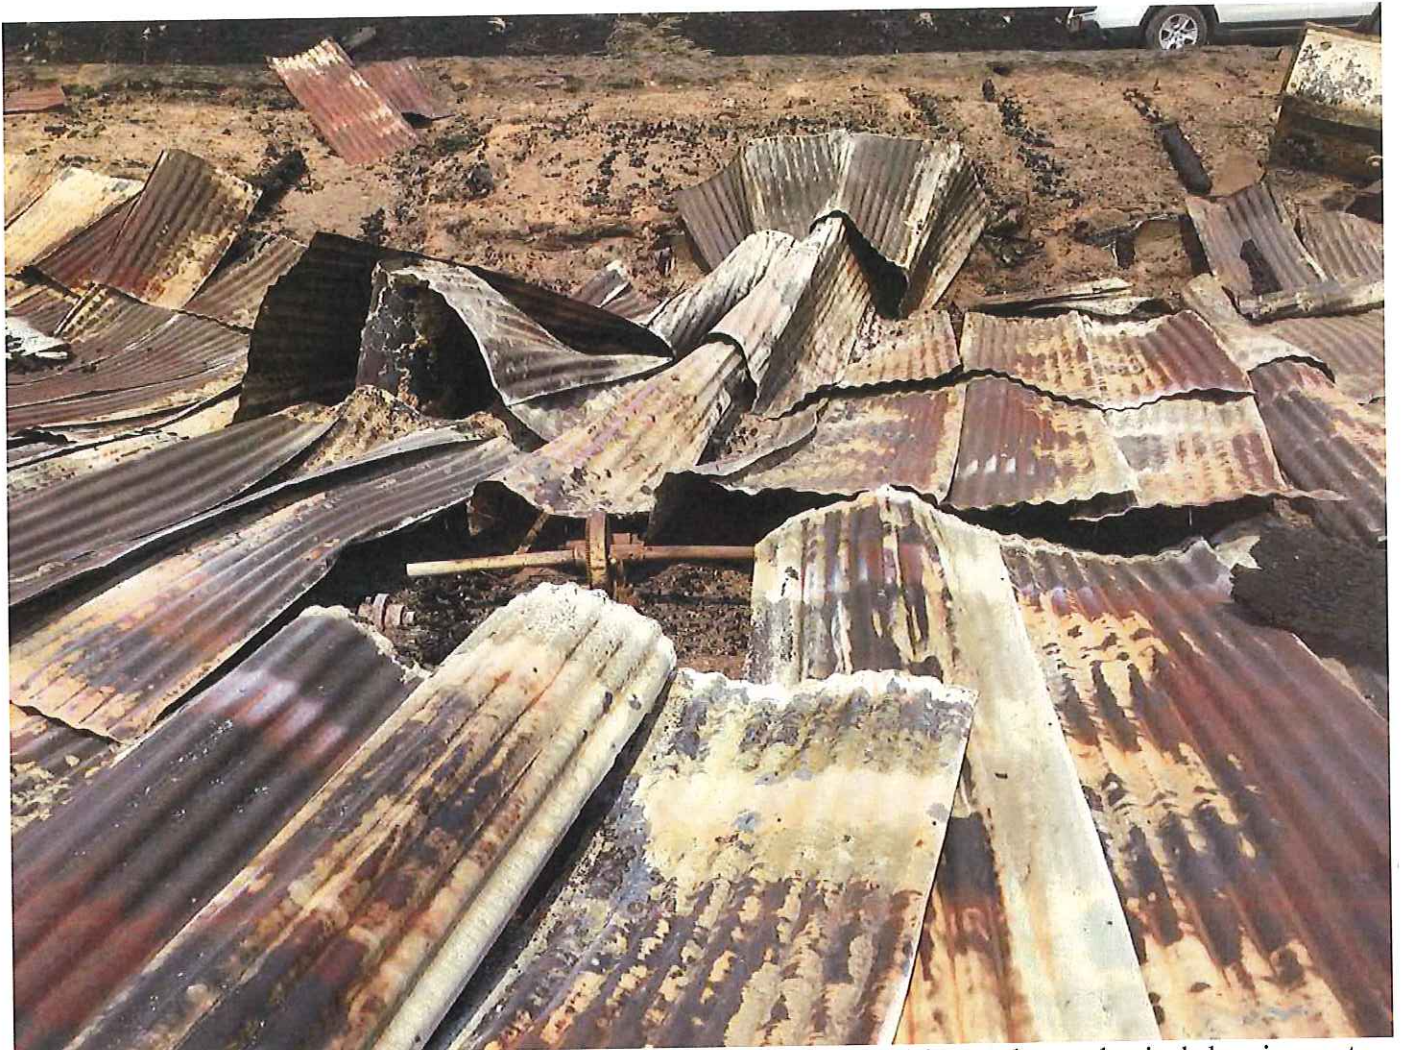
Figure 10. "Harris Ranch Shearing Shed and Corrals." The shearing shed featured a mechanical shearing system (axle pictured in center). It was built at an unknown time after the Harris House, but the worker bunkhouse (pictured below) associated with the shearing shed was constructed out of two railroad cars associated with the Deschutes Railroad that was deconstructed around the 1930s. Facing East.

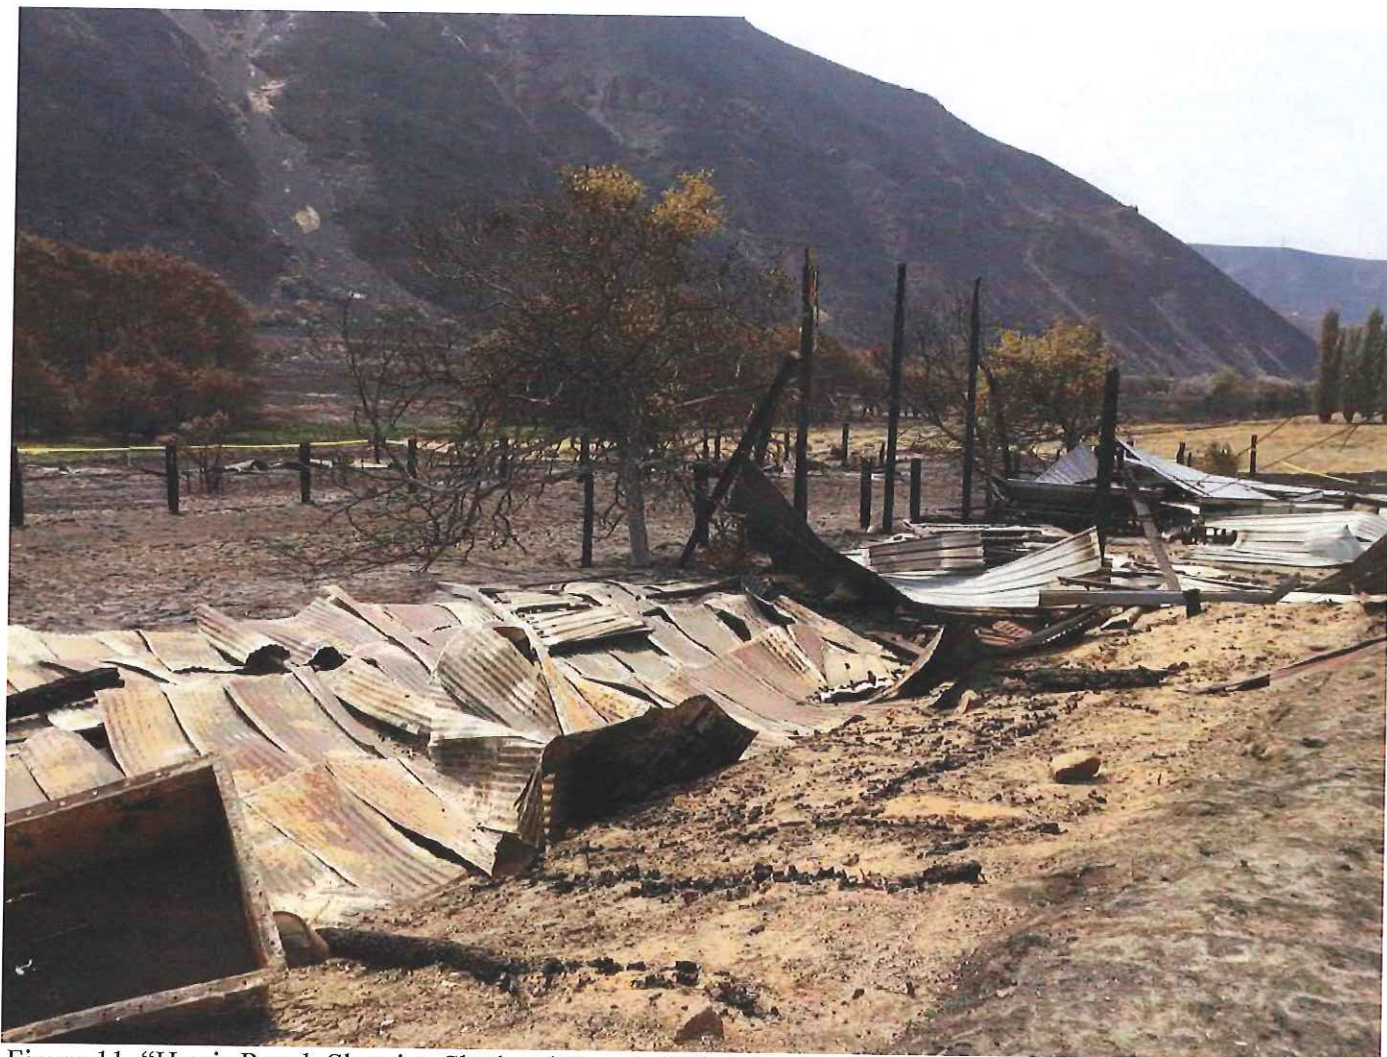
Figure 11. "Harris Ranch Shearing Shed and Corrals." Showing the shearing shed (left) and attached 1954 barn (right). Facing northwest. Remains of the Corrals are in the background.

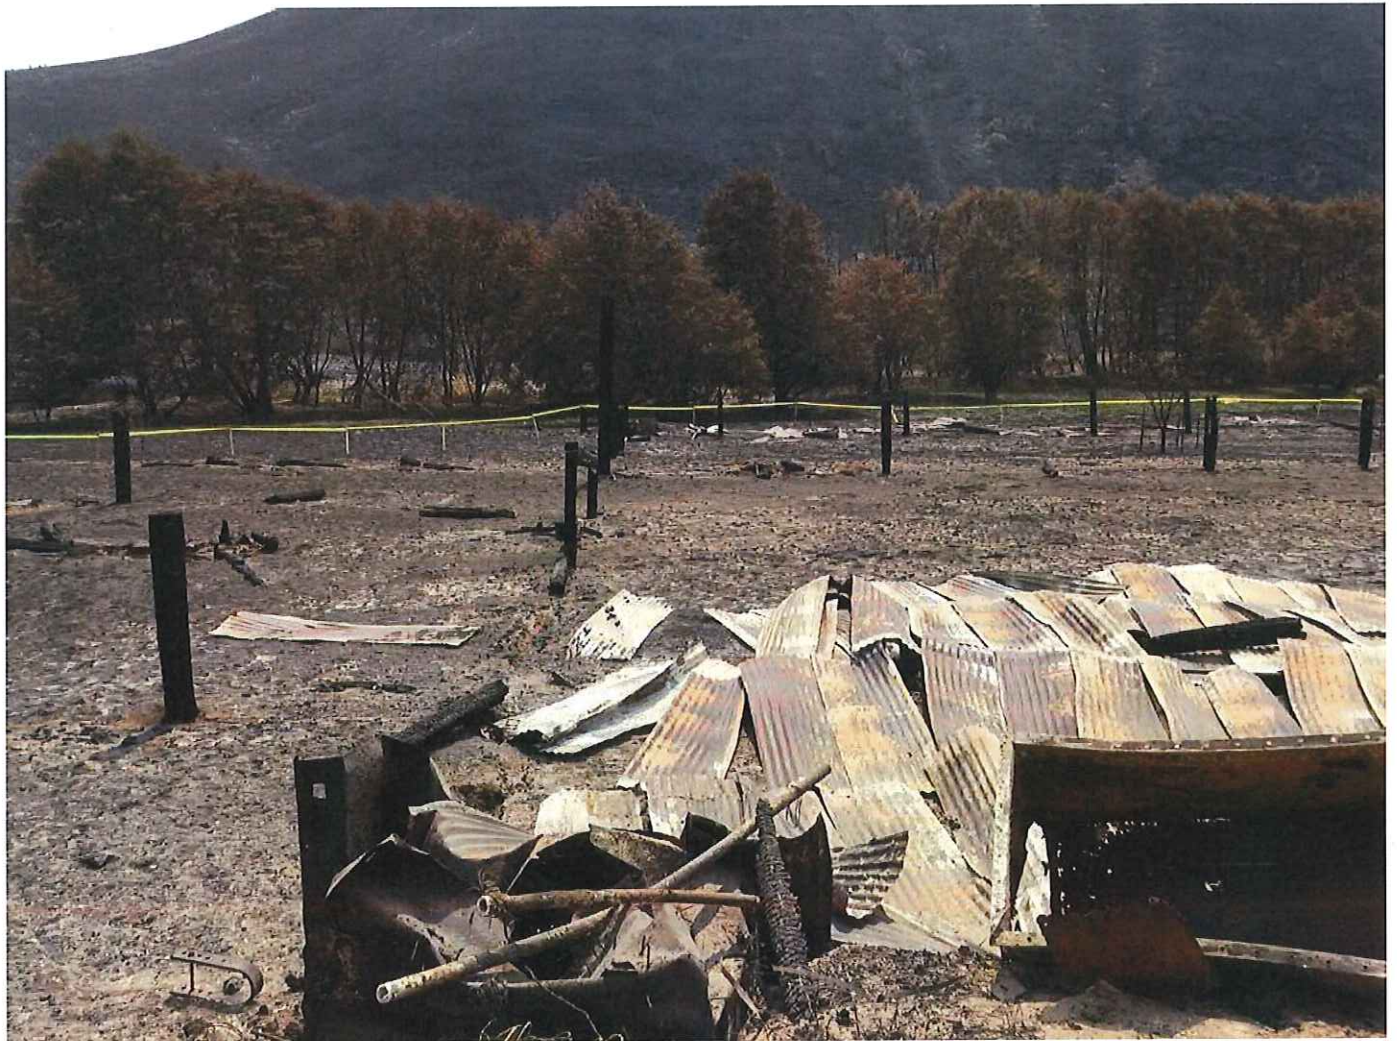
Figure 12. "Harris Ranch Shearing Shed and Corrals." Charred posts are all that remains of the shearing corrals.

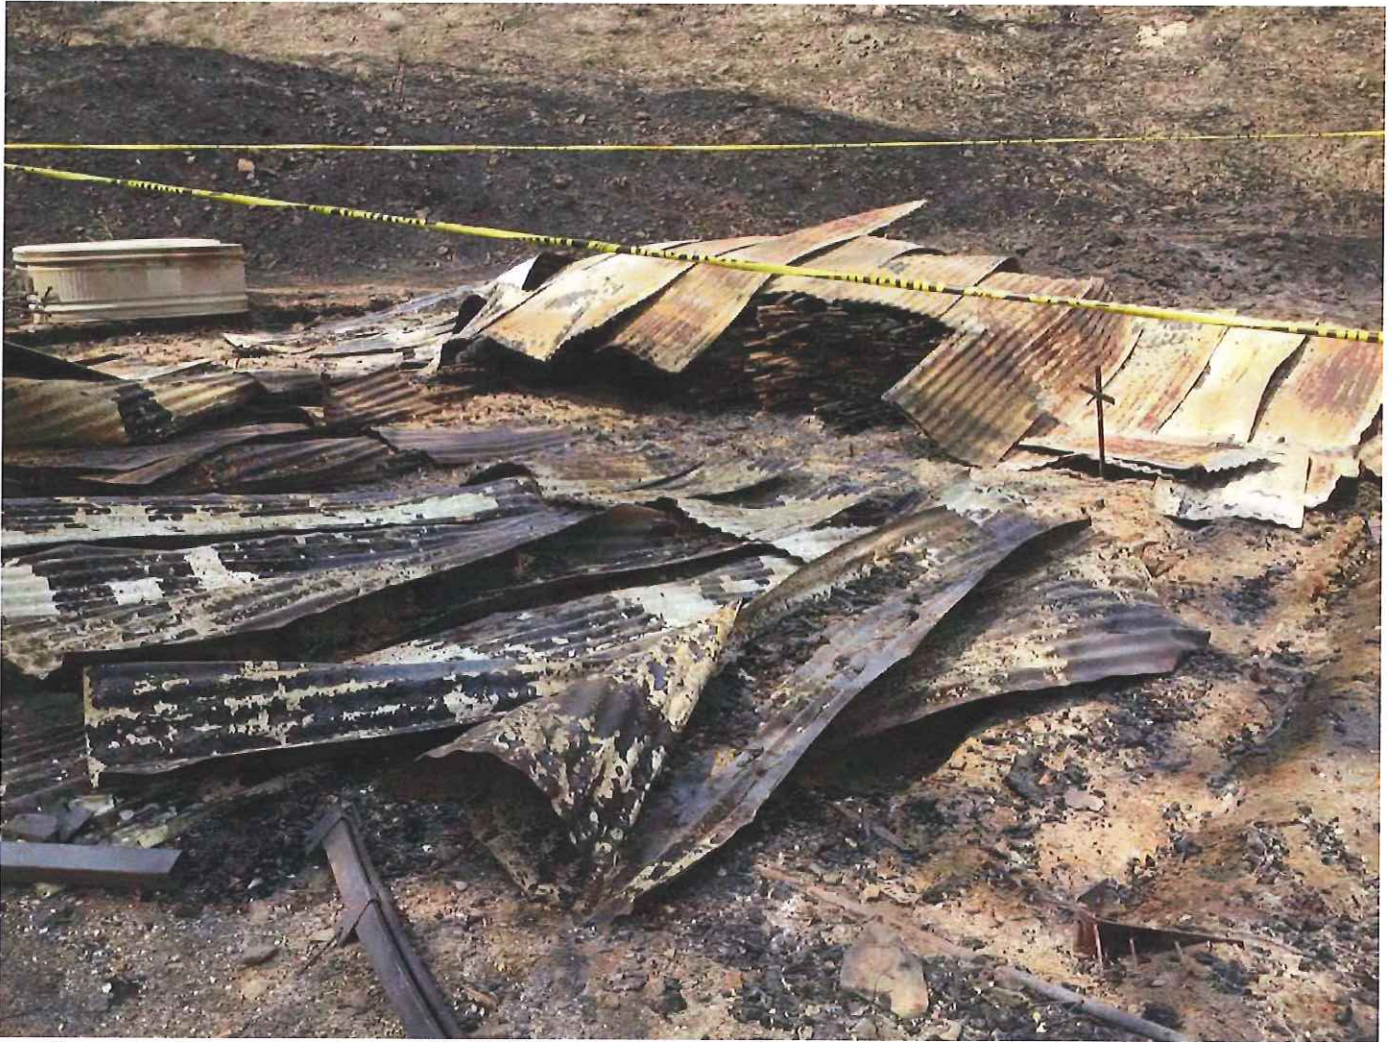
Figure 13. "Harris Ranch Barn/Shed." The Harris Ranch Barn/Shed was completely destroyed in the fire. Facing east.

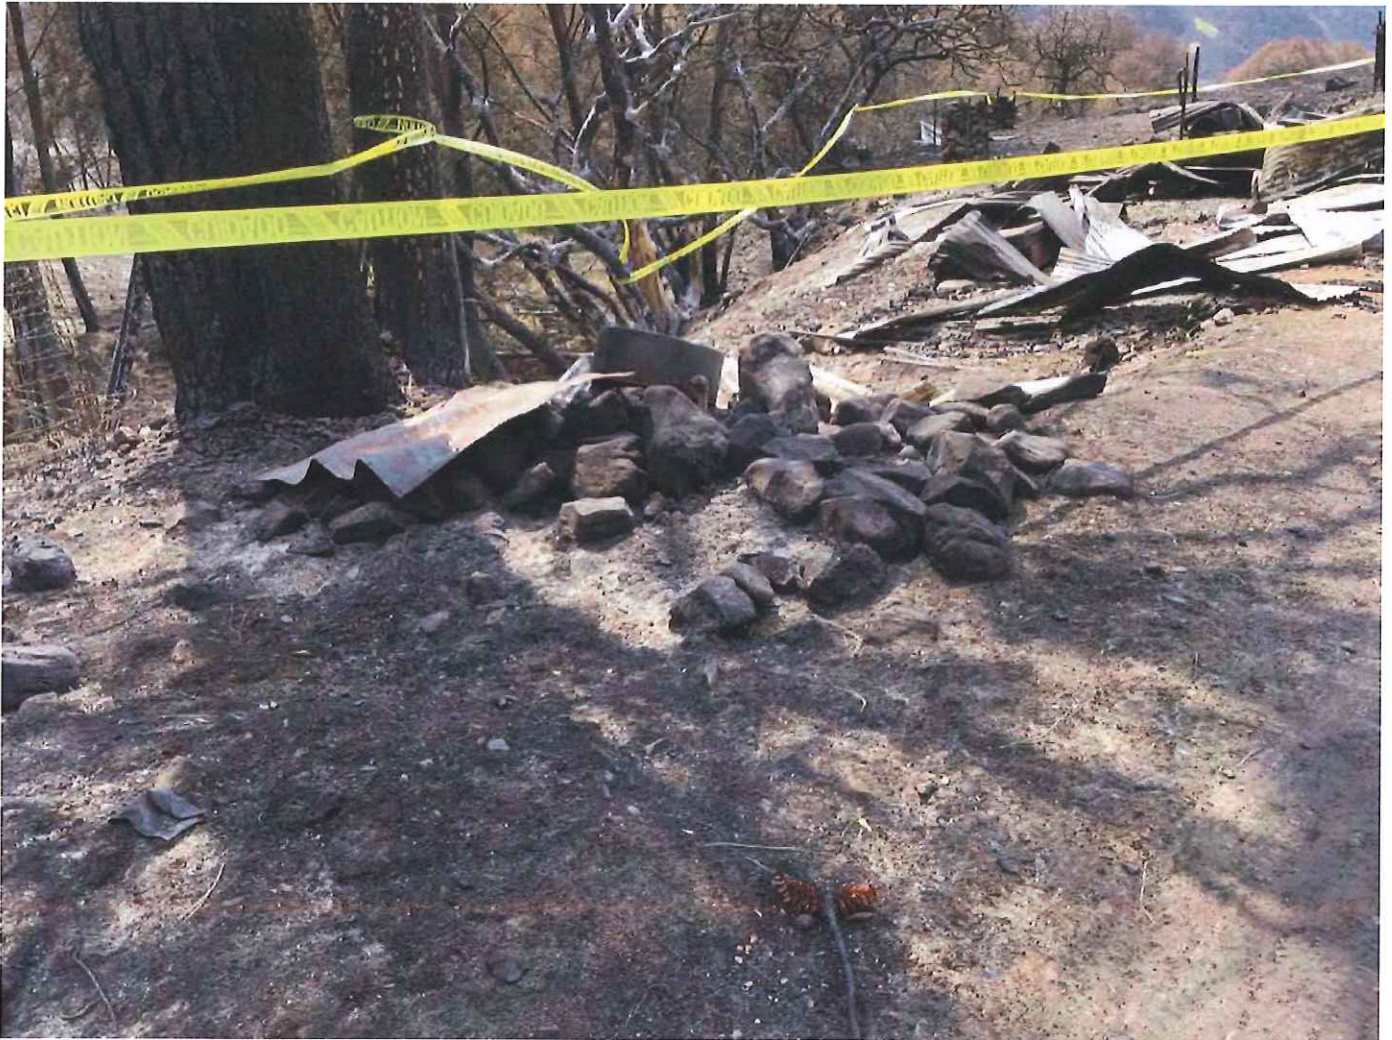
Figure 15. "Harris Ranch Bunkhouse". The Harris ranch bunkhouse was not previously recorded in the SHPO historic sites database, but was immediately across the road from the recorded "Harris Ranch Barn/Shed". The bunkhouse was constructed out of two historic railroad cars. One was converted into a kitchen and social space, and the second had been converted into bunks for workers at the sheep corrals. Both railroad cars burned in their entirety. Facing northwest.
