Fires in July 2018 and the Lower Deschutes Wildlife Area

SUBJECT: **Substation Fire (2018): Destroyed Historic Structures**
Lower Deschutes Wildlife Area
T1N, R15E, Sec 23, 25; T1S, R16E, Sec 4, 5
Emerson and Locust Grove Quads
Sherman County, Oregon

On the weekend of July 20, 2018, the Substation Fire burned over 7,000 acres in the Lower Deschutes Wildlife Area, owned by the Oregon Department of Fish and Wildlife (ODFW). Several historic structures previously documented with the Oregon SHPO were destroyed in the fire. These included two railroad cars associated with the Deschutes Railroad War, the Harris Ranch House, Harris Ranch Shearing Shed & Corrals, Harris Ranch Barn/Shed, and Harris Ranch Railroad Water Tower. Two other historic structures not previously documented, the Harris Ranch Bunkhouse and Rattlesnake Grade Bridge, were also destroyed. The only previously recorded historic structure in the area unaffected was the Freebridge over the Deschutes River (which only consists of concrete bridge pillars).

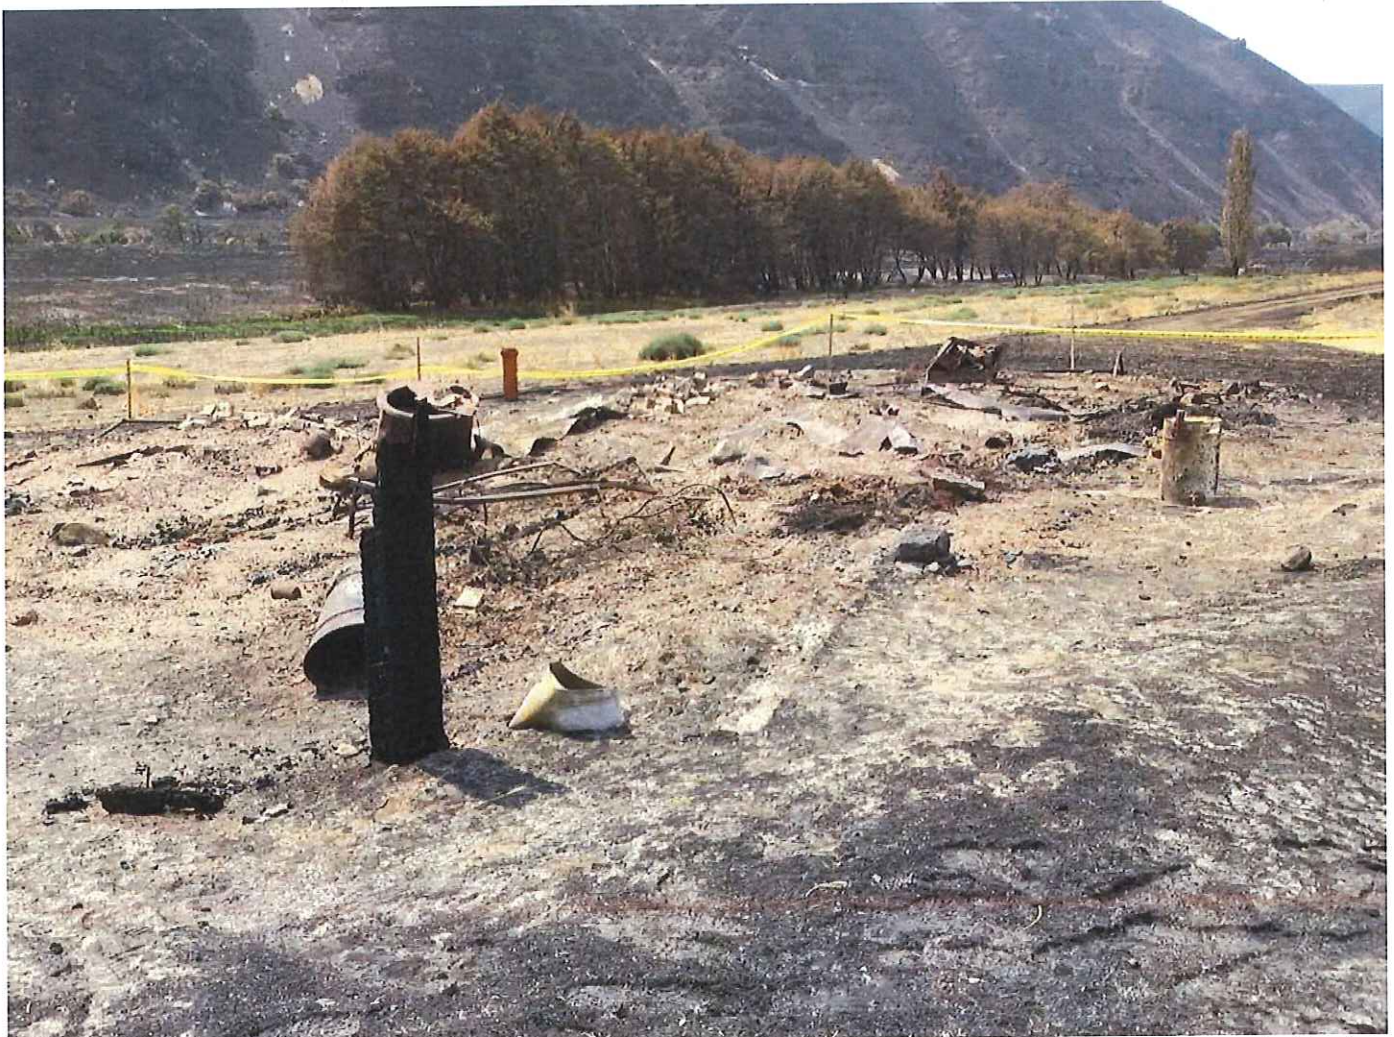
Figure 16. "River Mile 12: Deschutes River Harris Ranch House". The Harris Ranch house was recorded in the SHPO historic sites database on 6/1/1995 and was documented as being constructed circa 1880. The building was completely destroyed in the Substation Fire. The only structural remains are a brick lined root cellar on the east side of the structure. Photo facing northwest.

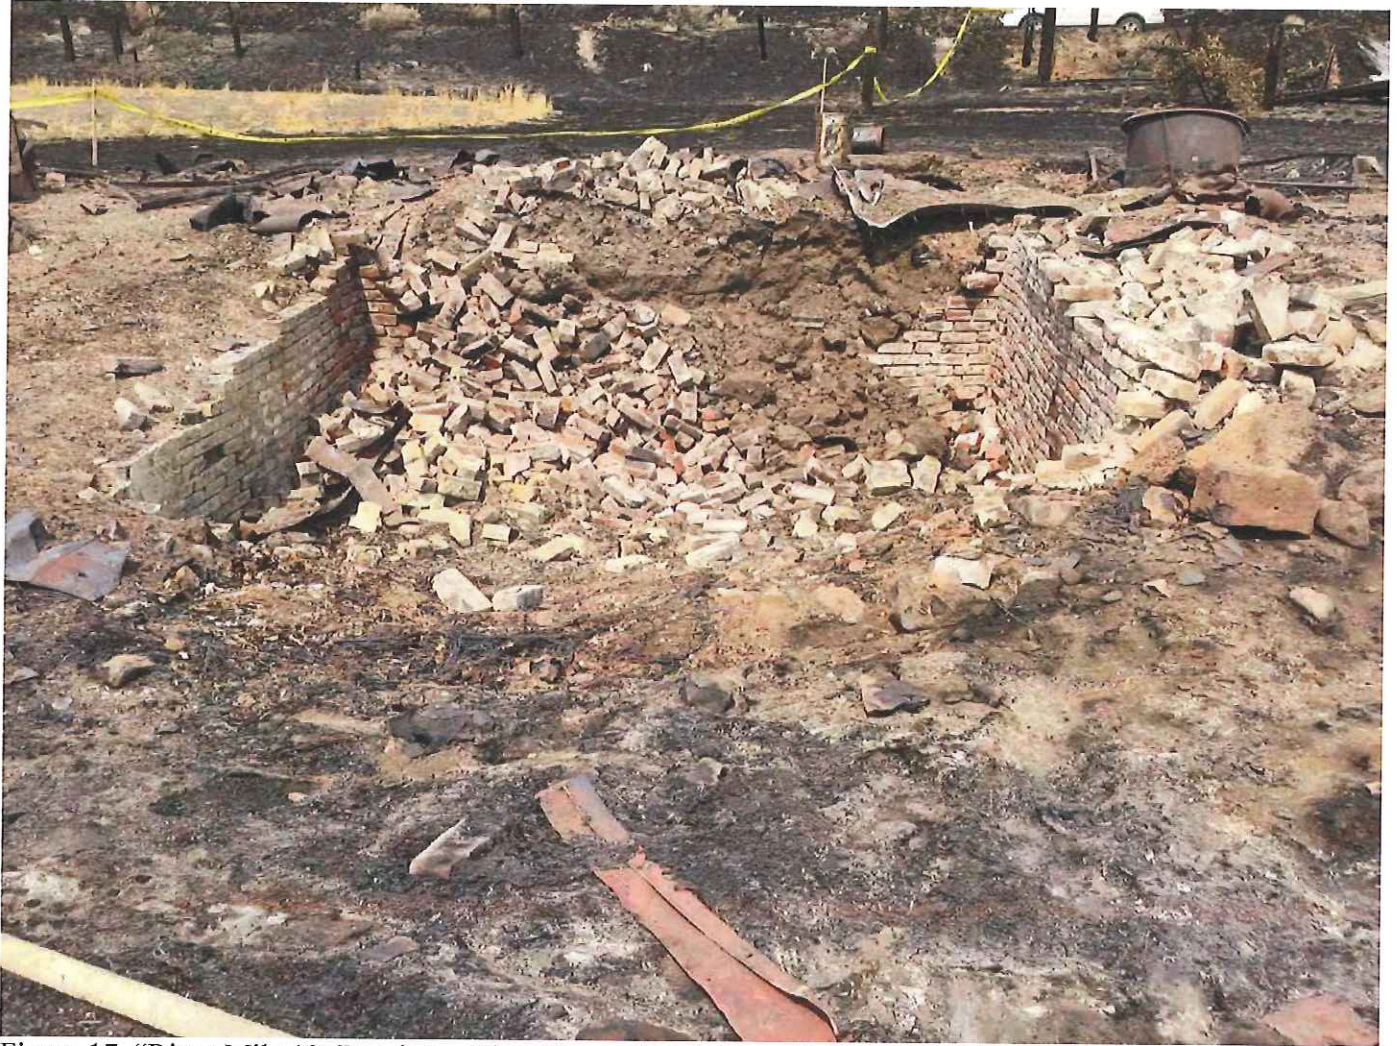
Figure 17. "River Mile 12: Deschutes River Harris Ranch House". Remains of the root cellar of the Harris Ranch House. Facing east.

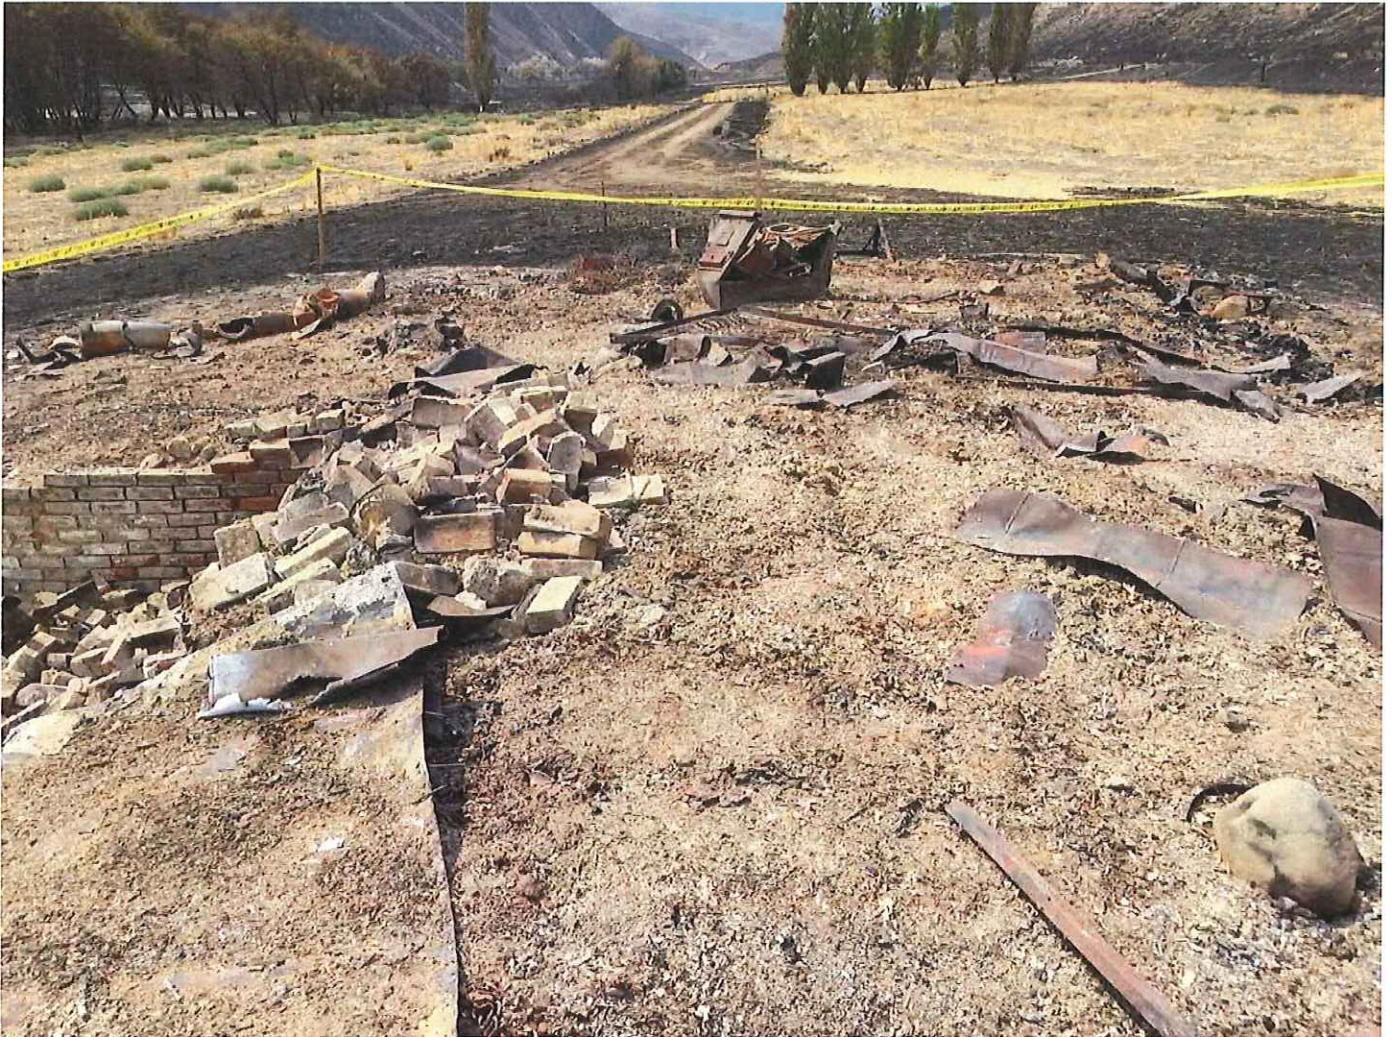
Figure 18. "River Mile 12: Deschutes River Harris Ranch House". Remains of the Harris Ranch House. Facing north.

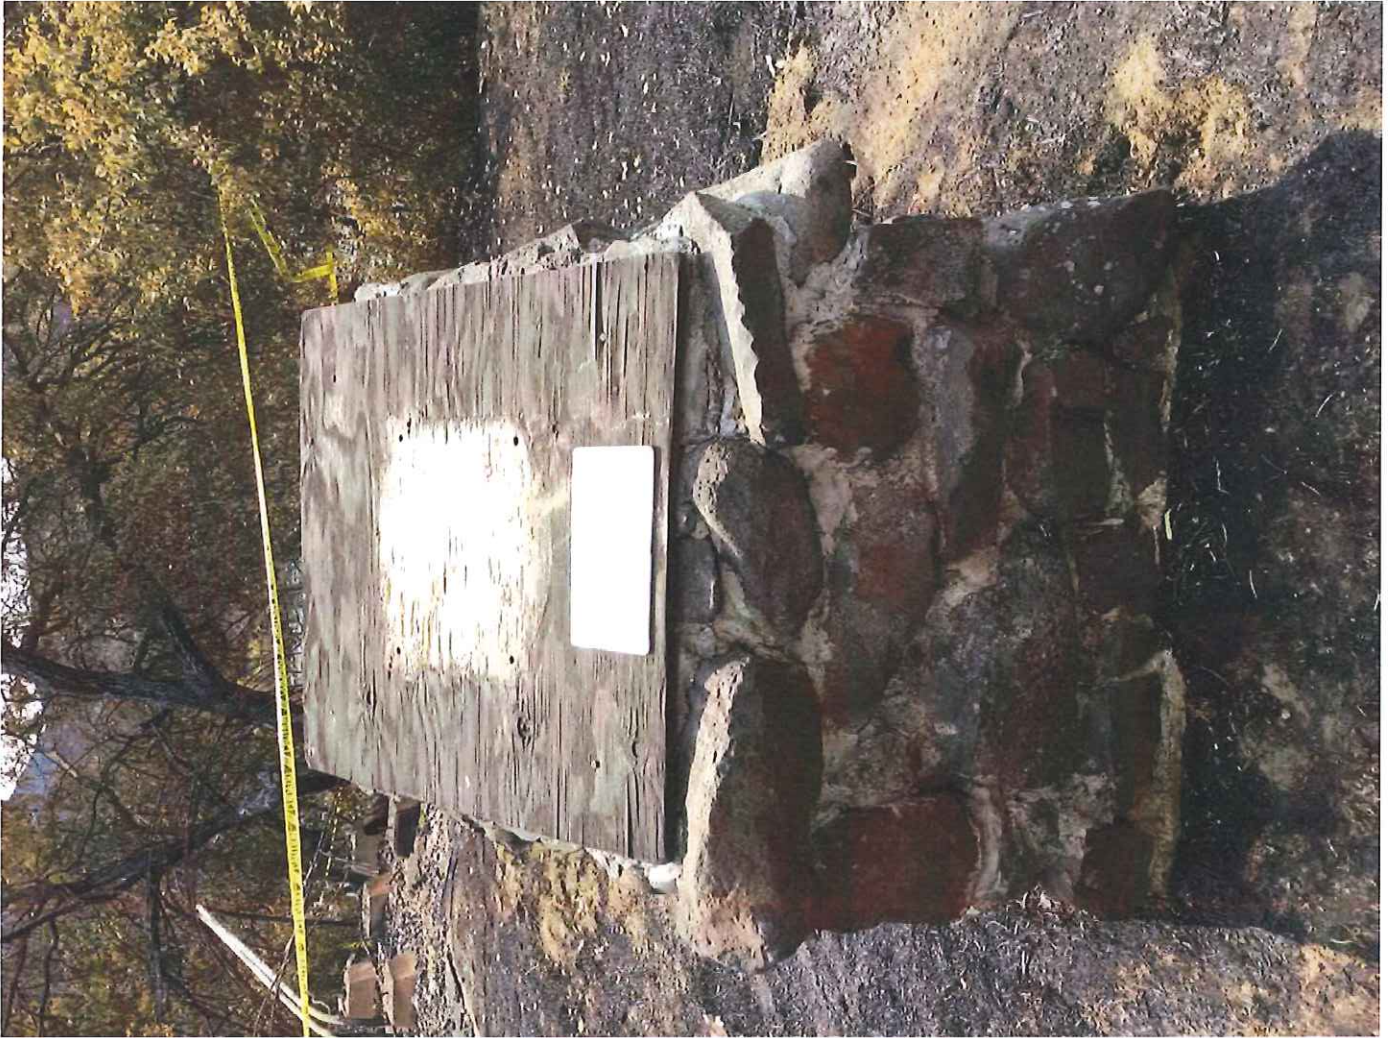
Figure 19. "River Mile 12: Deschutes River Harris Ranch Water Tower." Interpretive sign at the site of the water tower. The sign survived the fire but was subsequently stolen. Facing west.

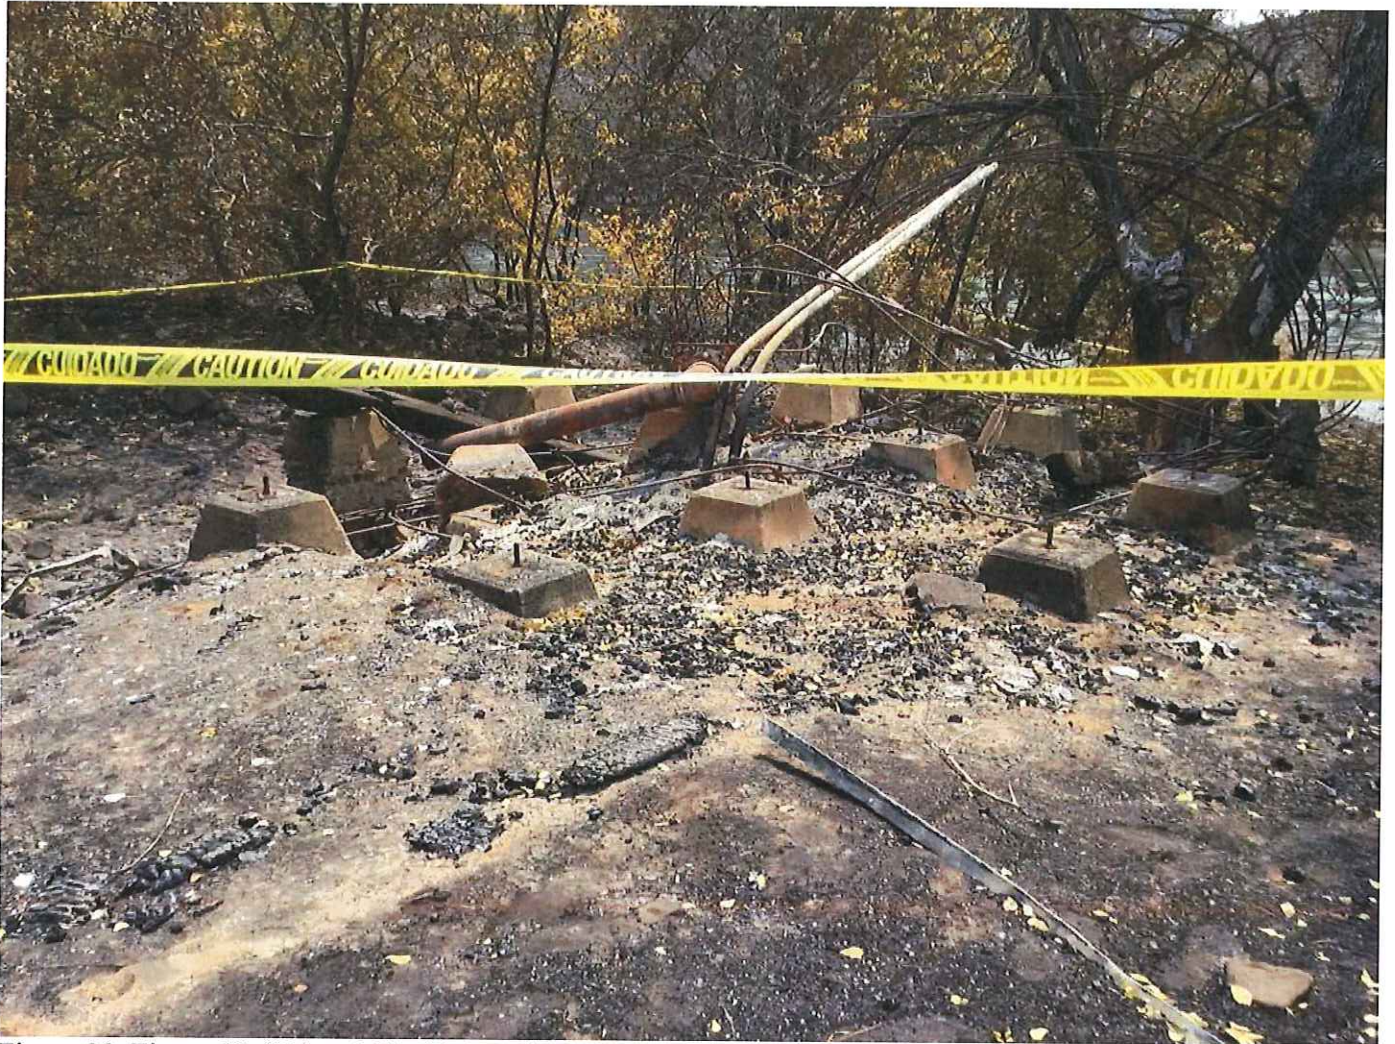
Figure 20. Figure 19. "River Mile 12: Deschutes River Harris Ranch Water Tower." The water tower had been restored approximately 10 years ago with private funds and SHPO consultation. It was completely destroyed in the Substation Fire. Facing southwest.

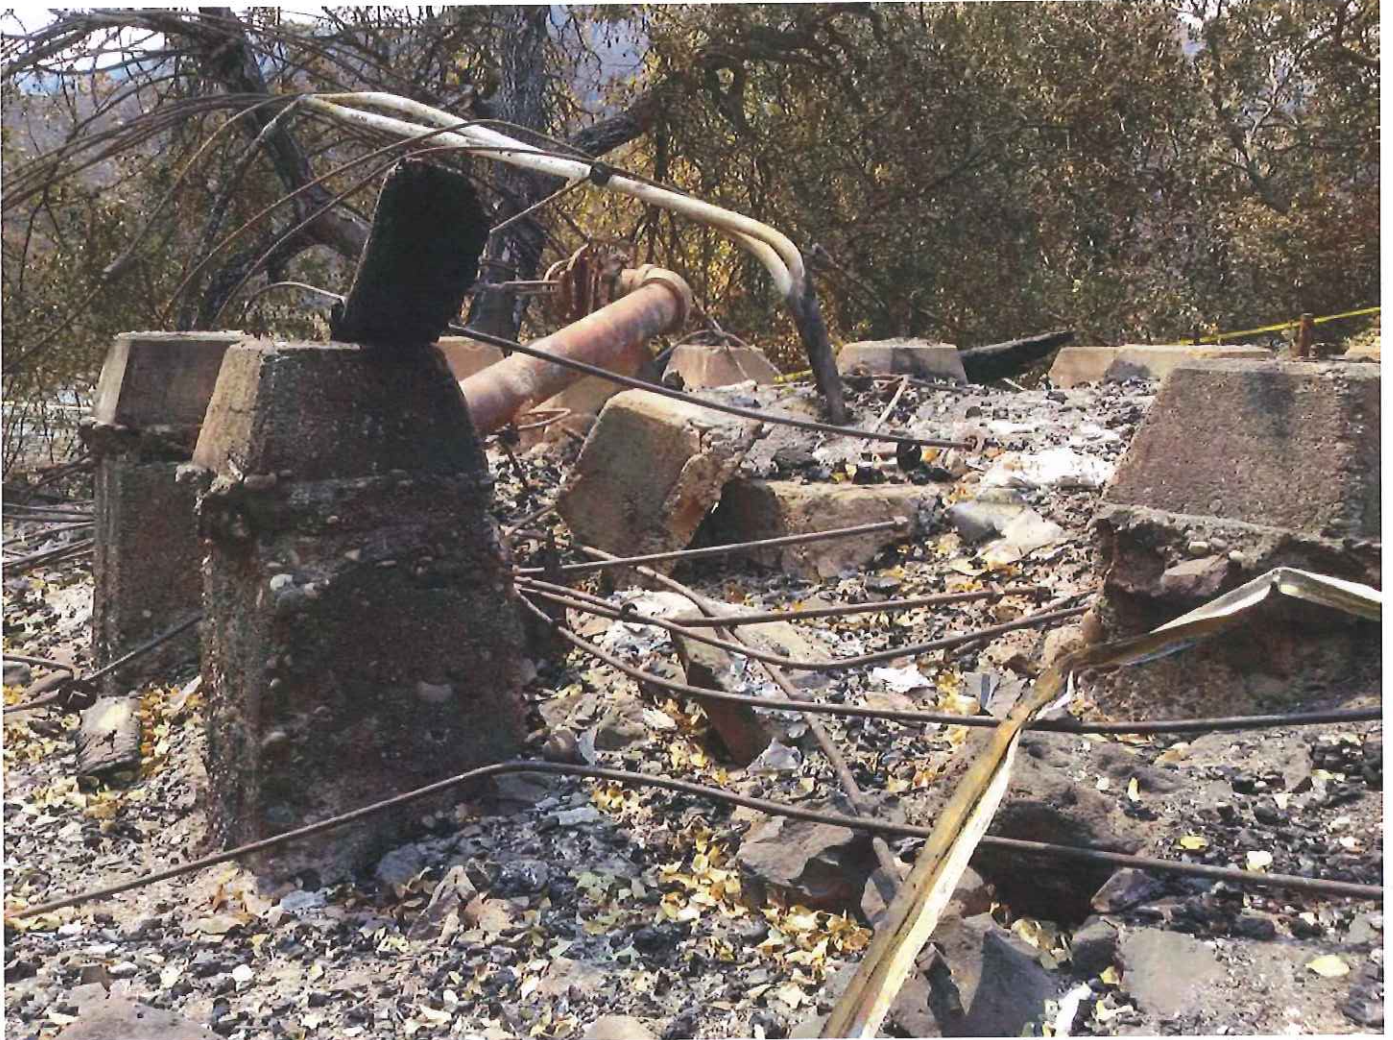
Figure 21. Support pillars are the only intact feature remaining of the water tower. Facing west-northwest.

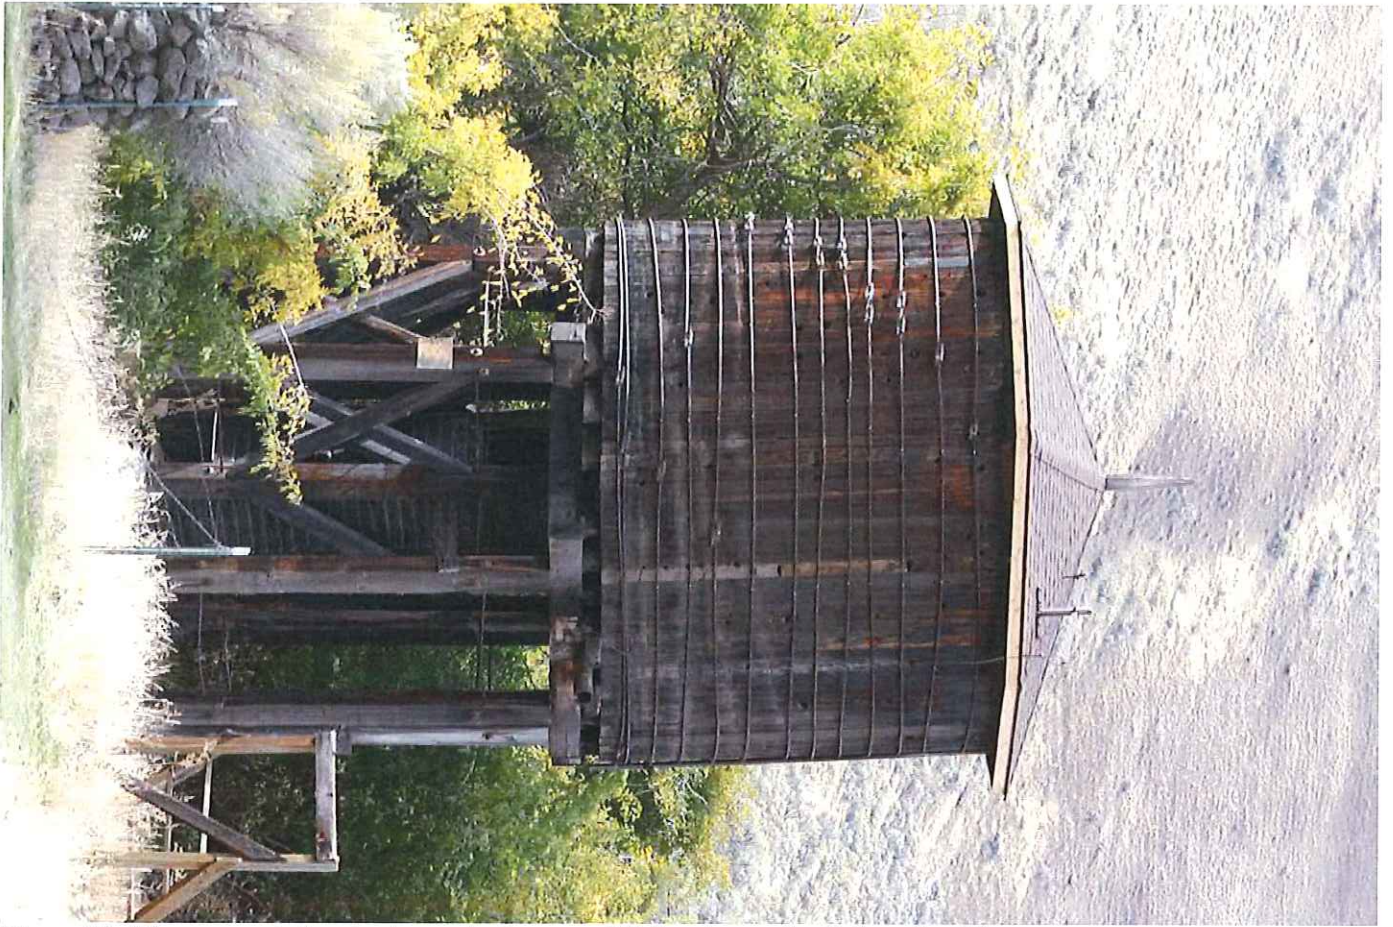
Figure 21. The renovated water tower in January 2018, prior to the Substation Fire.
