## OREGON DEPARTMENT OF FISH AND WILDLIFE

### Fish Passage EXEMPTION Application

1. TYPE OF ARTIFICIAL OBSTRUCTION:  Dam New   
 Culvert/Bridge Existing   
 Tidegate  
 Other (describe): Artificial Beaver Dams (“ABD”)

# Map of Jump Creek ABDs

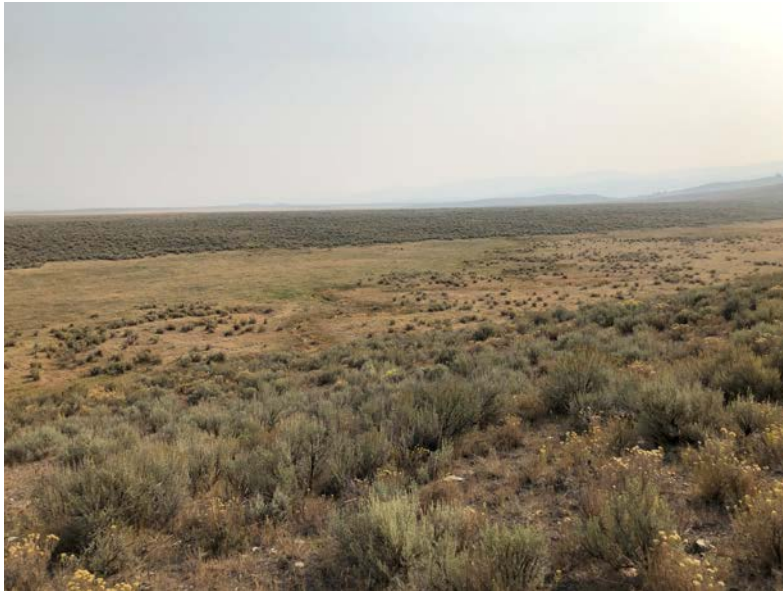
**Photo 1.** Photograph from September 2020 depicting conditions, including the near absence of riparian vegetation and limited channel expression in wide, highly permeable fan located in the lower part of the Jump Creek drainage. No ABDs are present in this area.

throughout the system and the absence of riparian vegetation, particularly in lower Jump Creek where already minimal flows come into contact with a wide, highly permeable fan. In this area, any flows that may present themselves quickly seep into the ground and are insufficient to sustain riparian vegetation or surface water expression. The limited flows within the entire system, and the geomorphology and stratigraphy of lower Jump Creek, preclude a hydraulic connection between Jump Creek and Silvie's River. Moreover, Elk Lake is an impassible fish passage barrier and substantially all to all of the water that may be present in Jump Creek in any given year is authorized for diversion during the irrigation season.

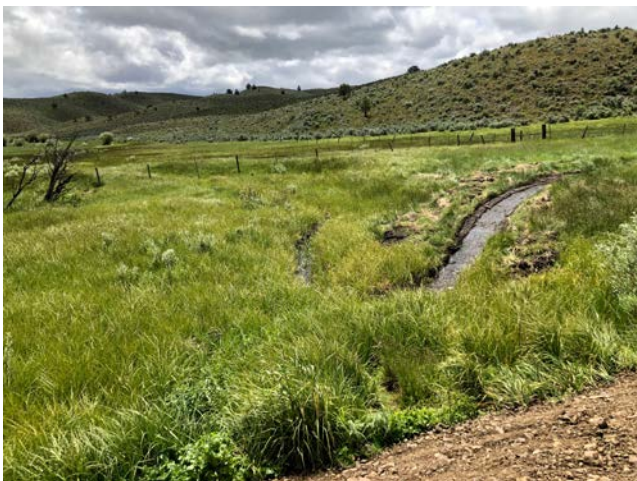
**Photo 2.** Photograph of Jump Creek in the area where ABDs were installed. This 2020 photograph taken from one of the road crossings shows the riparian vegetation and wetland restoration occurring in the mid-upper drainage. ABDs were installed on Jump Creek in 2009.

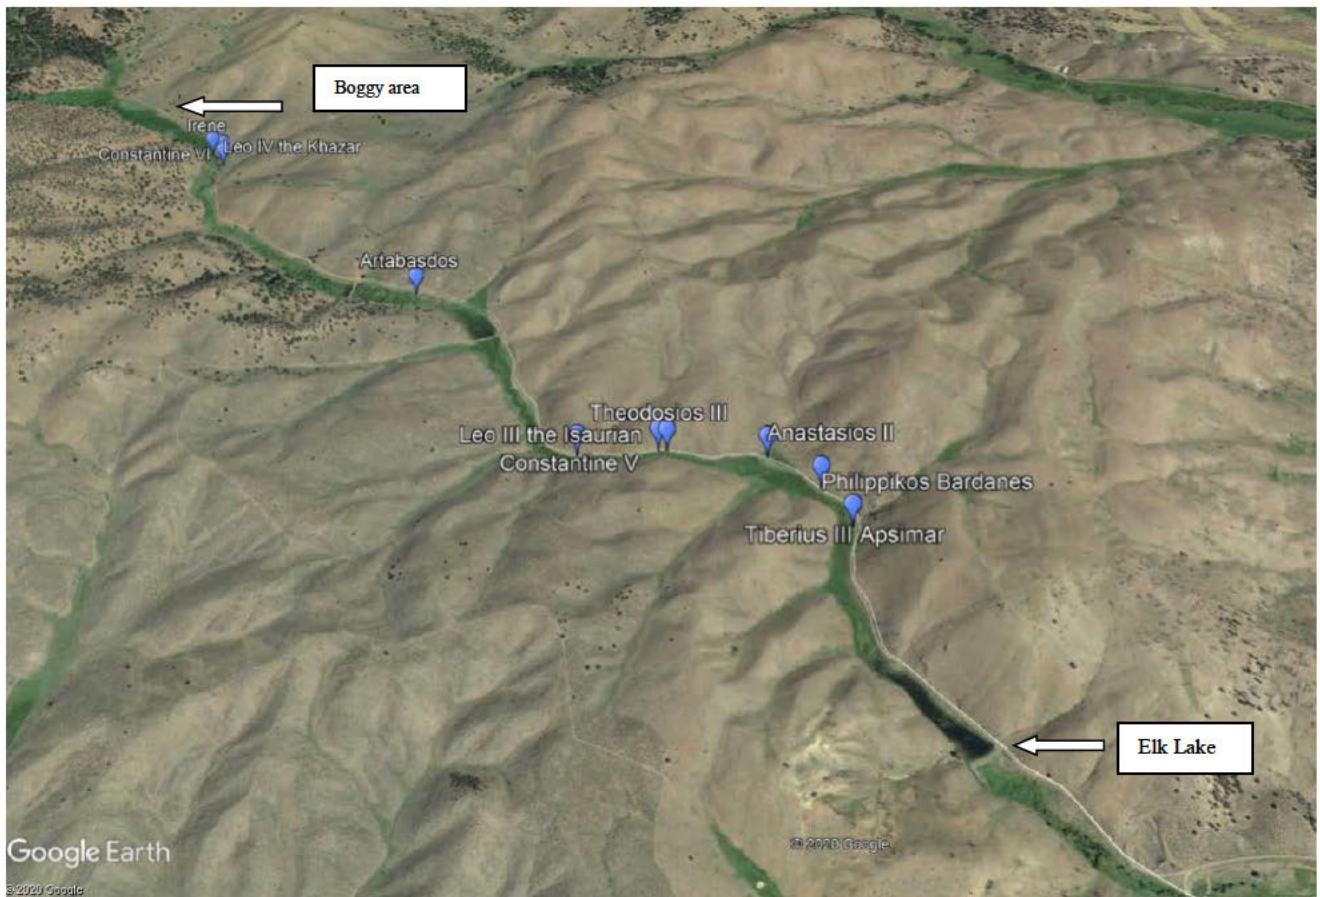
**Figure 1.** Image showing ten ABDs bounded by boggy, channeless area at the upper end and the impassible fish passage barrier Elk Lake impoundment at the lower end (Google Earth Pro 2020).

In total, there are ten (10) ABDs on Jump Creek (Table 1, Figure 1). The uppermost ABD is located immediately downstream of an extended, nearly half mile long boggy area that lacks any channel presence. The further downstream ABD is approximately one-half mile above the historic Elk Lake diversion and impoundment, a long-standing artificial barrier that prevents fish access to part of Jump Creek where ABDs were installed. In other words, the ABDs are located in an isolated area of Jump Creek that is disconnected from other parts of the drainage by natural and artificial fish passage barriers. The total length of valley floor between the impoundment at Elk Lake and the uppermost ABD (Irene) is approximately 2.5 miles.

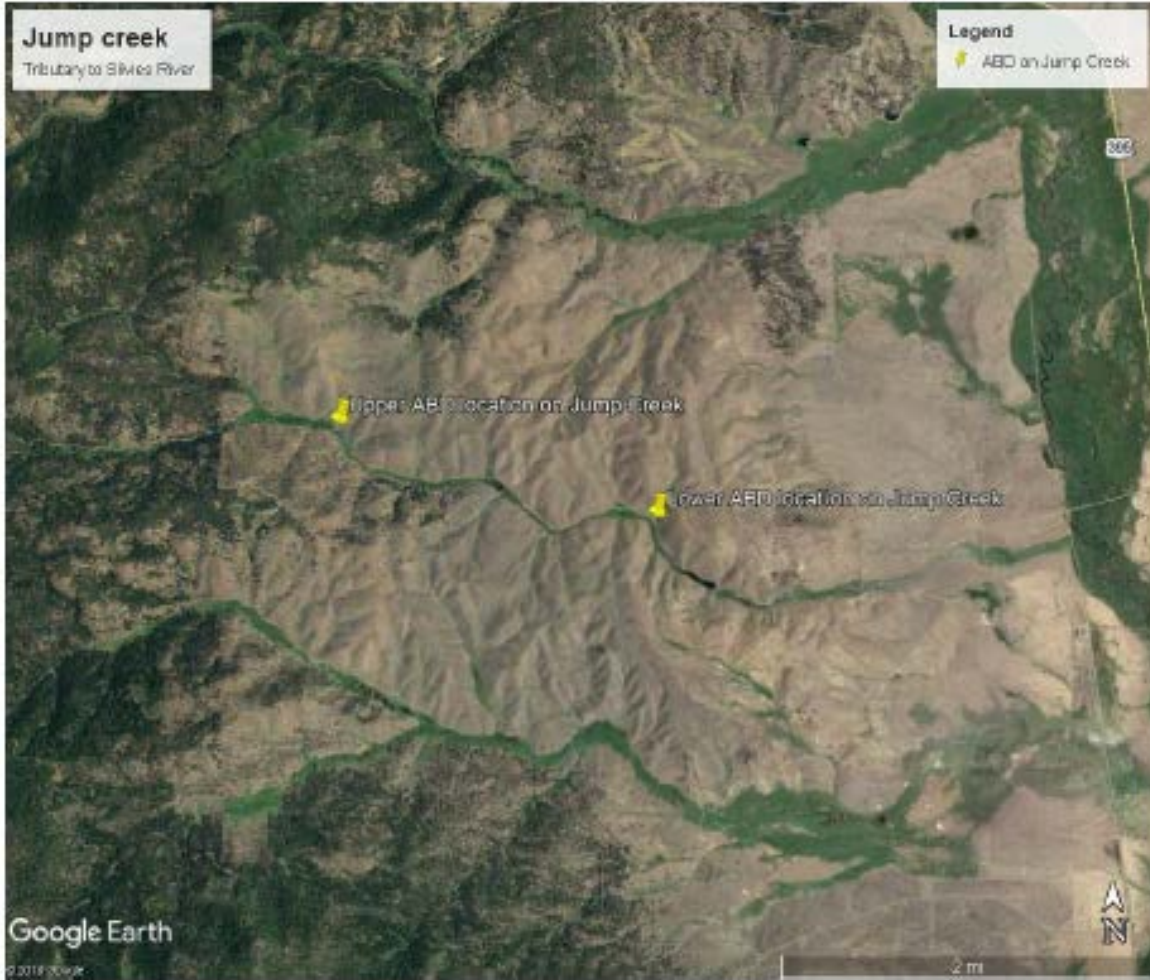
**Figure 2.** Upper and lower ABD locations on Jump Creek (figure obtained from ODFW Jump Creek Exemption Notice, 2019).

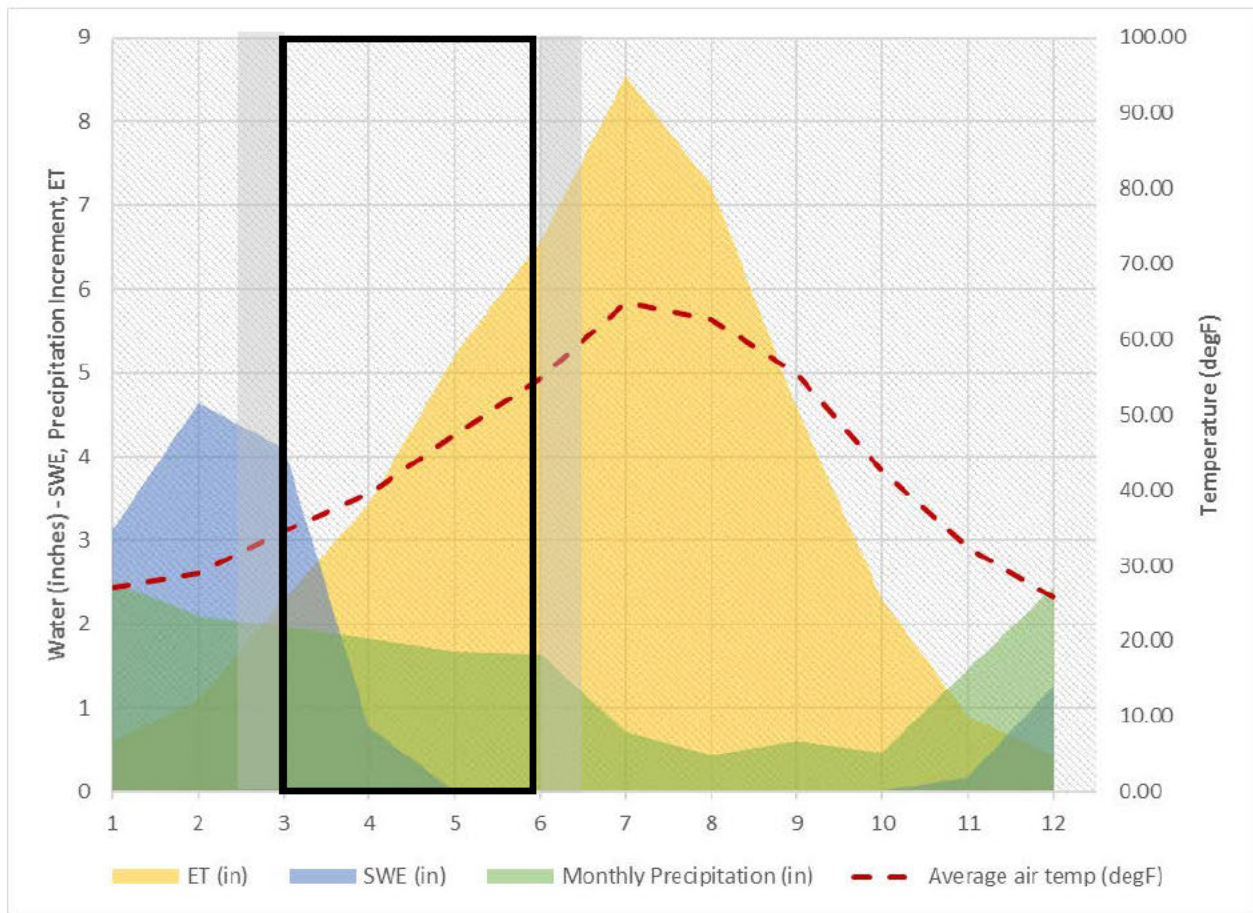
**Figure 6.** Average annual water budget for Silvie's River Basin, Oregon (1980-2020), based on data from NRCS SNOTEL station 0731. The black box indicates estimated continuous flow duration on Jump Creek, with grey shaded areas representing expected interannual variability. The x-axis values of 1-12 represent months of the year.

Based on these data, a generalized average annual water budget for this region can be constructed to visualize the timing of inputs, outputs, and key ecological events (Figure 6). This is a semi-arid region, so potential evapotranspiration exceeds available water on an annual basis, as is evidenced by the area under the evapotranspiration curve compared to the area under the snow-water equivalent and precipitation curves (Figure 6). By June, more water has evapotranspired than has accumulated via snow-water equivalent and monthly precipitation combined (Table 2).

Jump Creek, being a small, lower-elevation watershed (4730 to 5700 feet) for Eastern Oregon, does not have persistent snowpack to feed streamflow later into the summer and streamflow will consequently diminish. As mentioned above, the evapotranspiration values included in these figures represent plant usage given access to unlimited water; in Jump Creek the plants will likely encounter water limitations by June, as precipitation drops off. Regardless, by early June, evapotranspiration is almost four times monthly precipitation. Thus, any precipitation is likely to be used by plants rather than contributing to stream flow.

Based on this information, we can estimate that typical flows on Jump Creek begin in early March – when most accumulated snow melts and before evapotranspiration is high. Prior to this, the ground is likely frozen, as too is the water. Flows likely persist, on average, until late May – when plant water usage increases while moisture inputs, particularly from snowmelt, decrease. Precipitation, falling as rain, remains the same through May and June, but the small magnitude of rainfall (1.65 inches in a month) is likely able to soak into soils, where pore space has been made available due to transpiration of accumulated soil moisture during greenup. Additional incoming precipitation will likely only reach streams if it falls intensely (e.g. >1 inches/hr, as in convective storms) but will otherwise be transpired by plants.

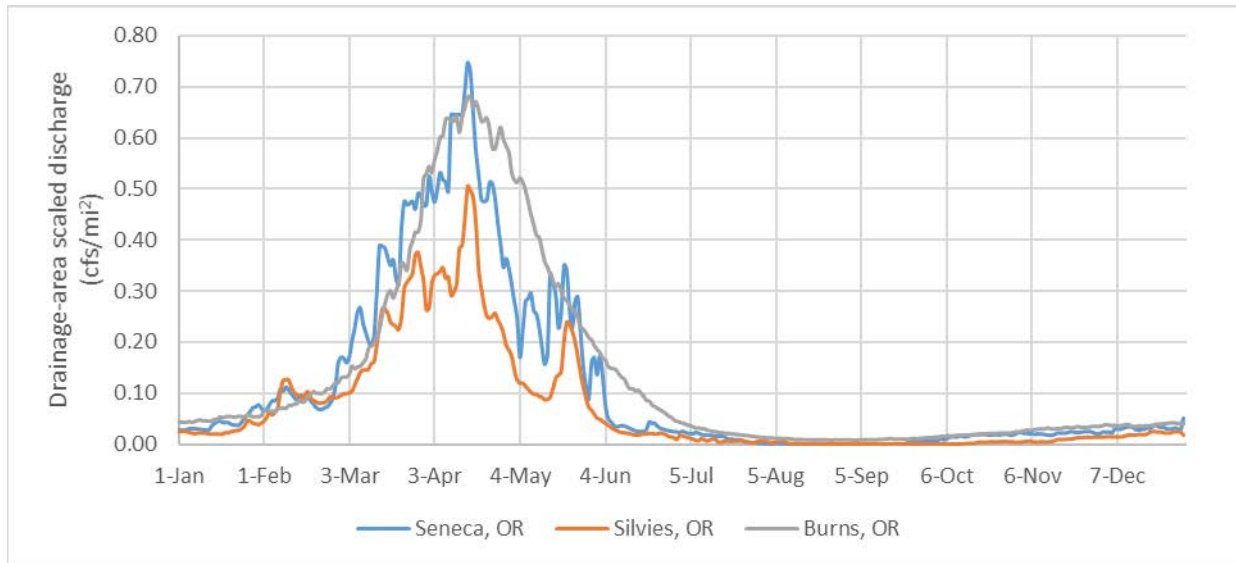
**Figure 8.** Median average DOY flow for the three gauges on the Silvies River, scaled by drainage area.

We can quickly test the validity of this method in the Silvies Basin by comparing normalized median day of year hydrographs for each of the three gauging sites (Figure 8). Here, the median average discharge for each day of the year (Figure 8) has been divided by the drainage area of the given gauge site (Table 2). The lowest gauge site in the basin (Burns) and highest (Seneca) display similar magnitudes of basin-area scaled discharge. The values from the middle gauge (Silvies) are lower during irrigation season, but produce similar values to the other two sites between October and April. Though far from exhaustive, this lends some confidence to using this method to estimate discharge in the tributaries.

The hydrograph from the upstream-most gauge, Seneca, shows a slightly earlier rising and receding limb, and a slightly higher and sharper peak flow. This may be a result of the limited period of record, but also makes conceptual sense given that this gauge is higher in the watershed and receives runoff more quickly from its tributaries. The record from this site is used to model the Jump Creek hydrograph as it is both closer to Jump Creek and will generate the highest possible peak flow, which is consistent with the effort to understand upper maximum expected median streamflow (Figure 9). Note that the shape of the resulting modelled hydrograph will closely mirror that of the Seneca gauge. The small rise in discharge in February is likely due to the Seneca gauge receiving water from tributaries with less forest cover and more of a south-facing aspect, among other conditions causing it to melt earlier in the year than Jump Creek might be expected to.

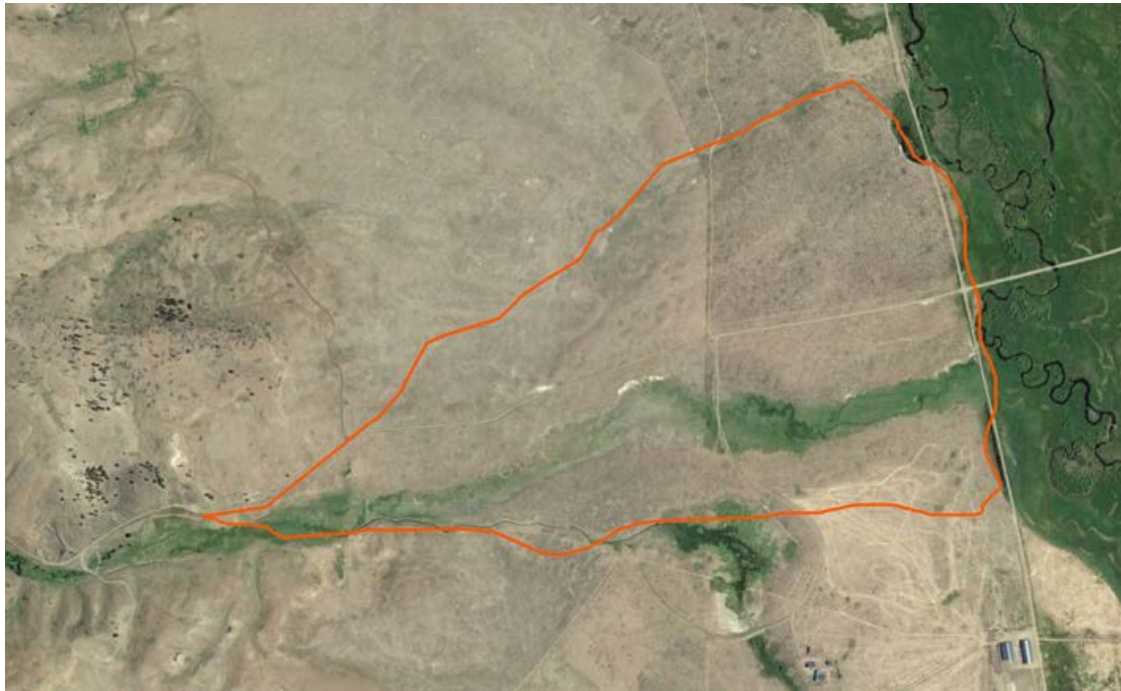
**Figure 10.** Google Earth image depicting the alluvial fan into which a small valley has carved near the bottom end of the Jump Creek drainage. Silvies River is the meandering water feature on the far right of the image.

The lack of connectivity is further explained by the geomorphology of the Jump Creek drainage. At its lower end, a marginally developed valley has cut through a large alluvial fan that is composed of coarse, highly permeable materials into which what little flow might reach this area under natural conditions would absorb.

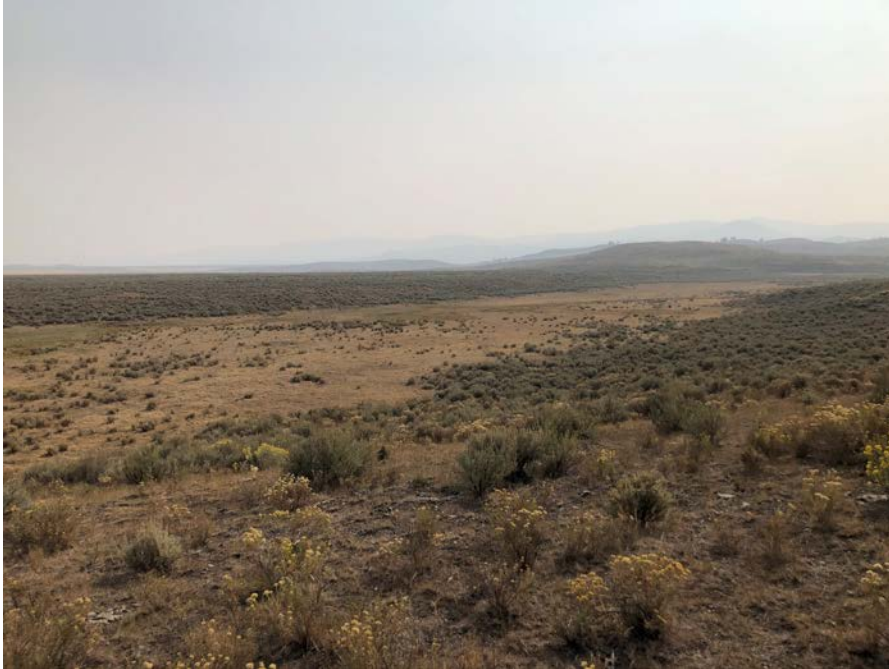
**Photo 3.** September 2020 looking “upstream” and across the wide valley bottom in the area of lower Jump Creek denoted in Figure 10.

The following photograph provides an on-the-ground depiction of the wide, marginally developed valley bottom located in the lower area of the Jump Creek drainage. Upland species grow at similar densities in the channel and upland areas. The valley fill here is coarse and permeable, causing the limited streamflow in this area to soak into the valley fill rather than run over it.

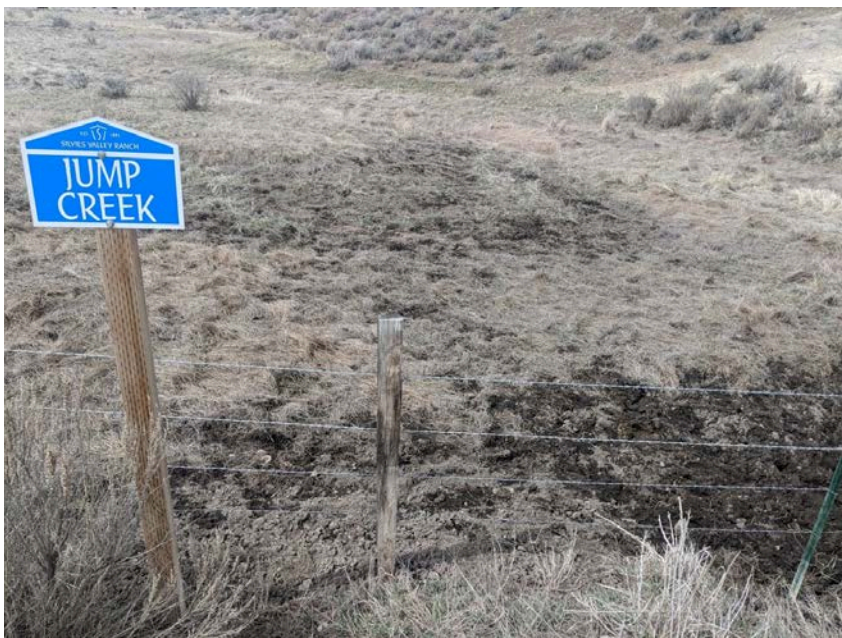
**Photo 4.** April 18, 2020 photograph documenting lack of flow at the lowest portion of Jump Creek near the Silvies River approximately two weeks prior to peak spring runoff. In upper Jump Creek, flows topped out at 1 cubic feet per second at this time. Due to the hydrology and geomorphology of the lower Jump Creek drainage, spring runoff would not have reached the lower end of Jump Creek even at peak flows.

The absence of flows to create hydrologic connectivity was also readily evident near the bottom of Jump Creek on April 18, 2020, during the near-peak spring runoff (2020 was an unusually cool spring, delaying peak runoff by approximately 2 weeks into early May).

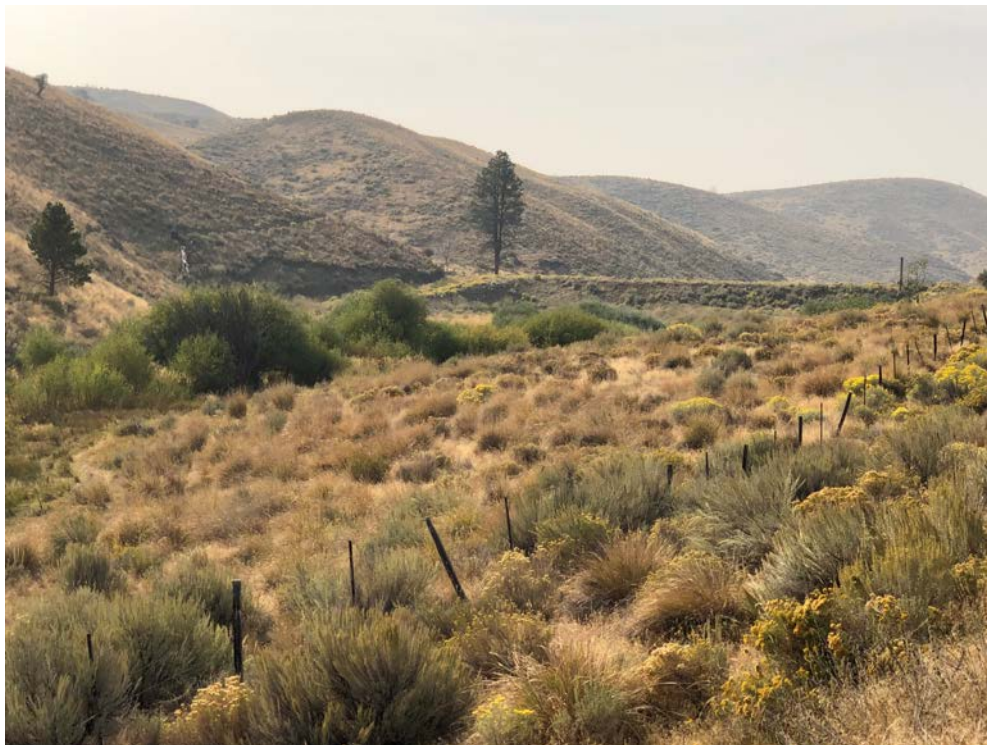
**Photo 5.** September 2020 photograph of the face of the Elk Lake impoundment, circa 1930s (note size of pine tree located on the impoundment). Alder and willow, and other riparian vegetation located downstream of dam face are supported by seepage from the impoundment and would be absent without it.

Approximately one-half mile downstream from the lowest downstream ABD is Elk Lake, a feature created by the construction of an impoundment in the 1930s (circa) accordingly to local information and history. This impoundment is a historical and long-existing complete artificial barrier to any fish passage. It is used as a diversion structure for an 1888 water right authorized by the Silvies River Decree for nearly the entire flow of Jump Creek.

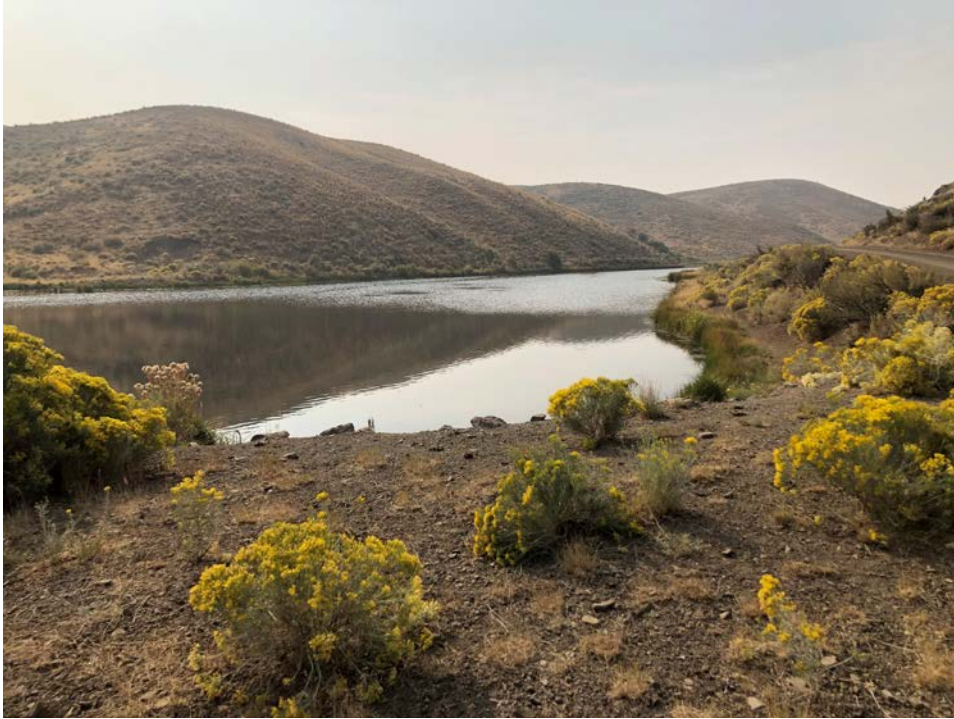
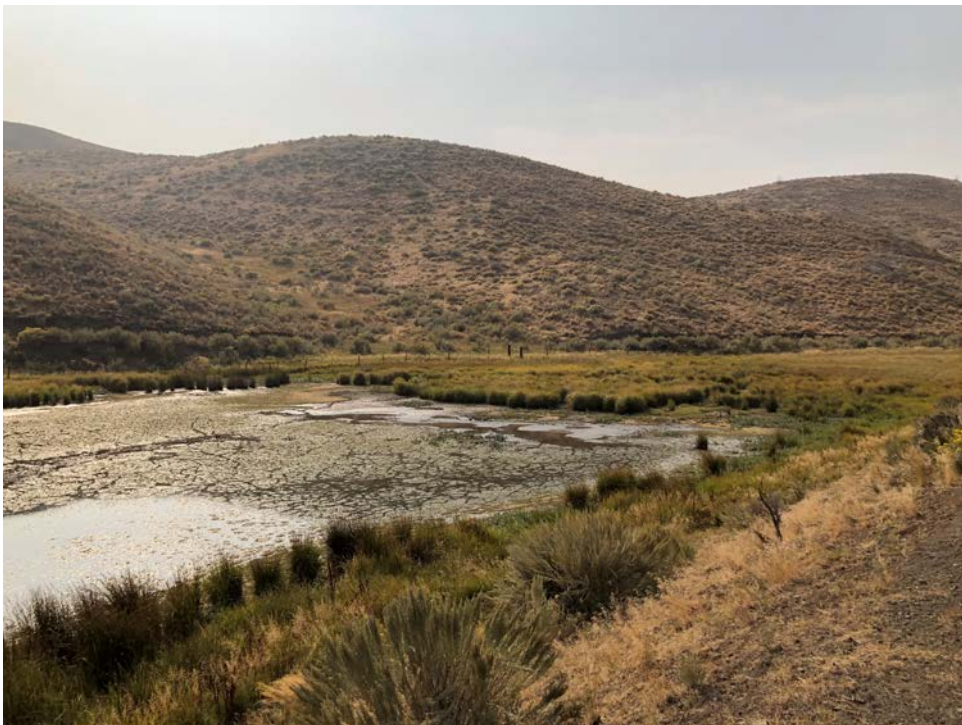
**Photos 6 (above) and 7 (below).** Elk Lake in mid-September 2020. This is the only water present this late in the year in the lower Jump Creek drainage. The lake is warm, supporting a population of perch. Note the riparian vegetation and wetland areas alongside this historical water feature. These would also be absent without the impoundment.

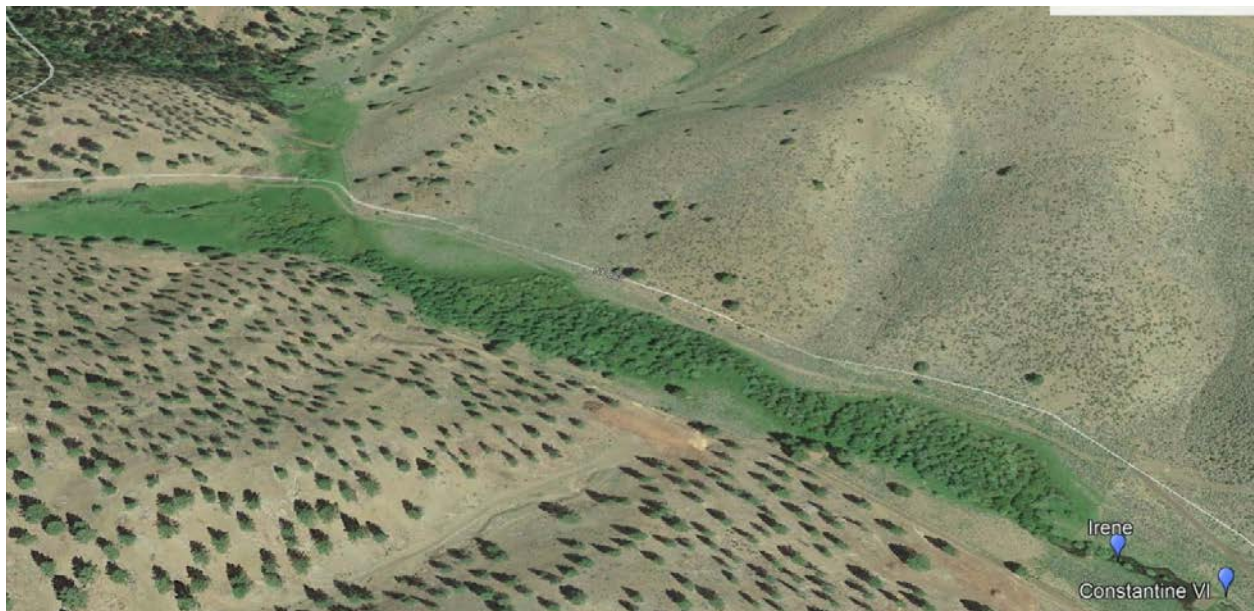
**Figure 11.** Image of approximately 0.4 mile lengthy of boggy area immediately “upstream” of ABD Irene. There is no channel present in this part of Jump Creek due to small volumes of incoming water, all of which flows subsurface(Google Earth Pro). This boggy area is a natural complete barrier to fish passage, to/from the private and federal lands above the boggy area and to/from the stretch of Jump Creek where ABDs were installed.

Above the uppermost ABDs, habitat conditions are limiting to fish presence due to limited hydrology and geomorphology. Immediately upstream of the uppermost ABD (Irene) there is a boggy area that presents no channel for an approximately 0.4 mile stretch (Figure 11). These conditions preclude connectivity between the middle portion of Jump Creek and the upper part of Jump Creek and its upper two forks (Figure 1). They are also a natural fish passage barrier.
