OREGON DEPARTMENT OF FISH AND WILDLIFE

Fish Passage EXEMPTION Application

Map of Jump Creek ABDs

Attachment 3 – Inventory of ABDs on Jump Creek

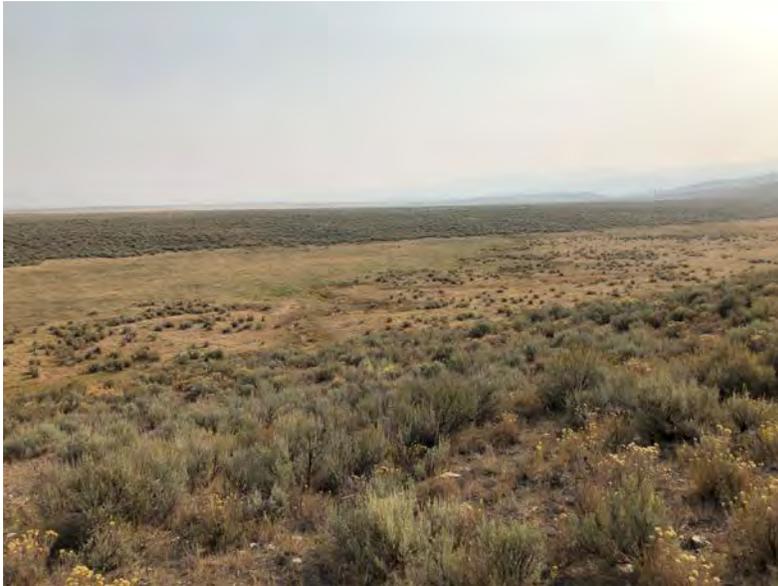
Photo 1. Photograph from September 2020 depicting conditions, including the near absence of riparian vegetation and limited channel expression in wide, highly permeable fan located in the lower part of the Jump Creek drainage. No ABDs are present in this area.

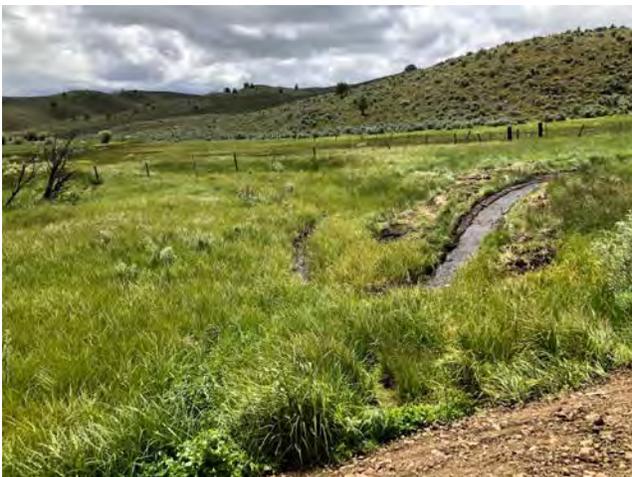
Photo 2. Photograph of Jump Creek in the area where ABDs were installed. This 2020 photograph taken from one of the road crossings shows the riparian vegetation and wetland restoration occurring in the mid-upper drainage. ABDs were installed on Jump Creek in 2009.

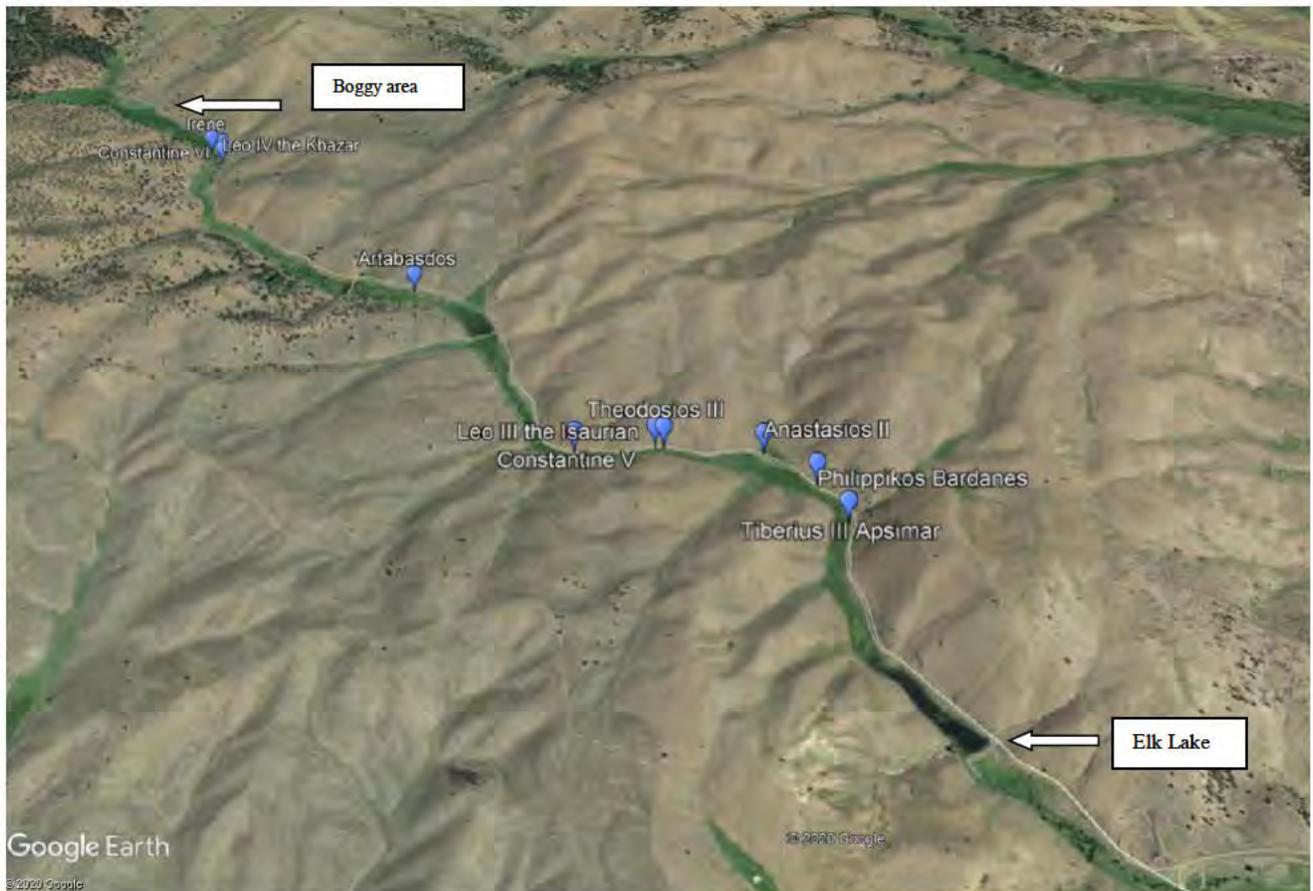
Figure 1. Image showing ten ABDs bounded by boggy, channeless area at the upper end and the impassible fish passage barrier Elk Lake impoundment at the lower end (Google Earth Pro 2020).

In total, there are ten (10) ABDs on Jump Creek (Table 1, Figure 1). The uppermost ABD is located immediately downstream of an extended, nearly half mile long boggy area that lacks any channel presence. The further downstream ABD is approximately one-half mile above the historic Elk Lake diversion and impoundment, a long-standing artificial barrier that prevents fish access to part of Jump Creek where ABDs were installed. In other words, the ABDs are located in an isolated area of Jump Creek that is disconnected from other parts of the drainage by natural and artificial fish passage barriers. The total length of valley floor between the impoundment at Elk Lake and the uppermost ABD (Irene) is approximately 2.5 miles.

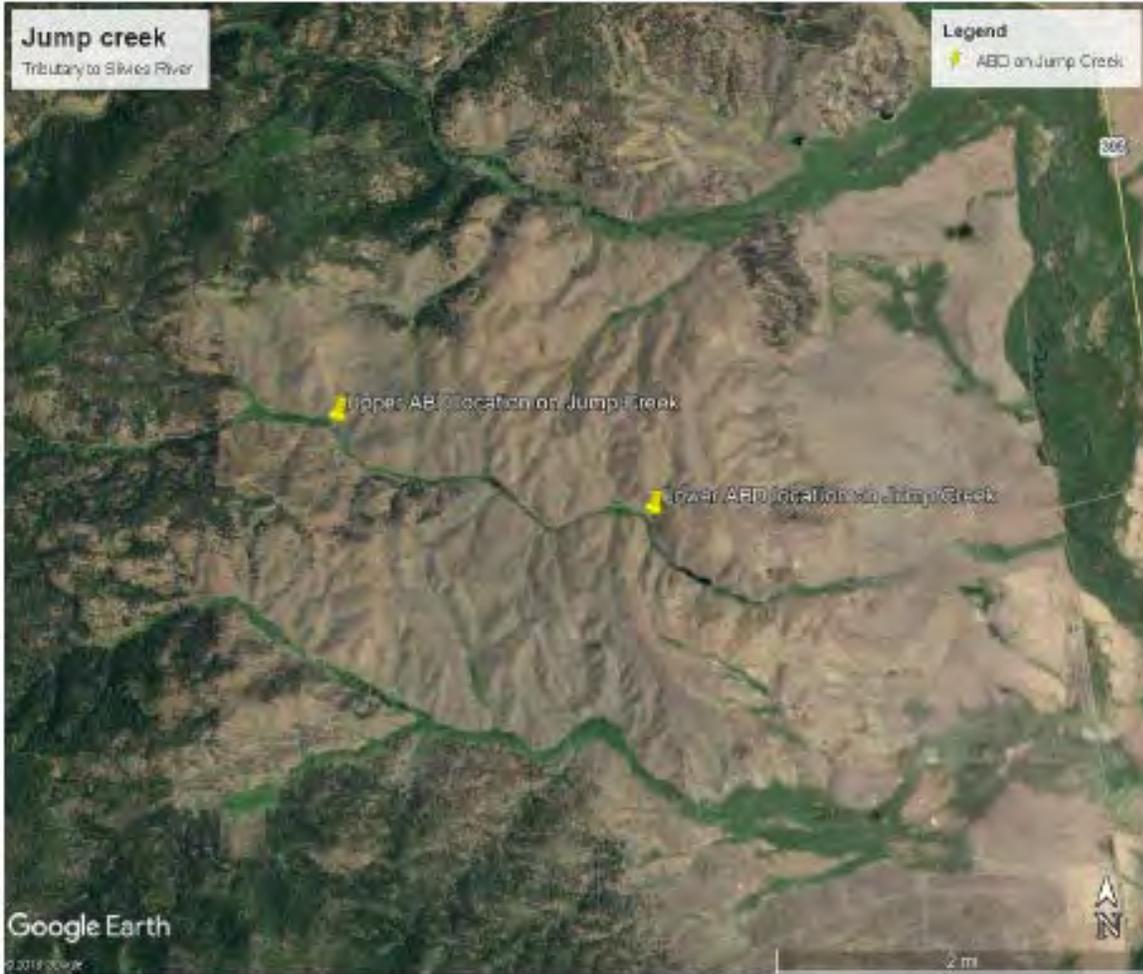
Figure 2. Upper and lower ABD locations on Jump Creek (figure obtained from ODFW Jump Creek Exemption Notice, 2019).

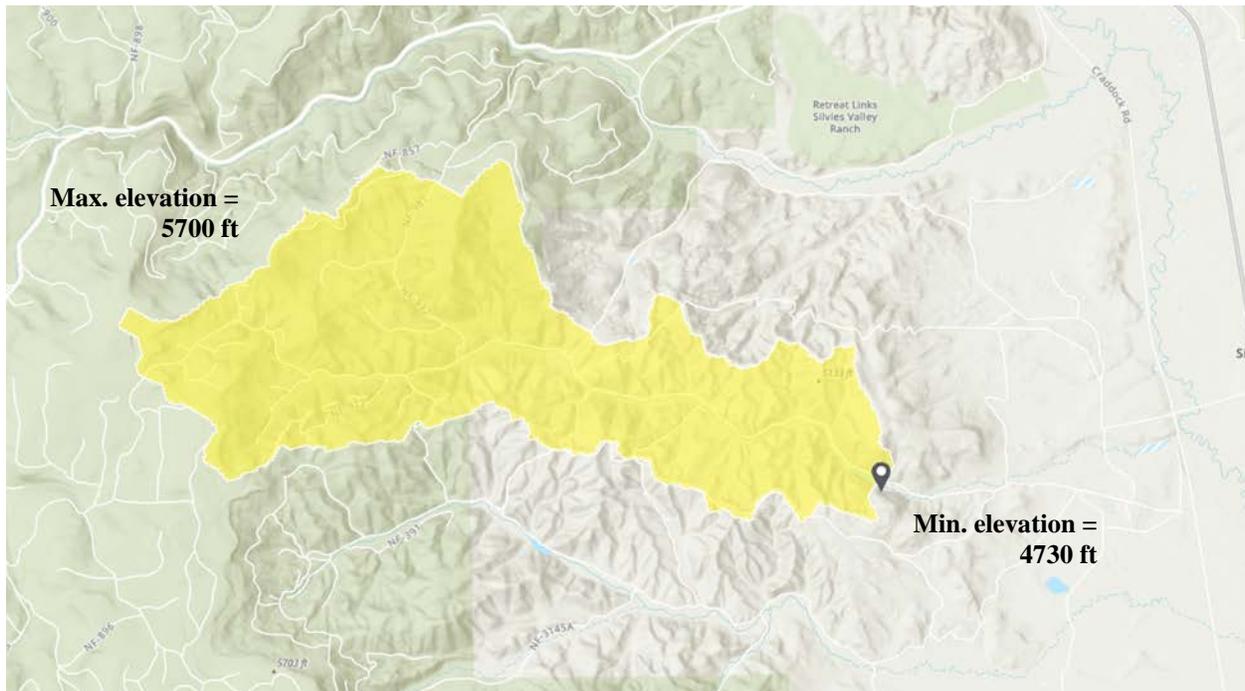
Figure 3. StreamStats generated map of Jump Creek drainage area.

Jump Creek is an ungauged tributary that, at base of Elk Lake, drains 5.37 square miles of mostly sage-steppe ground in the Silvie's River Basin (Figure 3).

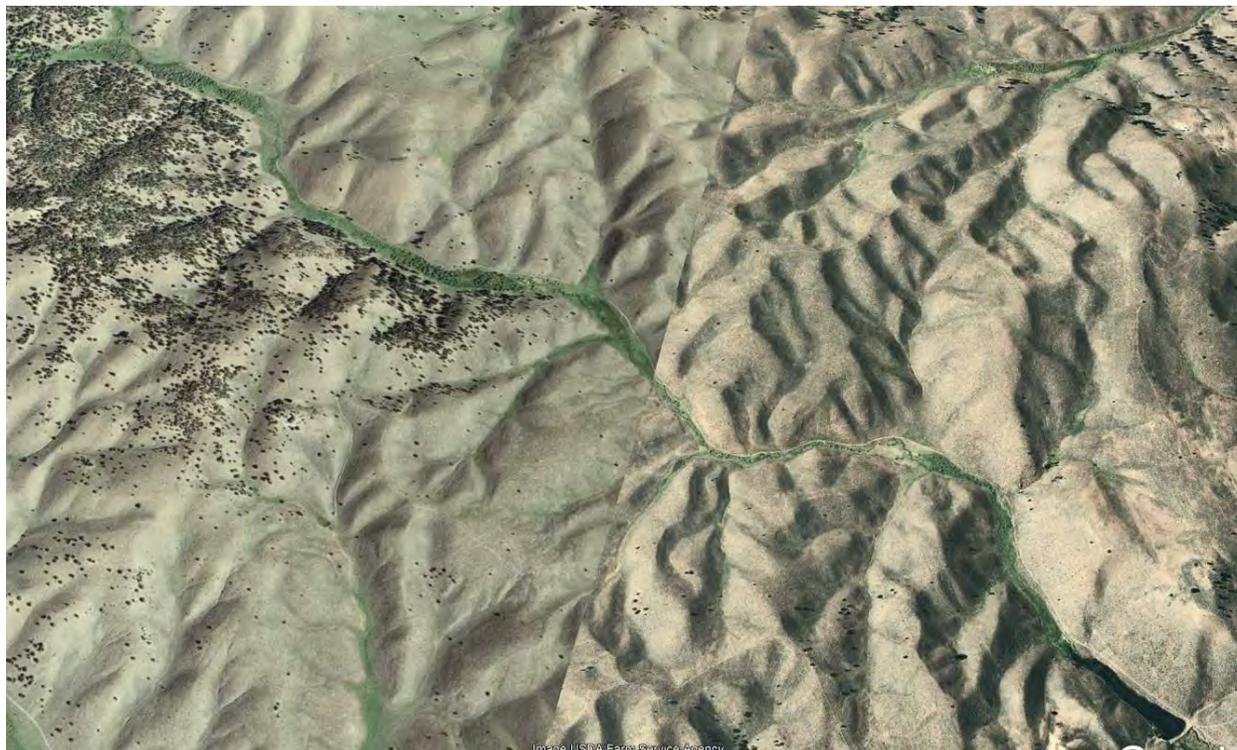
Figure 4. Aerial imagery dated August 2006, showing discontinuous woody plant cover on valley floor, Jump Creek drainage, before ABDs were installed in 2009 (Google Earth Pro).

Water moving through the drainage is often of insufficient rate or velocity to mobilize root-bound sediment to carve a channel. Instead, the water moves as shallow interflow and, during intense precipitation or snowmelt events as limited-duration sheet flow. This water supports small, discrete grassy areas on hillslopes and in small tributaries and comparatively broader, gently sloping, valley-spanning meadows on main valley floors of varying widths. On Jump Creek, the difference in groundwater discharge may account for the striking discontinuities in woody plant cover on valley floors (Figure 4).

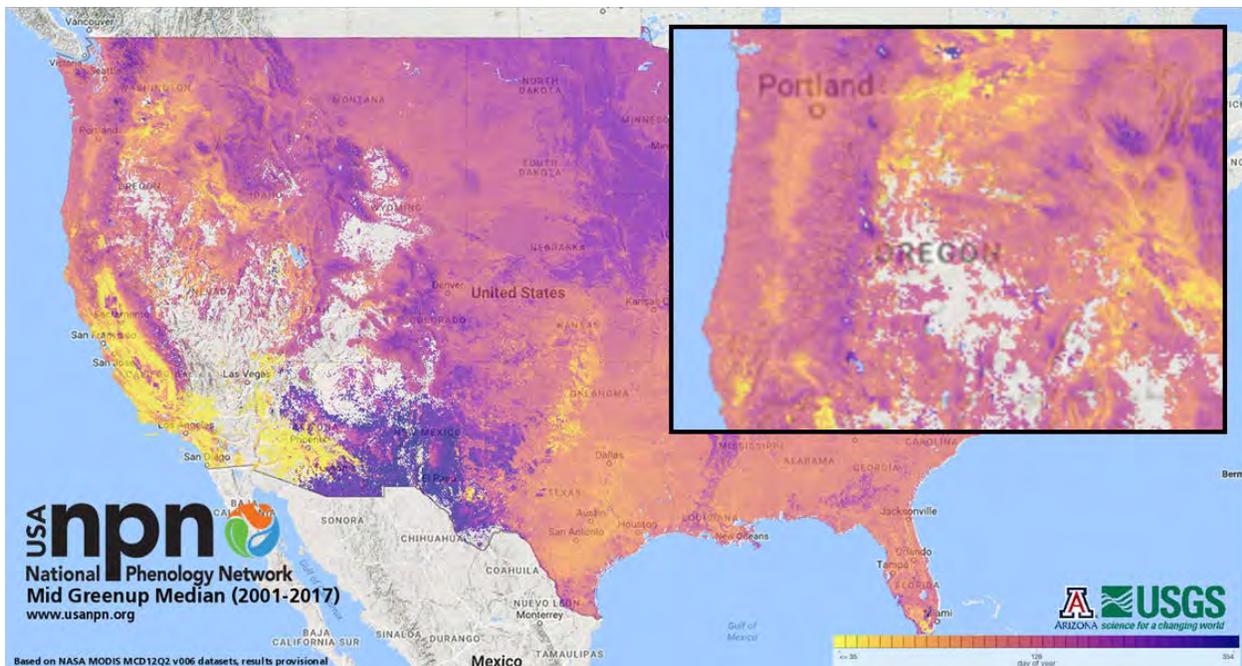
Figure 5. Mid Greenup Median from the National Phenology Network. Mid Greenup represents the day of year when a given pixel has achieved 50% of peak greenness.

Plants in this region typically leaf out in late April or May and begin transpiring greater volumes of water (Table 2, Figure 5). Reference monthly evapotranspiration data from the nearest AgriMet Station to Jump Creek suggest that evapotranspiration typically peaks between July 1 and August 1 annually. A major slope-break in evapotranspiration values, likely corresponding to greenup, occurs between April 1 and May 1. This aligns with observations of a median mid greenup (when half of peak greenness has occurred) occurring mid-May for the region based on aggregated satellite imagery from 2001 to 2017 (Figure 5). As noted above, evapotranspiration in Table 2 was collected from a well-irrigated field of alfalfa, and thus the volumes listed are likely much higher than plant usage in Jump Creek, where plants will become water limited by mid-summer.

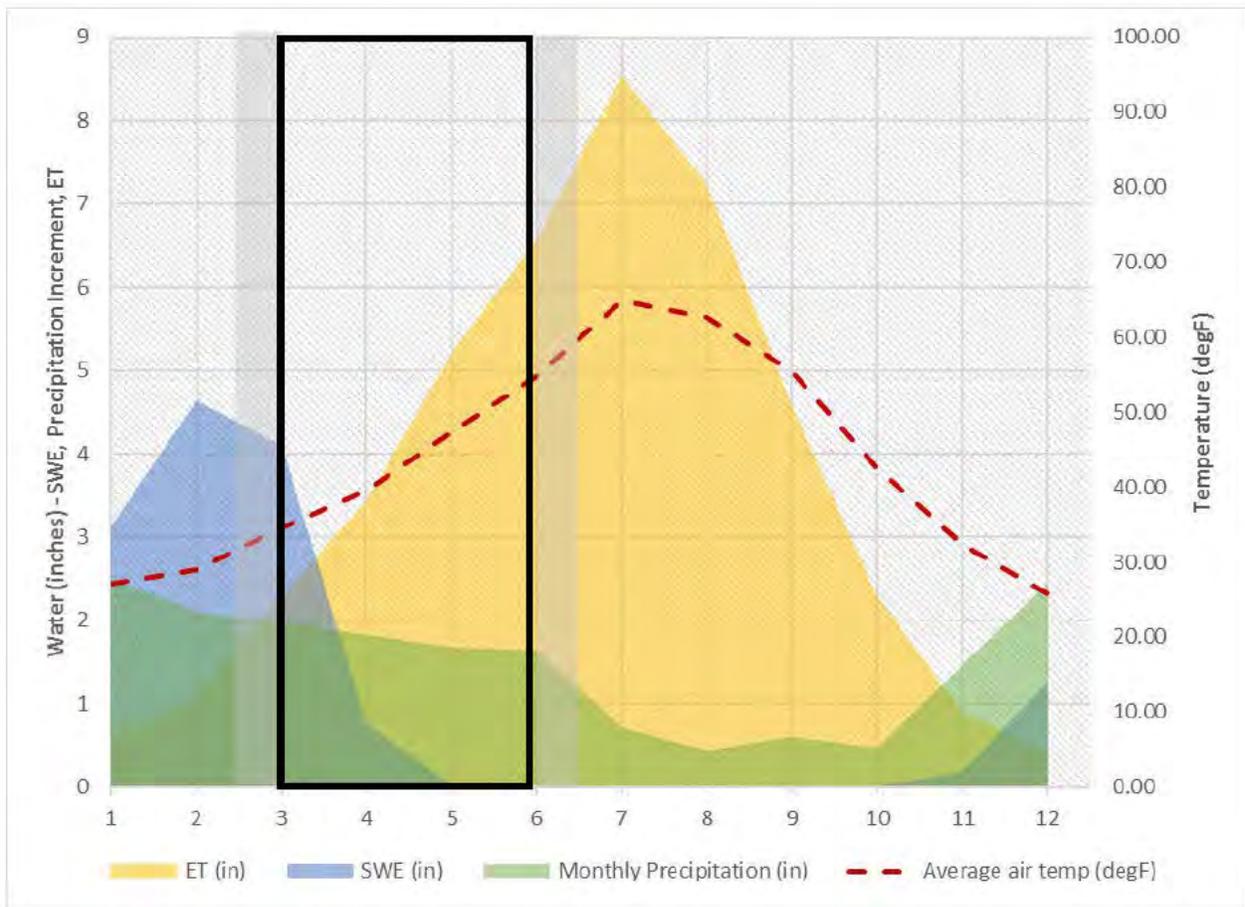
Figure 6. Average annual water budget for Silvie's River Basin, Oregon (1980-2020), based on data from NRCS SNOTEL station 0731. The black box indicates estimated continuous flow duration on Jump Creek, with grey shaded areas representing expected interannual variability. The x-axis values of 1-12 represent months of the year.

Based on these data, a generalized average annual water budget for this region can be constructed to visualize the timing of inputs, outputs, and key ecological events (Figure 6). This is a semi-arid region, so potential evapotranspiration exceeds available water on an annual basis, as is evidenced by the area under the evapotranspiration curve compared to the area under the snow-water equivalent and precipitation curves (Figure 6). By June, more water has evapotranspired than has accumulated via snow-water equivalent and monthly precipitation combined (Table 2).

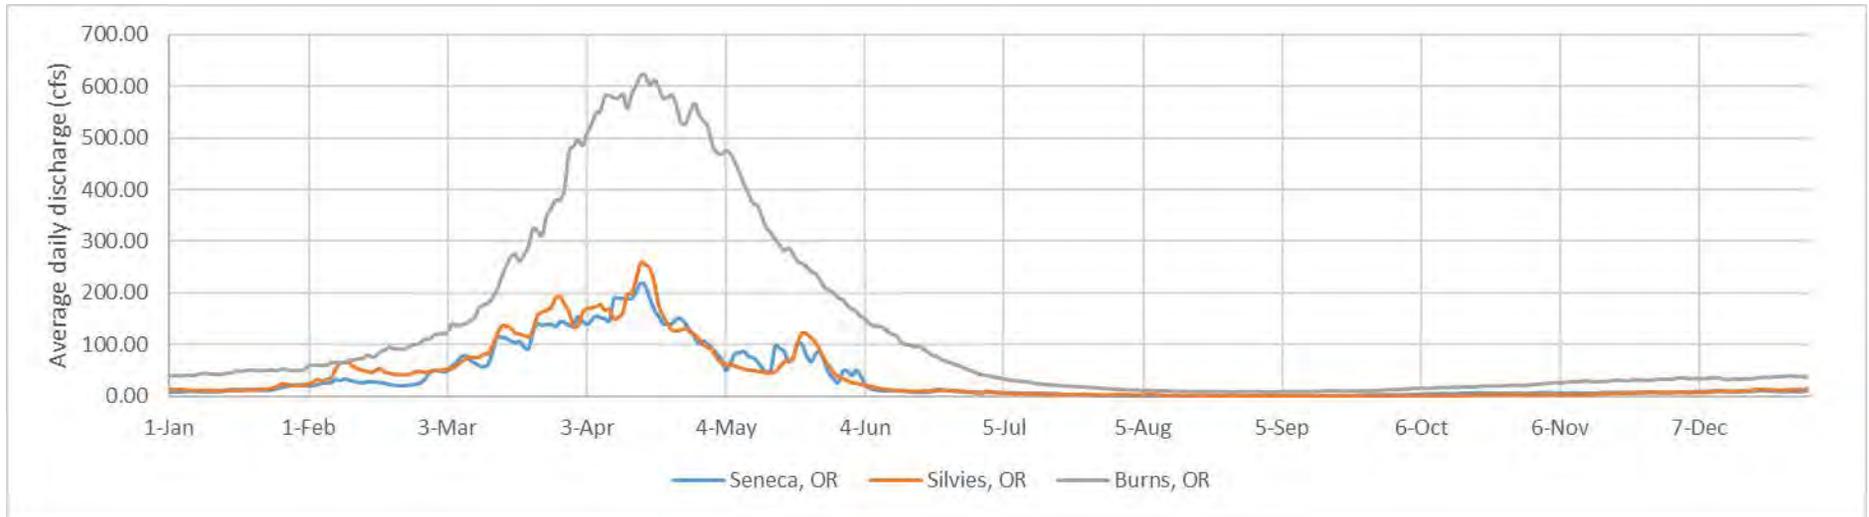
Figure 7. Median average daily discharge for each day of the year, over the period of record available, for the three stream gauges on the Silvie River. These data represent median flows experienced on each day of the year at each gauging site, based on a statistical analysis of the period of record (2014 to present for Seneca and Silvies).

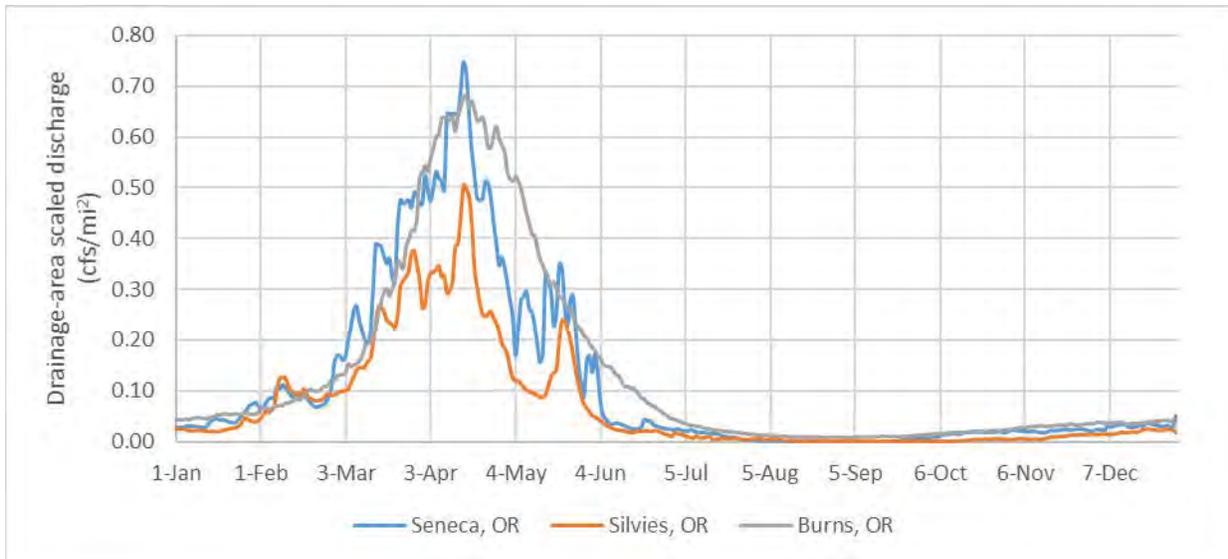
Figure 8. Median average DOY flow for the three gauges on the Silvies River, scaled by drainage area.

We can quickly test the validity of this method in the Silvies Basin by comparing normalized median day of year hydrographs for each of the three gauging sites (Figure 8). Here, the median average discharge for each day of the year (Figure 8) has been divided by the drainage area of the given gauge site (Table 2). The lowest gauge site in the basin (Burns) and highest (Seneca) display similar magnitudes of basin-area scaled discharge. The values from the middle gauge (Silvies) are lower during irrigation season, but produce similar values to the other two sites between October and April. Though far from exhaustive, this lends some confidence to using this method to estimate discharge in the tributaries.

The hydrograph from the upstream-most gauge, Seneca, shows a slightly earlier rising and receding limb, and a slightly higher and sharper peak flow. This may be a result of the limited period of record, but also makes conceptual sense given that this gauge is higher in the watershed and receives runoff more quickly from its tributaries. The record from this site is used to model the Jump Creek hydrograph as it is both closer to Jump Creek and will generate the highest possible peak flow, which is consistent with the effort to understand upper maximum expected median streamflow (Figure 9). Note that the shape of the resulting modelled hydrograph will closely mirror that of the Seneca gauge. The small rise in discharge in February is likely due to the Seneca gauge receiving water from tributaries with less forest cover and more of a south-facing aspect, among other conditions causing it to melt earlier in the year than Jump Creek might be expected to.

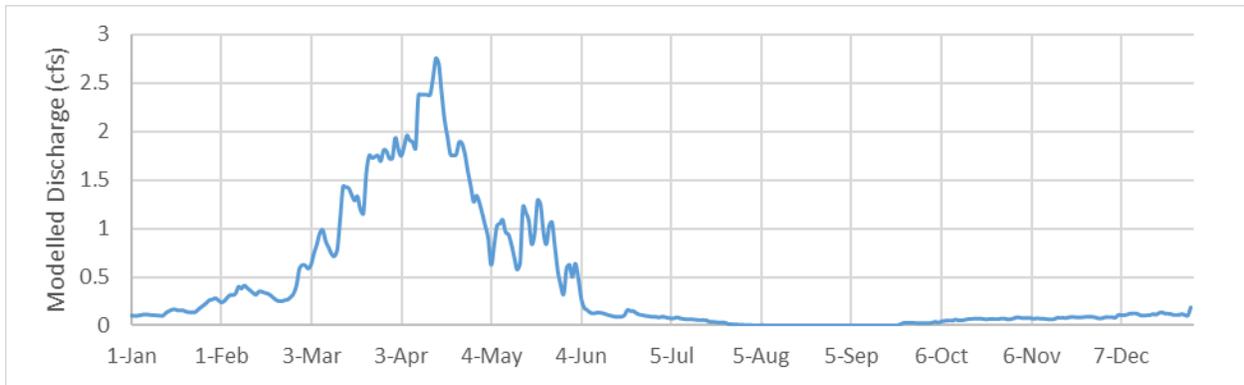
Figure 9. Modeled median average daily flows for each day of the year at Jump Creek, Oregon.

This analysis suggests that peak flows should be around 2.8 cfs and median flow during the typical period of run-off (mid-March to late May) would be approximately 1.3 cfs. Measured flow on April 17, 2020 was approximately 1 cfs (using velocity-area method). Though April 17 is, over the period of record on the Silvies River, the day of year when highest flows are most likely to occur, this particular year a considerable amount of snow persisted on hillslopes, and peak flows do not appear to have occurred until two weeks later, on May 2, 2020. This emphasizes the outside control of seasonal variation in climate patterns on the emergence of streamflow in these small, intermittent and ephemeral channels. Scaling just the data on the Seneca gauge from January 1, 2020 to May 6, 2020 suggests flows on Jump Creek on April 17th should have been approximately 1.9 cfs, and peak flows on May 2nd should have been 3.1 cfs. This nearly 100% overestimation is consistent with expected performance of drainage-area ratio modelling in nearby drainages (Risley et al. 2008).

Note, too, that the model predicts streamflow (less than 1 cfs) in October –early March, when in fact the measured flows are, except in rare circumstances, 0 cfs. And, even where some limited (less than 1 cfs) flows may occur, nighttime temperatures cause these small flows to freeze, eliminating flowing water within the channel.

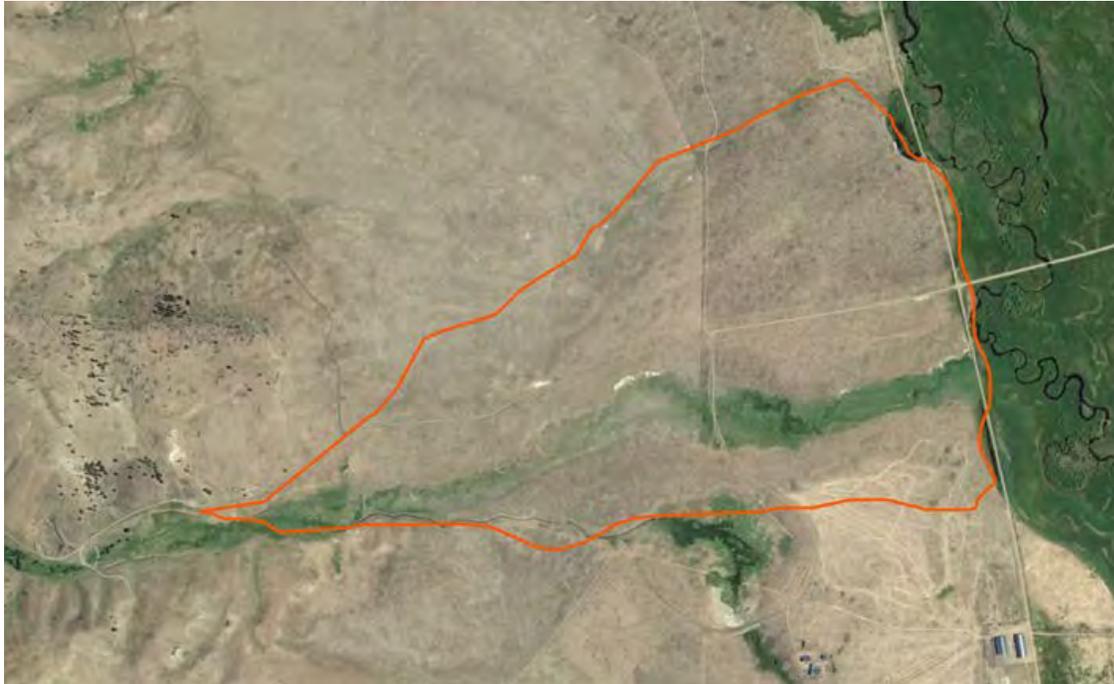
Figure 10. Google Earth image depicting the alluvial fan into which a small valley has carved near the bottom end of the Jump Creek drainage. Silvies River is the meandering water feature on the far right of the image.

The lack of connectivity is further explained by the geomorphology of the Jump Creek drainage. At its lower end, a marginally developed valley has cut through a large alluvial fan that is composed of coarse, highly permeable materials into which what little flow might reach this area under natural conditions would absorb.

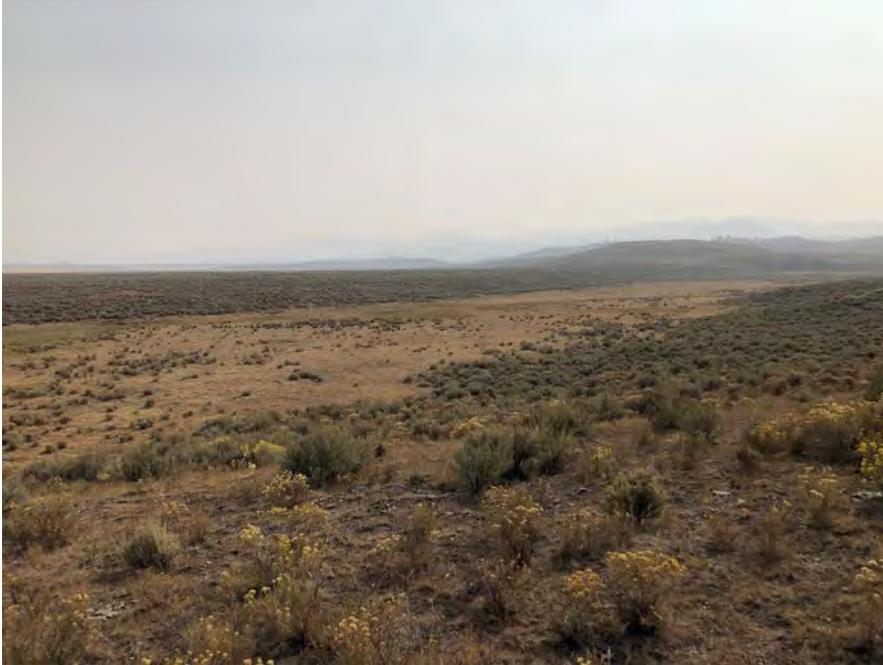
Photo 3. September 2020 looking “upstream” and across the wide valley bottom in the area of lower Jump Creek denoted in Figure 10.

The following photograph provides an on-the-ground depiction of the wide, marginally developed valley bottom located in the lower area of the Jump Creek drainage. Upland species grow at similar densities in the channel and upland areas. The valley fill here is coarse and permeable, causing the limited streamflow in this area to soak into the valley fill rather than run over it.

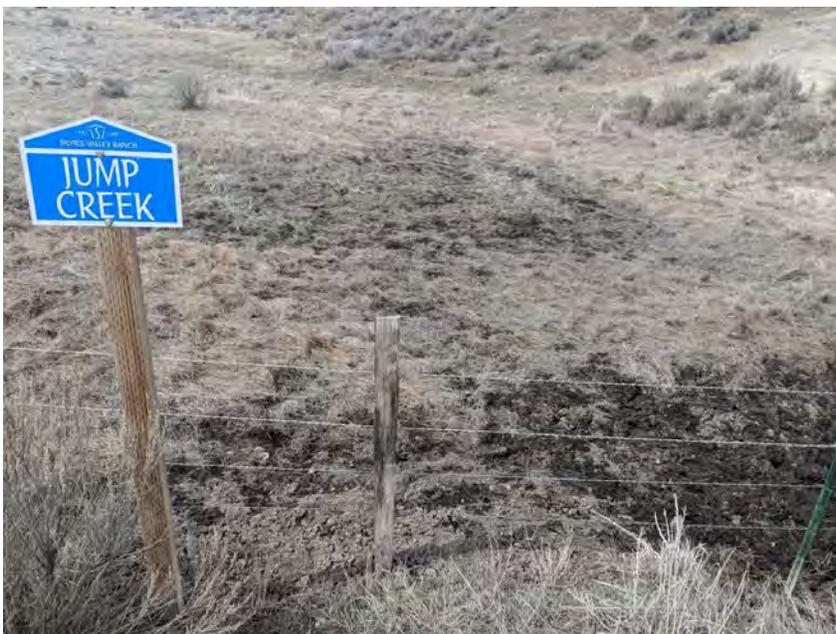
Photo 4. April 18, 2020 photograph documenting lack of flow at the lowest portion of Jump Creek near the Silvies River approximately two weeks prior to peak spring runoff. In upper Jump Creek, flows topped out at 1 cubic feet per second at this time. Due to the hydrology and geomorphology of the lower Jump Creek drainage, spring runoff would not have reached the lower end of Jump Creek even at peak flows.

The absence of flows to create hydrologic connectivity was also readily evident near the bottom of Jump Creek on April 18, 2020, during the near-peak spring runoff (2020 was an unusually cool spring, delaying peak runoff by approximately 2 weeks into early May).

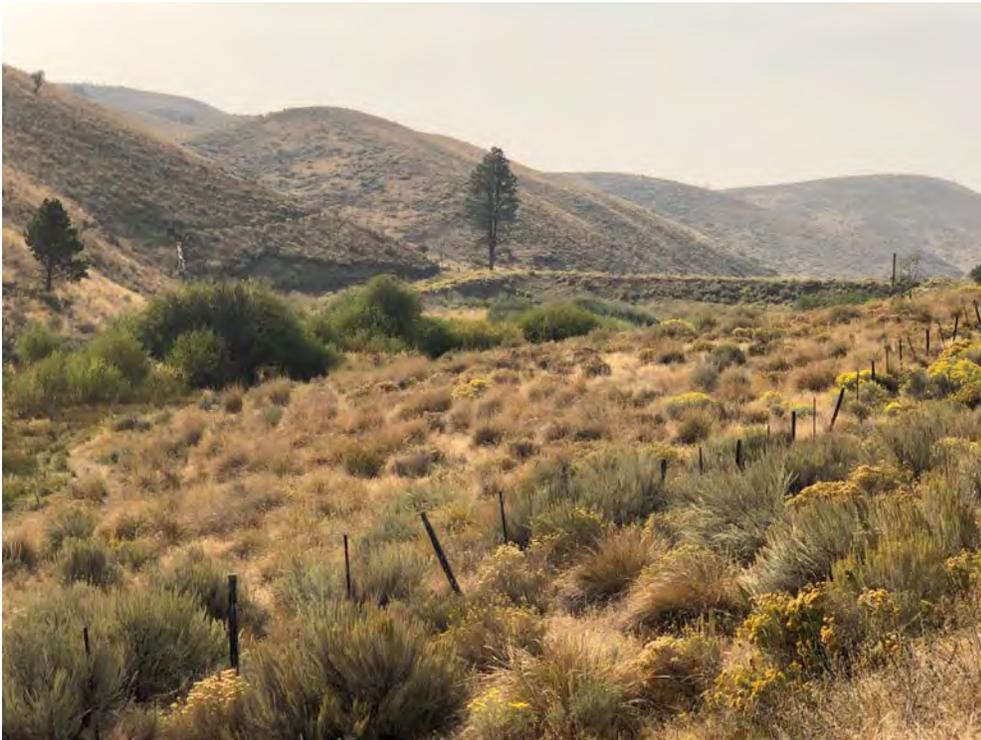
Photo 5. September 2020 photograph of the face of the Elk Lake impoundment, circa 1930s (note size of pine tree located on the impoundment). Alder and willow, and other riparian vegetation located downstream of dam face are supported by seepage from the impoundment and would be absent without it.

Approximately one-half mile downstream from the lowest downstream ABD is Elk Lake, a feature created by the construction of an impoundment in the 1930s (circa) accordingly to local information and history. This impoundment is a historical and long-existing complete artificial barrier to any fish passage. It is used as a diversion structure for an 1888 water right authorized by the Silvies River Decree for nearly the entire flow of Jump Creek.

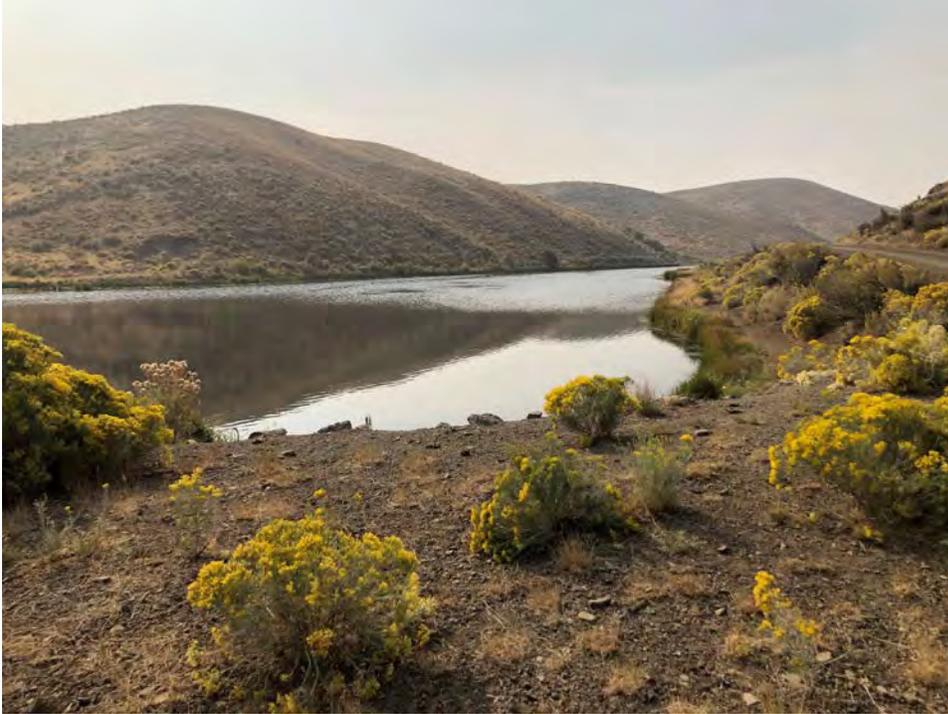
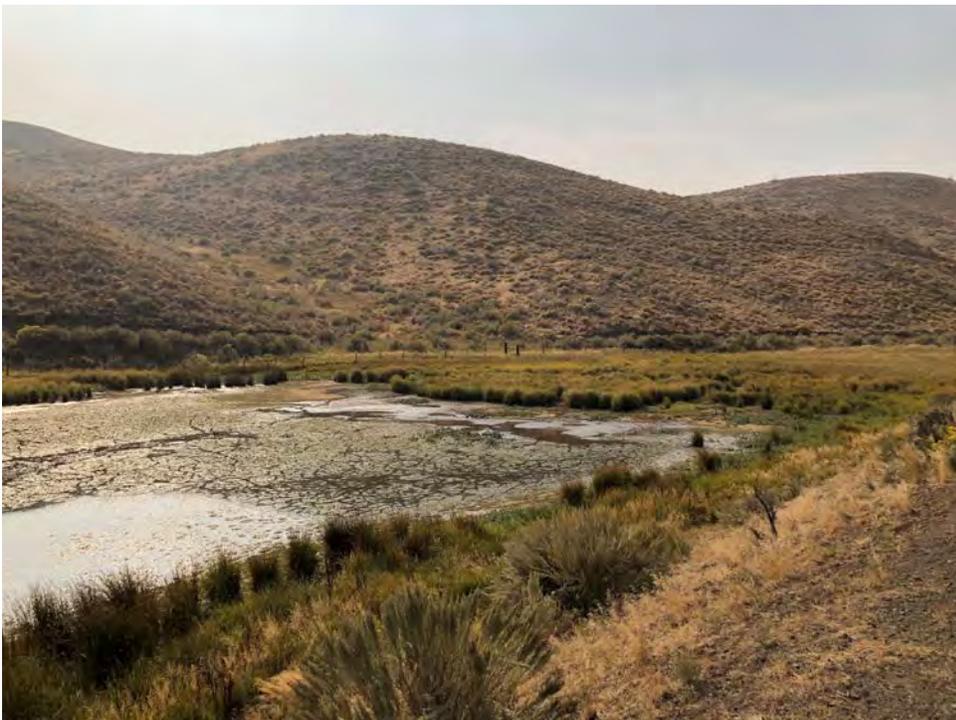
Photos 6 (above) and 7 (below). Elk Lake in mid-September 2020. This is the only water present this late in the year in the lower Jump Creek drainage. The lake is warm, supporting a population of perch. Note the riparian vegetation and wetland areas alongside this historical water feature. These would also be absent without the impoundment.

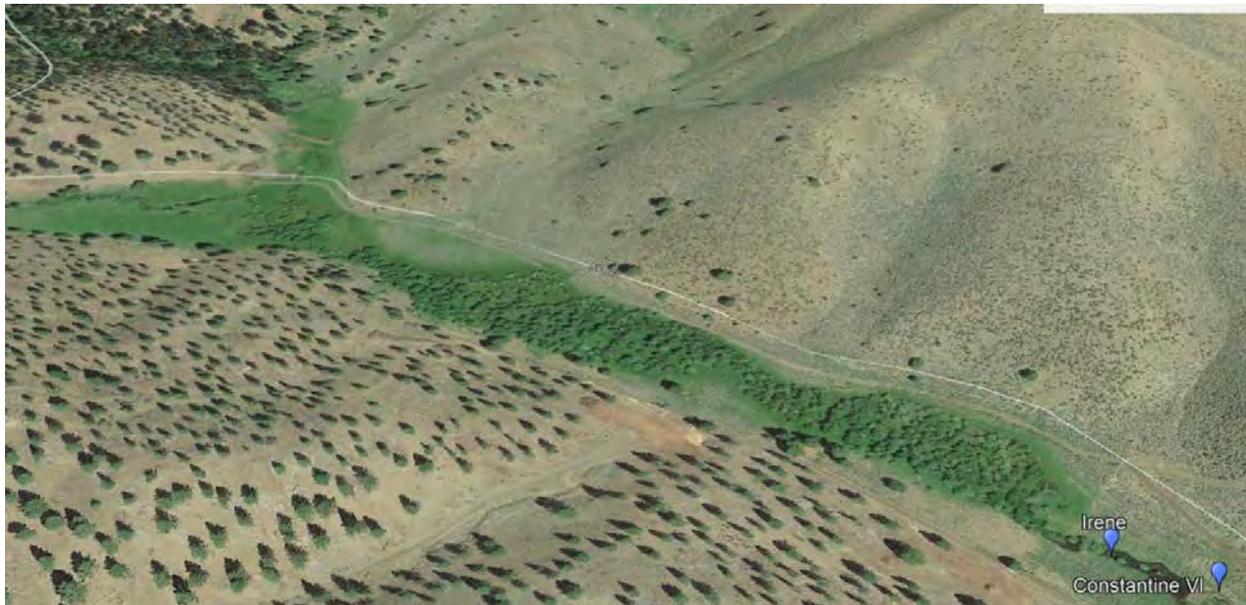
Figure 11. Image of approximately 0.4 mile length of boggy area immediately “upstream” of ABD Irene. There is no channel present in this part of Jump Creek due to small volumes of incoming water, all of which flows subsurface(Google Earth Pro). This boggy area is a natural complete barrier to fish passage, to/from the private and federal lands above the boggy area and to/from the stretch of Jump Creek where ABDs were installed.

Above the uppermost ABDs, habitat conditions are limiting to fish presence due to limited hydrology and geomorphology. Immediately upstream of the uppermost ABD (Irene) there is a boggy area that presents no channel for an approximately 0.4 mile stretch (Figure 11). These conditions preclude connectivity between the middle portion of Jump Creek and the upper part of Jump Creek and its upper two forks (Figure 1). They are also a natural fish passage barrier.
