# OCRF Grant Project Completion Report

**Project Name:** OCRF 2023-21 Fish Habitat Protection with Thermal Infrared Imagery

# 2024 Thermal Infrared Drone Imagery to Assess Climate Resiliency in Restoration Design

To: Kellogg Design Team

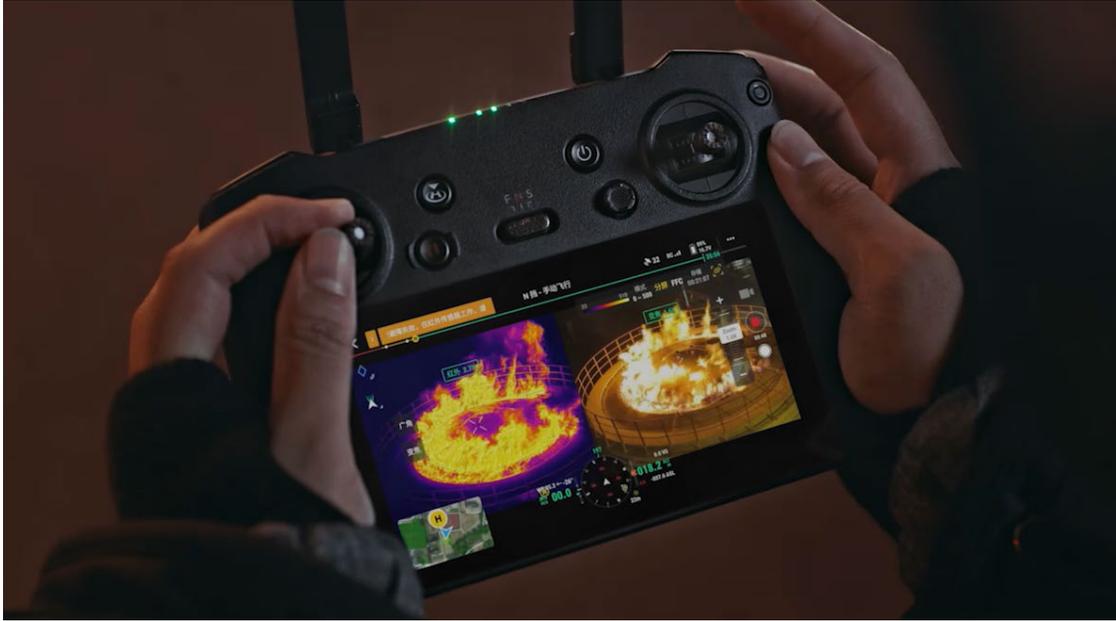
*Figure 1- Side by side viewfinder on remote controller of DJI Mavic 3T (image from DJI Enterprise).*

The drone selected for this work was the DJI Mavic 3T. This drone is portable enough for field work and has two cameras, a Zoom camera for the visible light spectrum and an infrared camera for the thermal spectrum. The Mavic 3T's zoom and thermal cameras also support continuous side-by-side views on the controller for easy comparisons. The flight interface allows for pre-programming the flight paths and specifying image overlap, both of which is necessary for the creation of orthomosaic photos.

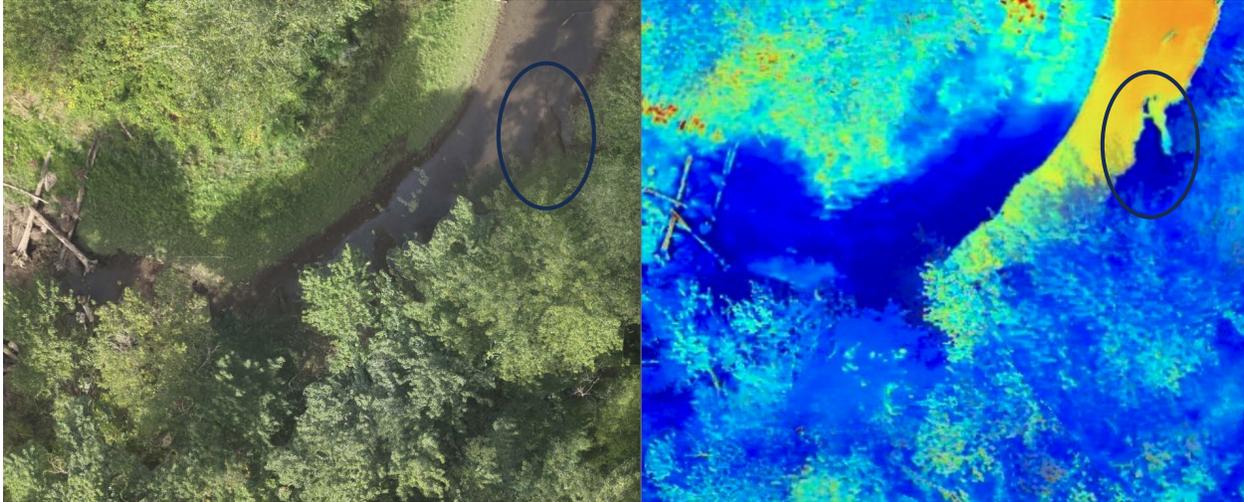
Figure 6 - Location of cold-water springs on the south end of the project site.

The 30% concept level restoration design did not have log jams that far south in the channel. To maximize climate resiliency associated with the restoration design, the logjams will be extended to the south, ensuring that instream cover is created in areas that also provide cold water refuge for juvenile salmonids in the summer months.

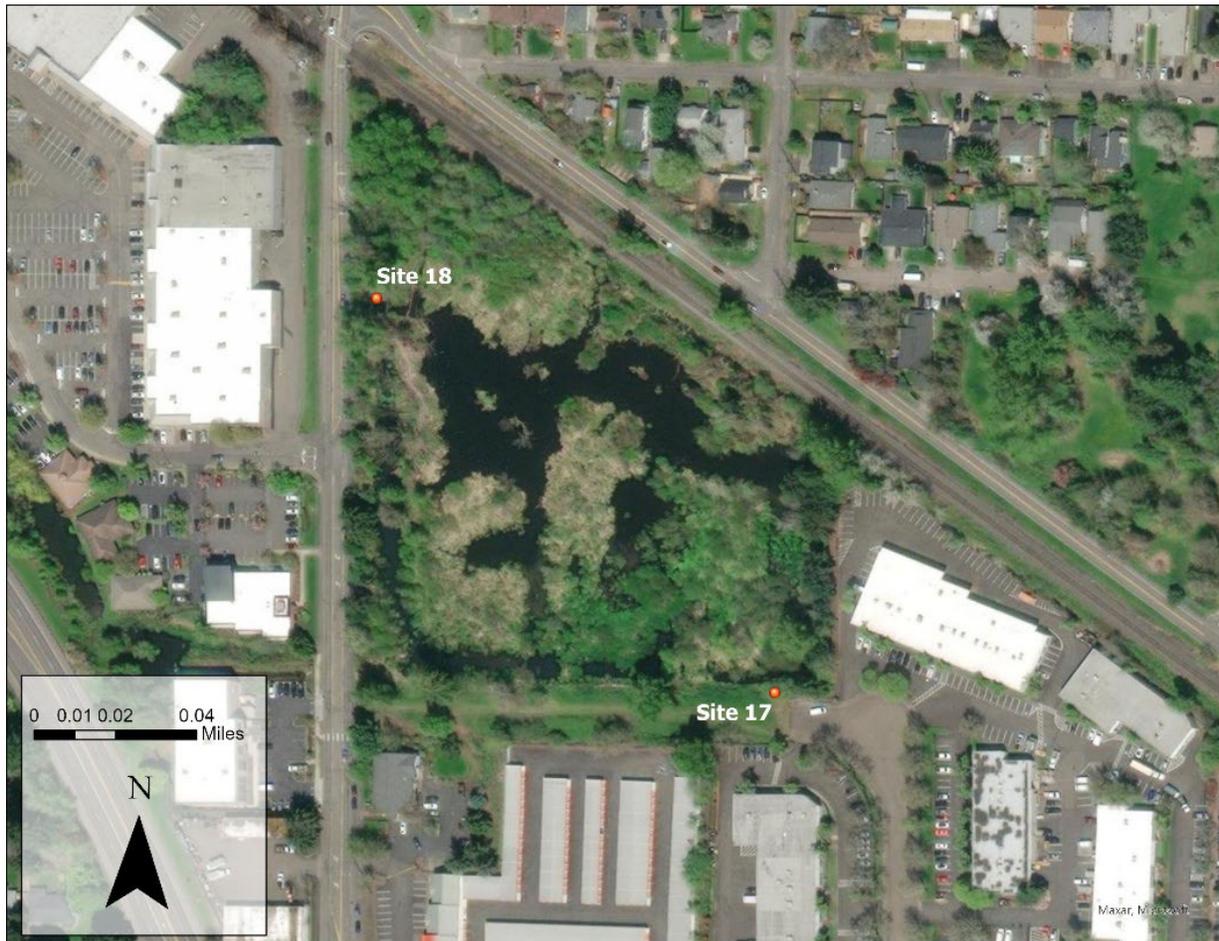
Figure 8 - Location of continuous temperature loggers in Minthorn Springs Wetland.

water quality (including temperatures) in the wetland was considered poor. In 2022, the Council placed 2 temperature loggers in the wetland: one in the spring-fed inlet of the wetland (Site 18), and one at the outlet (Site 17). This continuous monitoring study showed that the inlet maintained a consistent 13-15 ° C all summer long, showing the coolest water temperatures in the watershed. However, the logger placed at the outlet of the wetlands showed some of the highest temperature in the watershed (NCWC, 2023).

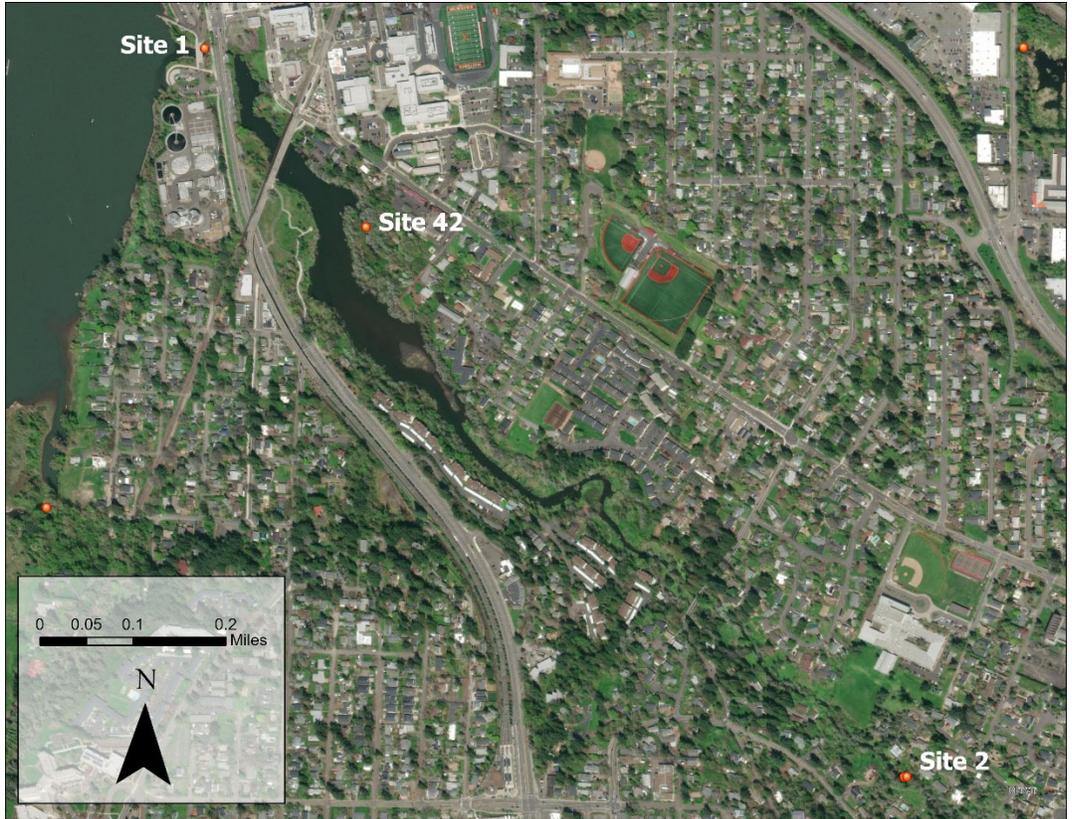
Figure 2- Location of temperature loggers associated with Kellogg project.
