R & E Grant Application 13 Biennium

Project #:
13-085

Sullivan Gulch Bottomland Restoration

DRAFT
Sullivan Gulch Restoration Project
90% Design Report

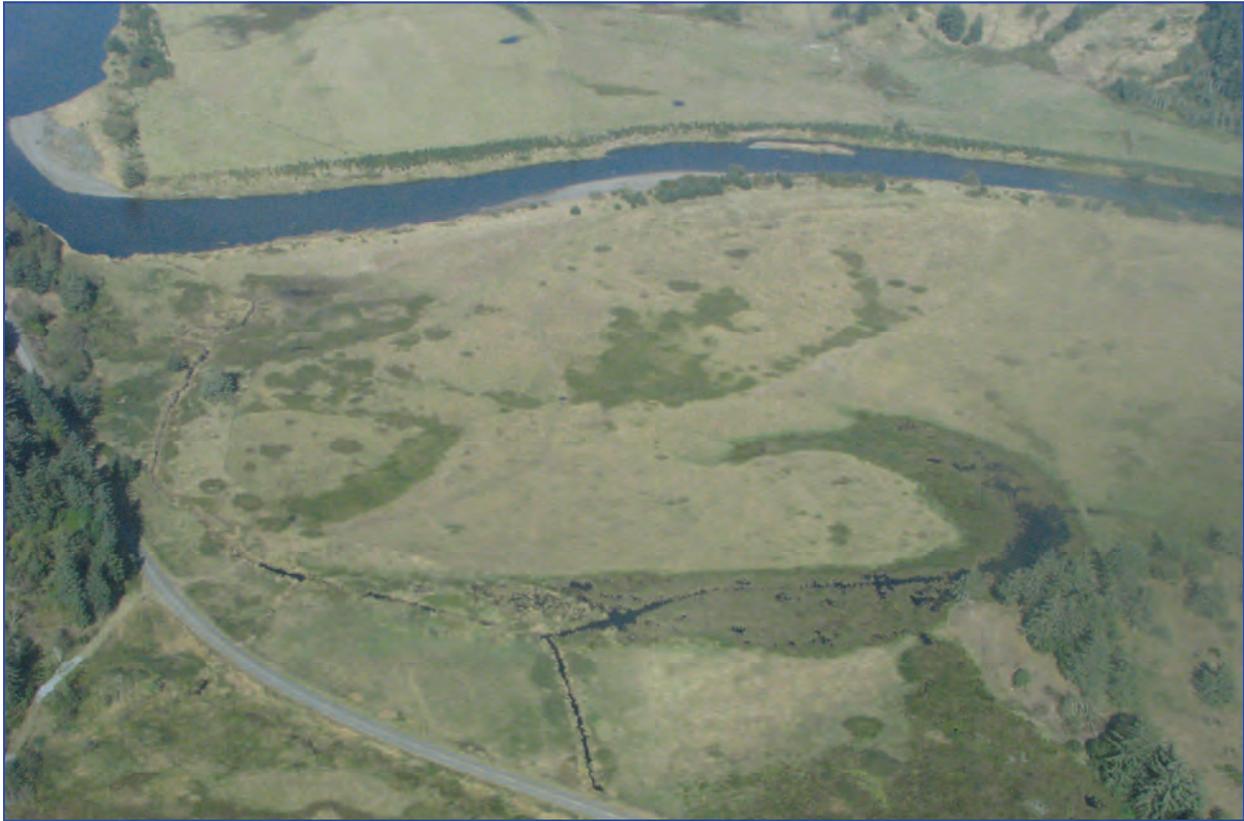
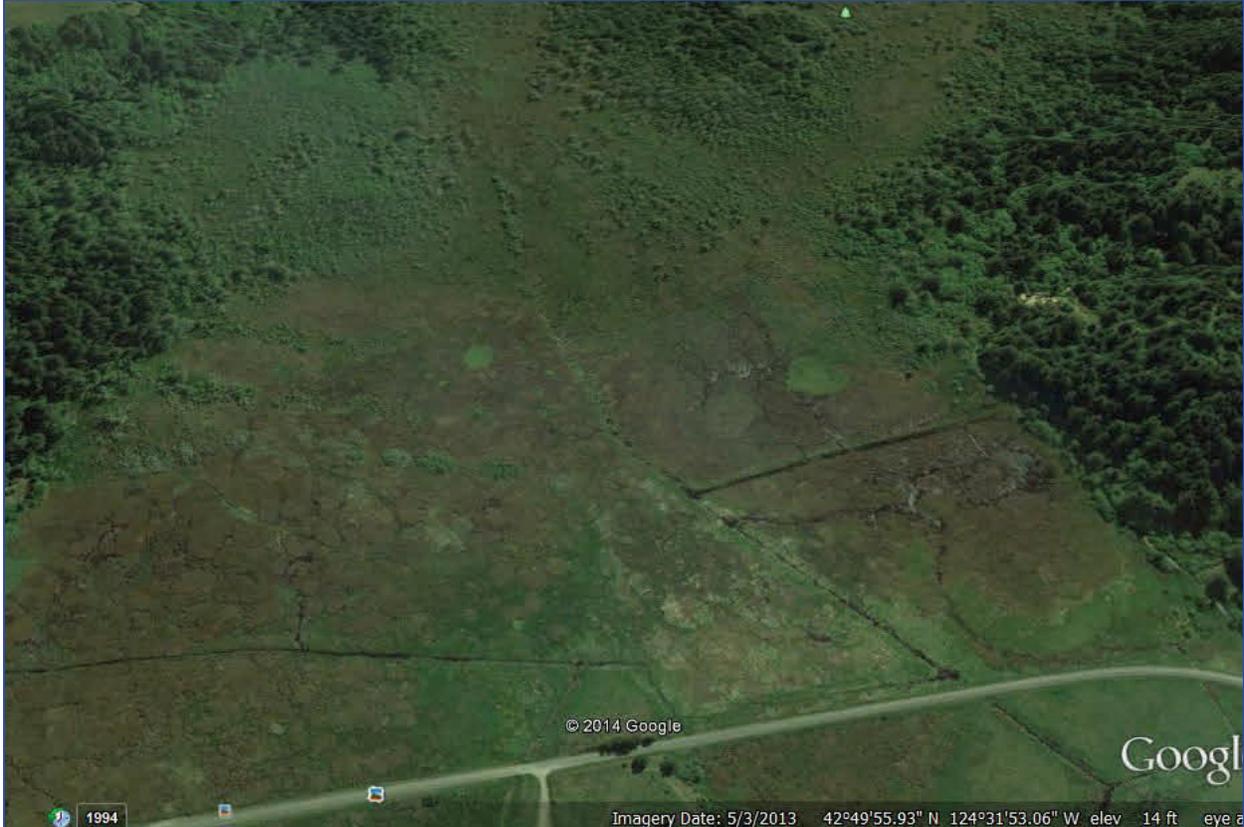
Sullivan Gulch Bottomland Restoration: The top photo is looking north at the project area (the Sixes River is in the background). The dominant ditch channel in the photo is Sullivan Gulch — most of this channel will be decommissioned and a new stream channel will be routed through the oxbow and existing depressions. The bottom photo is looking south at the wetlands located upstream of the Cape Blanco access road, which are inundated throughout the wet season. The ditches that are visible were dug in the late 19th century to convert the area to pasture, but since beaver recolonized the bottomlands in the 1990's the wetlands have rehydrated and are reverting back toward their natural state. Through this project the hydrology upstream of the road will be stabilized to prevent rapid dewatering, and access for juvenile fish will be improved.

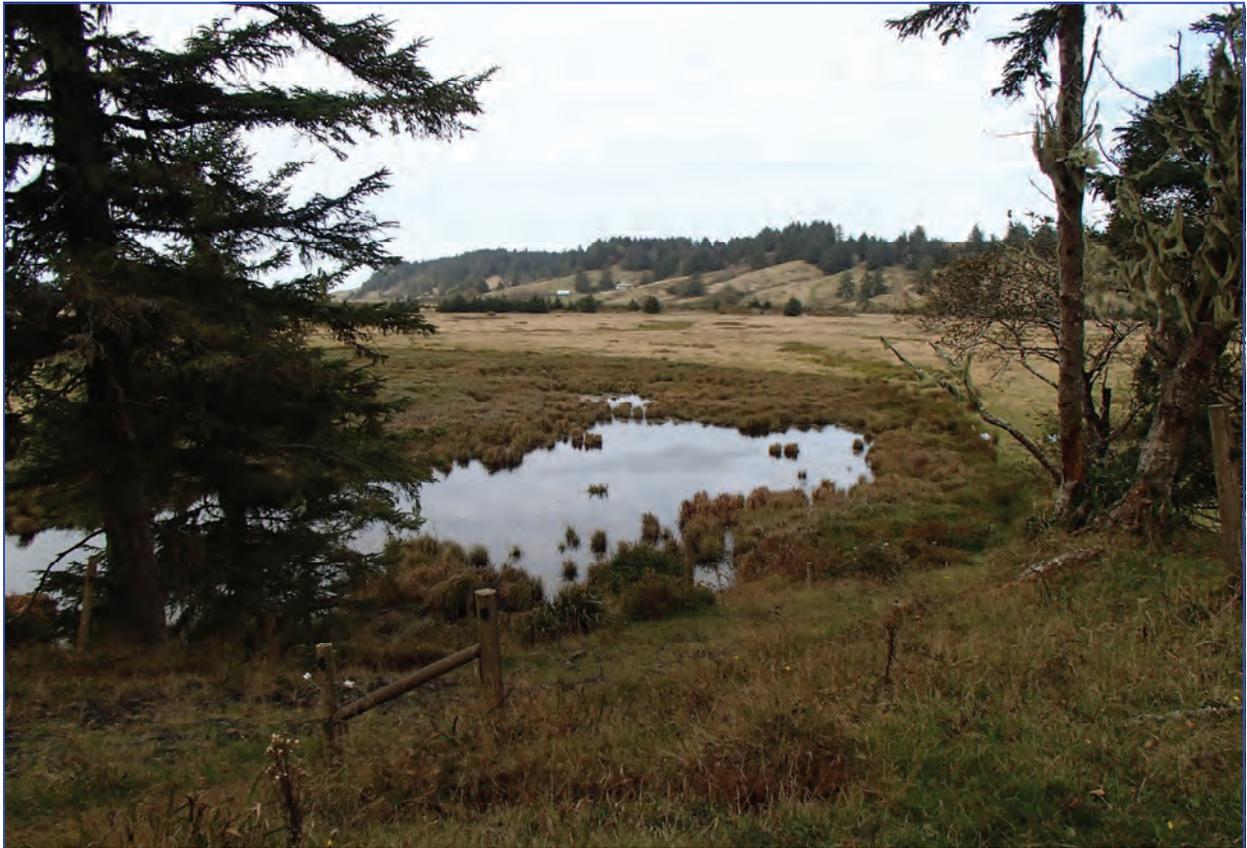
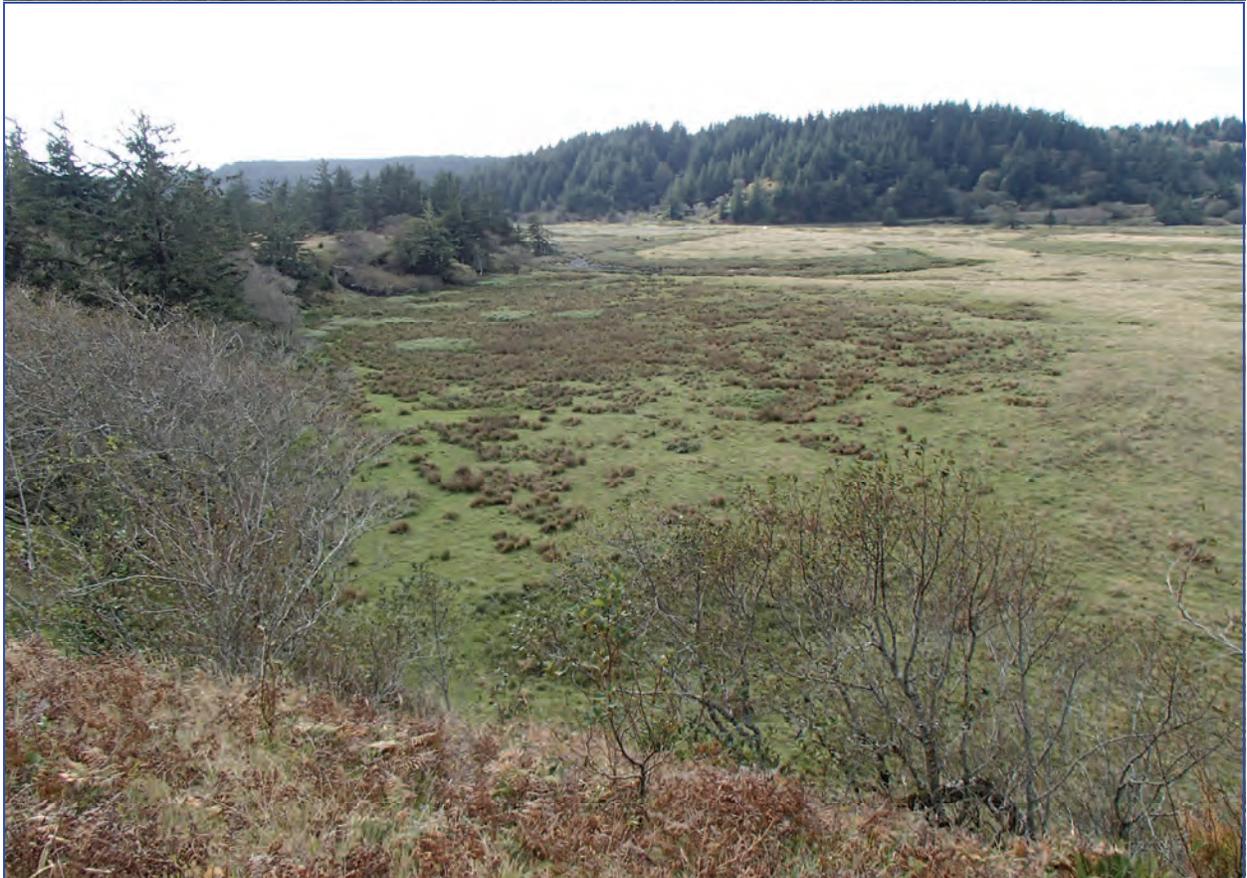
Sullivan Gulch Bottomland Restoration: The top photo is looking at a remnant oxbow riverine feature within the project area. The new Sullivan Gulch stream channel will be routed through this feature to increase summer and rearing habitat. The bottom photo is looking at a ditched wetland within the project area that will be converted into a backwater area with open water habitat similar to the oxbow in the top photo.

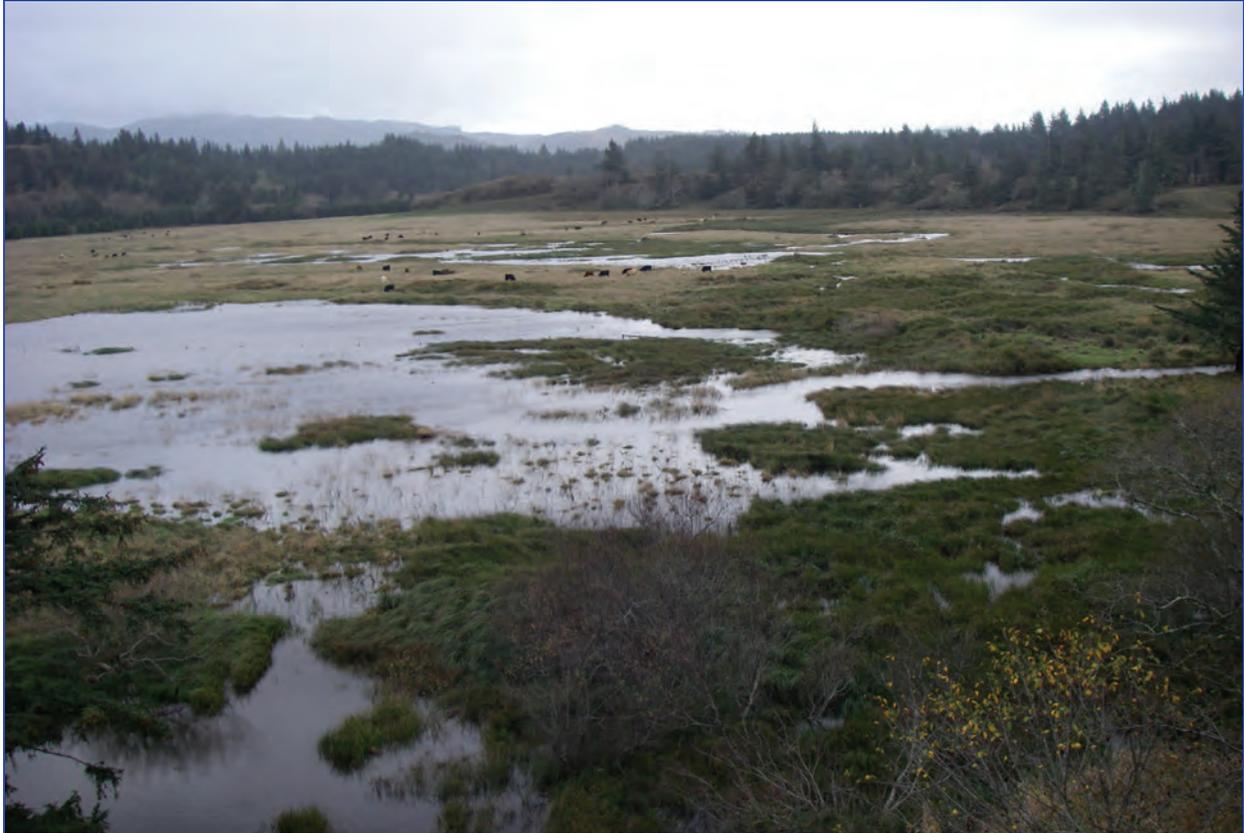
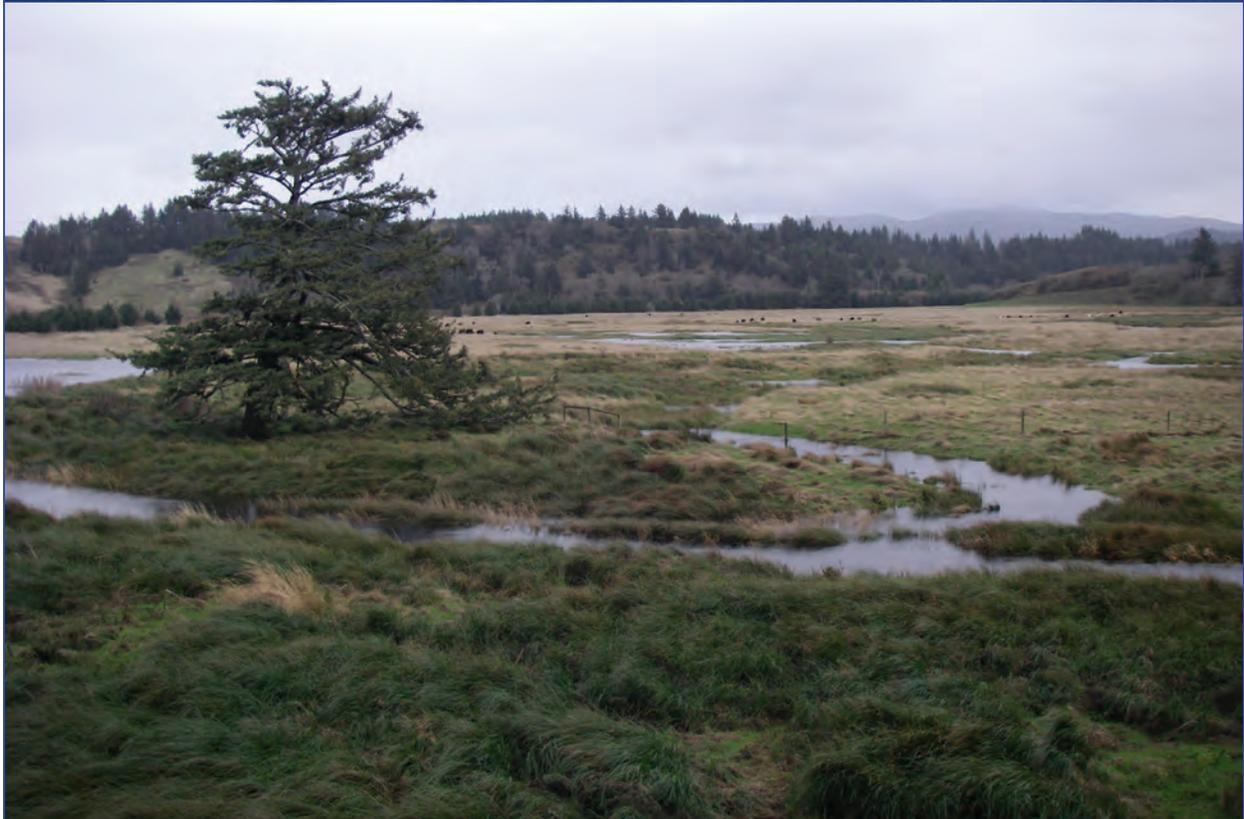
Sullivan Gulch Bottomland Restoration: Both photos show portions of the project area during high flow winter conditions when the Sixes River backwaters Sullivan Gulch. In the top photo the backwatered area includes a natural segment of the Sullivan Gulch channel and an old riverine feature. Through this project wood structures will be added to this area to increase habitat complexity, and livestock will be fenced out of the wetted features. The bottom photo shows the confluence of the existing Sullivan Gulch channel and a remnant stream channel which will be incorporated into the new Sullivan Gulch alignment.

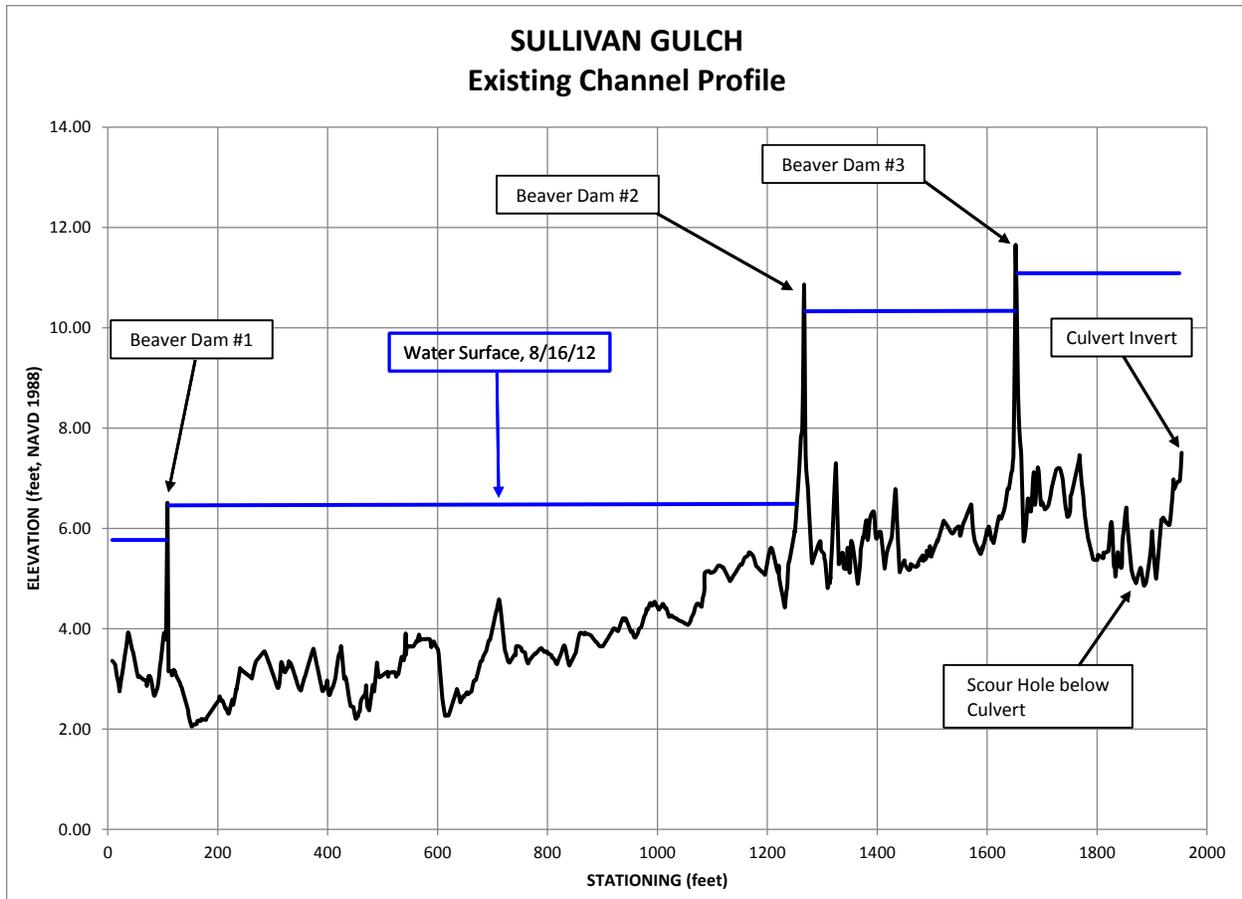
Figure 1: Existing Channel Profile at time of Field Surveys, Aug 2012.

The following bullets provide a summary of key information that can be found in Figure 1:

generally gradual slope from the Sixes to the culvert, although the lower 700 feet of the existing channel are essentially flat. If the beaver dams were not controlling the water surface, the oxbow would likely be completely dry. Fish passage is affected by the beaver dams except when the Sixes is bar bound and there is flow in Sullivan Gulch, or if the Sixes is elevated enough (over 5 feet higher than low flow conditions at time of survey) during winter storms to backwater the upper two dams (certainly would not occur very often). There is no evidence that high flows have been able to remove or substantially modify the beaver dams in recent years (certainly did not happen in 2012 which was a very wet year with a large event, estimated at perhaps a 20 year recurrence interval). There is evidence from historic aerial photographs that the oxbow was mostly dry in the past, likely when the beaver dams were either not present or had been removed by human activities or high flows. One other piece of information obtained by the surveys is the presence of gravel in the culvert. This implies that some sediment transport occasionally occurs in this area, although this could have occurred when the beaver dams were not present and the culvert was not backwatered. There is no evidence, however, that the channel behind the beaver dams has substantially filled with deposited sediment, suggesting that sediment may not be a significant issue.

Clearly, much of the wetland habitat present in the project area is due to backwater conditions from beaver dams, the fill from the roadway, and vegetation upstream of the culvert. If the culvert was not backwatered, far less wetland habitat would be present, as water levels would be about 4ft lower. Thus to maintain existing wetland habitat conditions, the project design must incorporate elevations that create similar backwater conditions.

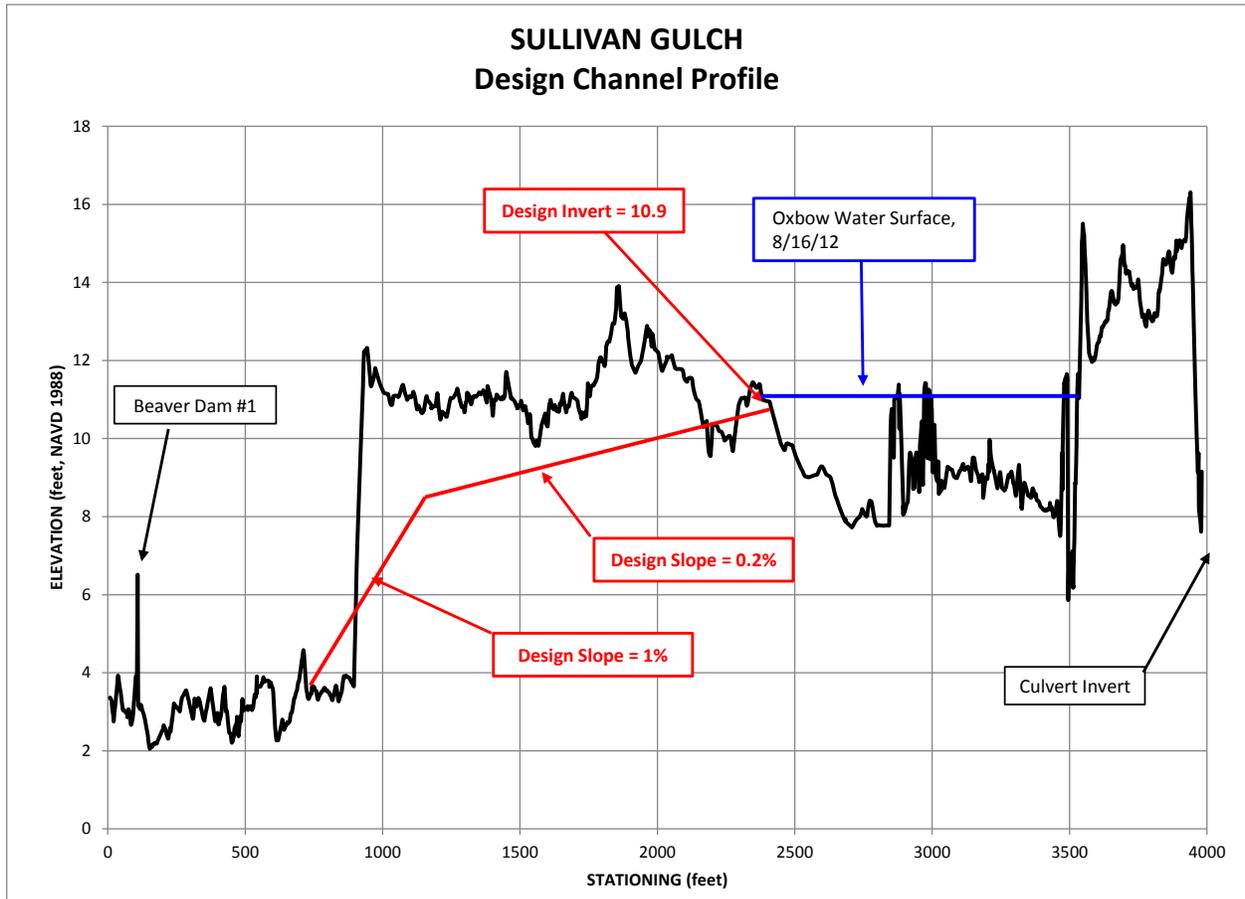
Figure 2: Design Channel invert along Preliminary Design alignment (through oxbow)

The following bullets provide a summary of key information that can be found in Figure 2 and in the preliminary (25%) design drawings.

The preliminary design channel alignment, main channel profile, and typical cross sections can be found on the Sullivan Gulch Preliminary (25%) Design Drawings. The design would create roughly 3,000 ft of new channel, combining both the primary and secondary channel lengths. The main channel, flowing from the eastern culvert, is routed through the existing oxbow feature on the project site and then utilizes existing swales to flow back west to the head of the proposed grade control structure. The main channel slopes entering and exiting the existing oxbow feature are currently at 0.2 %. Minimal to no work is proposed in the existing oxbow feature. Once the main channel reaches the proposed grade control structure, the channel slope is increased to 1.0 % for roughly 300 ft at which time the design channel joins the existing Sullivan Gulch alignment.

Preliminary design would involve excavation of approximately 10,100 cubic yards (cy) and would require roughly 9,800 cy to fill the existing Sullivan Gulch alignment. It should be noted the estimated excavation quantities do not include any cut that would be generated from the off channel habitat/pond areas. It is assumed that any additional cut material from the off channel habitat/pond areas will be used to fill the existing Sullivan Gulch alignment. In addition, by splitting the two channels, a direct path for livestock movement is possible from Cape Blanco Road to the initial floodplain grazing area.

The proposed grade control structure could be a roughened channel, drop structures, or a hybrid, although the preliminary design shows a series of rock drop structures. Each drop structure would be designed with a 0.5 ft drop (or greater if appropriate) for fish passage. Fine grained material will be incorporated into each drop structure to prevent underflow and potential dewatering over the drop structure at lower flows. The concept of a roughened channel is to provide a hydraulic environment that is similar to a natural channel at the same slope. Depending on design considerations, a roughened channel may also incorporate larger rock elements that provide velocity shelter for salmonids and stability elements for the roughened channel matrix. It is currently anticipated that the material used in a roughened channel would have to be stable for most flow conditions, as upstream sediment supply is probably limited. Fine grained material would be added to the roughened channel matrix to prevent significant subsurface flow and channel dewatering at lower flows.

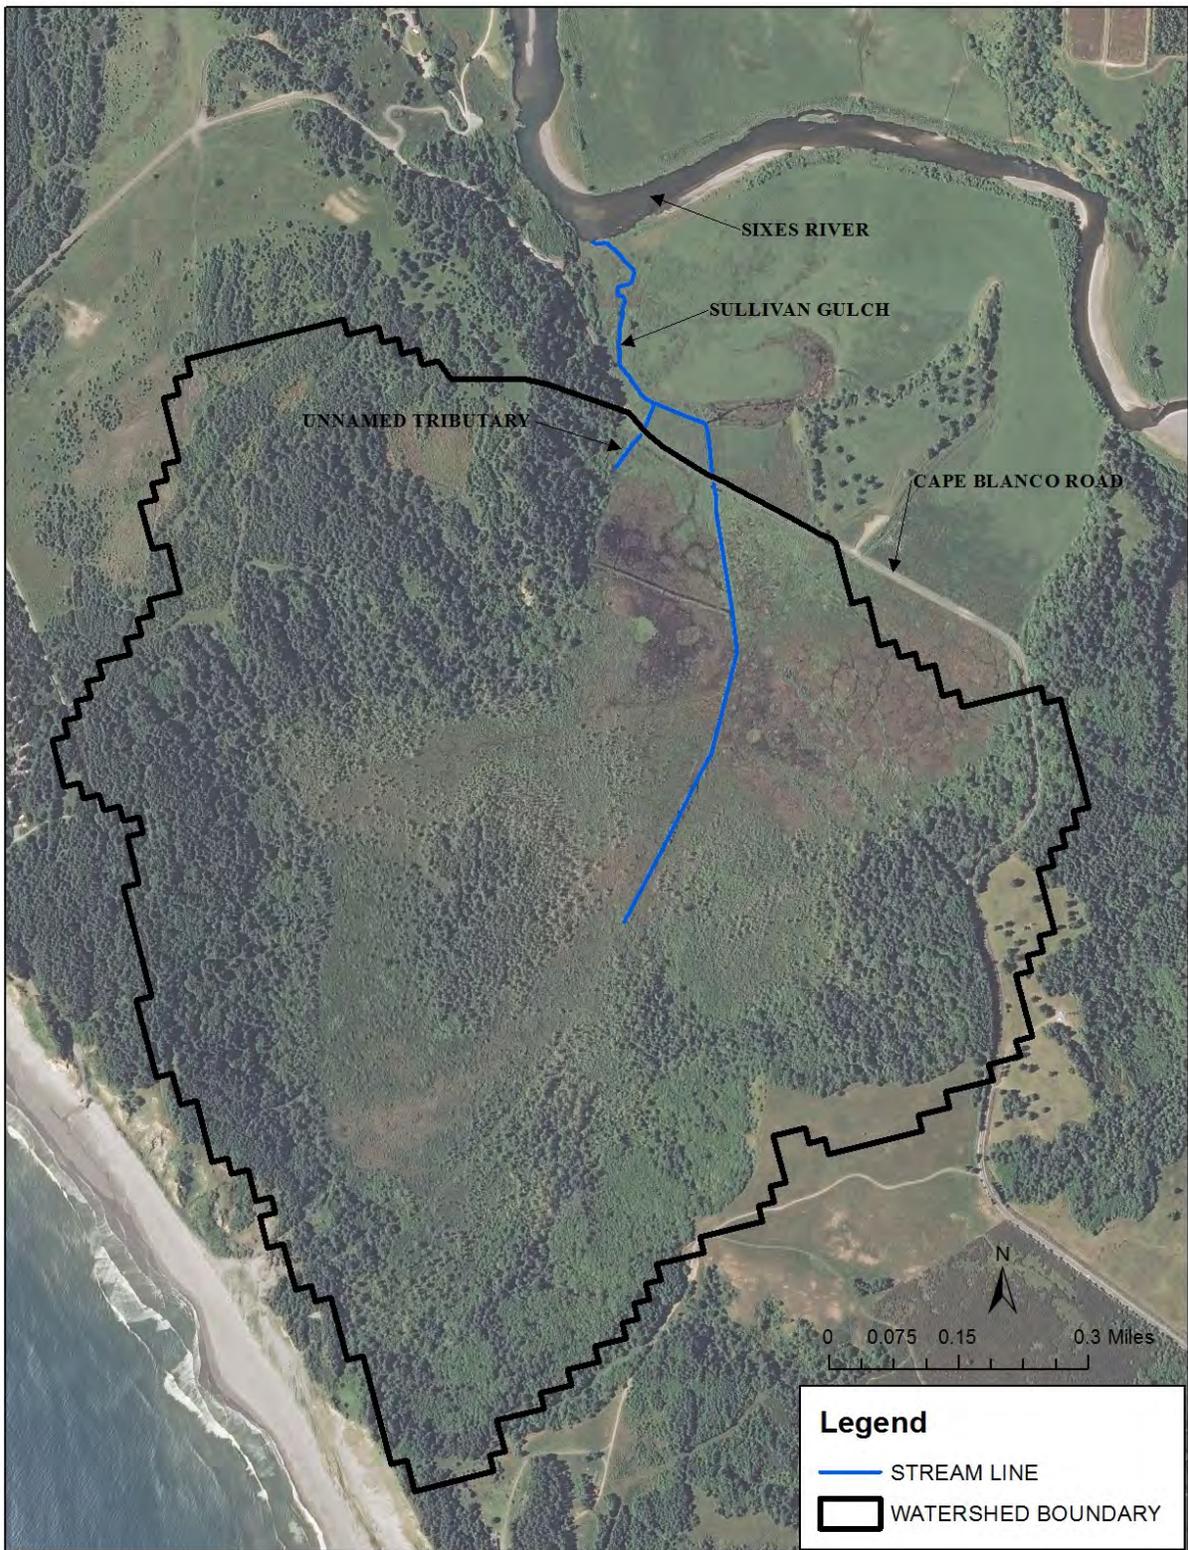
Figure 3: Sullivan Gulch above Cape Blanco Road watershed/hydrology map.

Sullivan Gulch watershed boundaries, areas, stream lengths and channel slopes were measured from contours generated from the available LiDAR digital elevation model (LiDAR DEM) and the 10-meter digital ortho-photo quadrangle using ArcGIS. Soil conditions were determined from the NRCS Soil Survey Geographic (SSURGO) Database, and land cover classifications were based on the 2006 National Land Cover Database. A composite curve number (CN) was determined from area-weighted land use curve numbers defined by the underlying soil drainage quality (NRCS, 1986). HEC-HMS input parameters for Sullivan Gulch above Cape Blanco Road is summarized in Table 1.

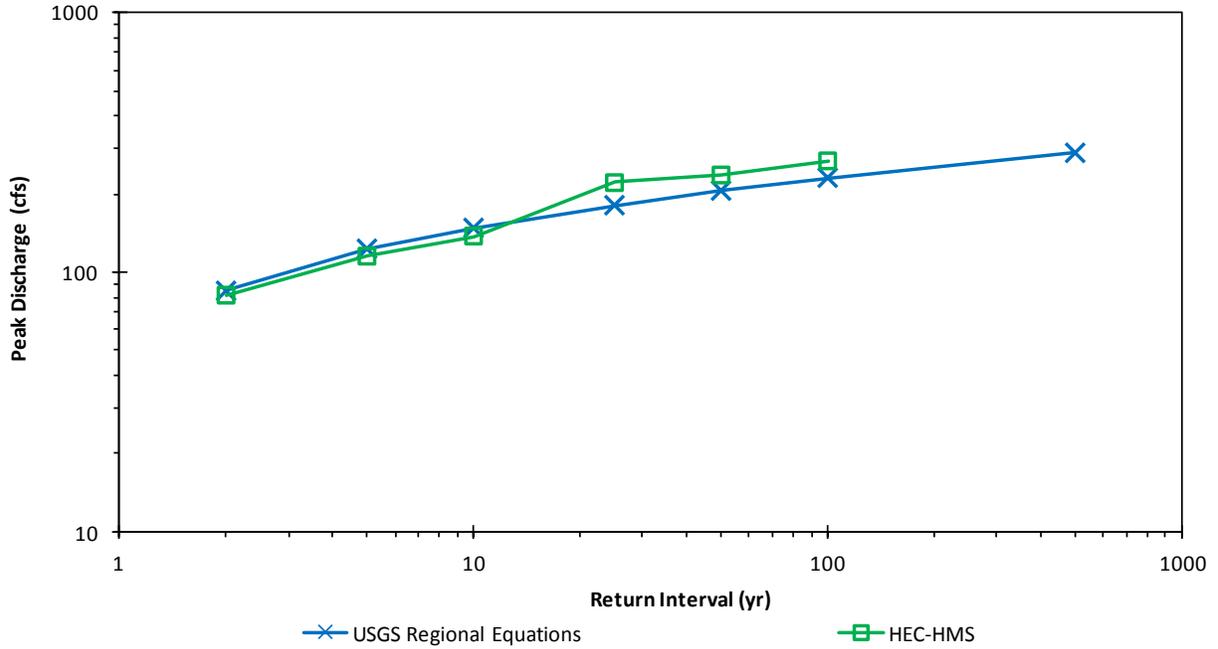
Figure 4: USGS regional equation and HEC-HMS peak flood estimates for Sullivan Gulch above Cape Blanco Road.

Winter high flows in Sullivan Gulch with given return intervals are required as boundary conditions for the hydraulic model to assess flood inundation on the project site, and provide design flows for channel and floodplain design. Two methods are applied and compared to estimate peak discharge for specified return intervals. These methods are the U.S. Army Corp of Engineers (COE) Hydrologic Modeling System, HEC-HMS V3.5 (COE, 2010) and the U.S. Geological Survey (USGS) regional flood frequency relations for Western Oregon (Cooper, 2005).

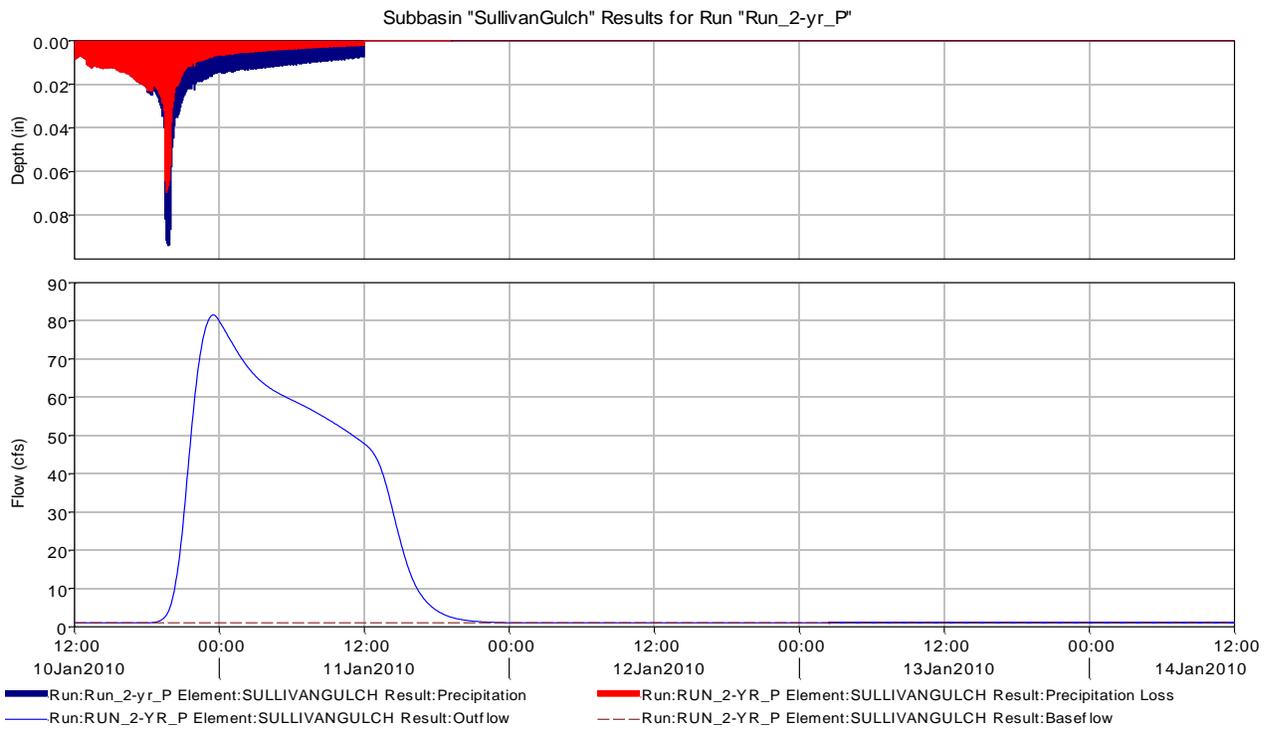
Figure 5: HEC-HMS 2-year, 24-hour precipitation and 2-year flood hydrograph for Sullivan Gulch above Cape Blanco Road.

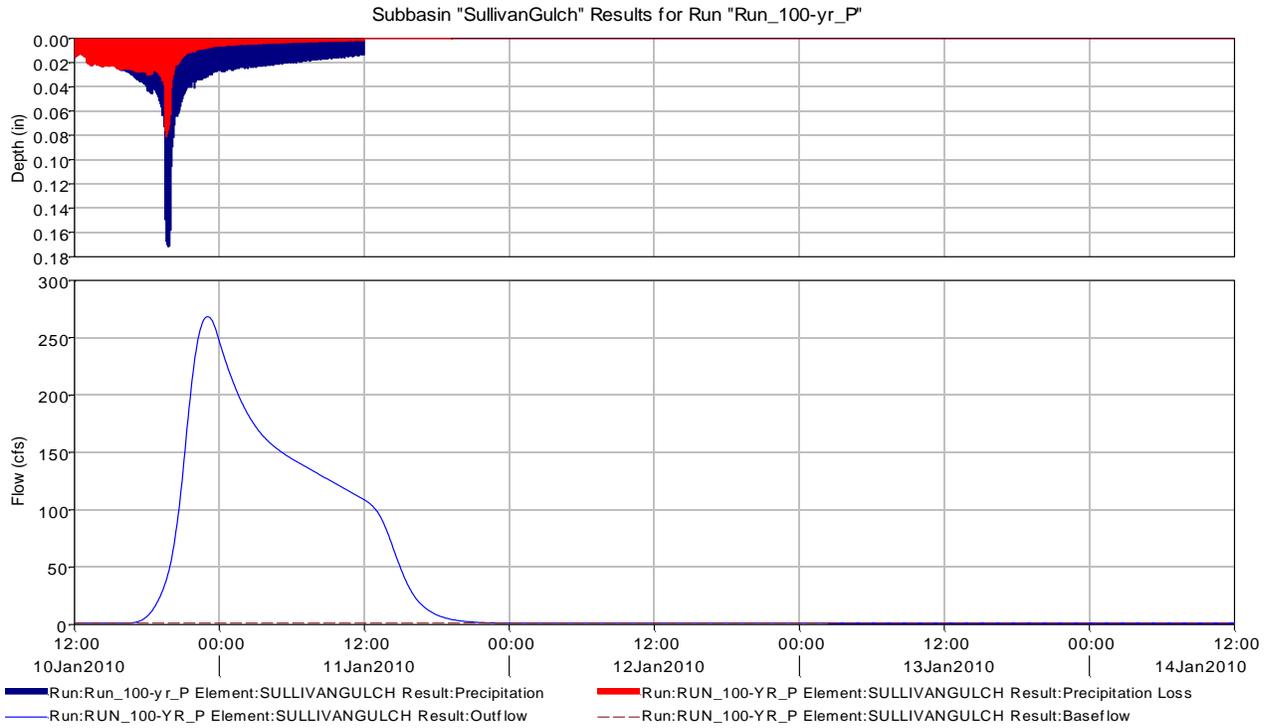
Figure 6: HEC-HMS 100-year, 24-hour precipitation and 100-year hydrograph for Sullivan Gulch above Cape Blanco Road.

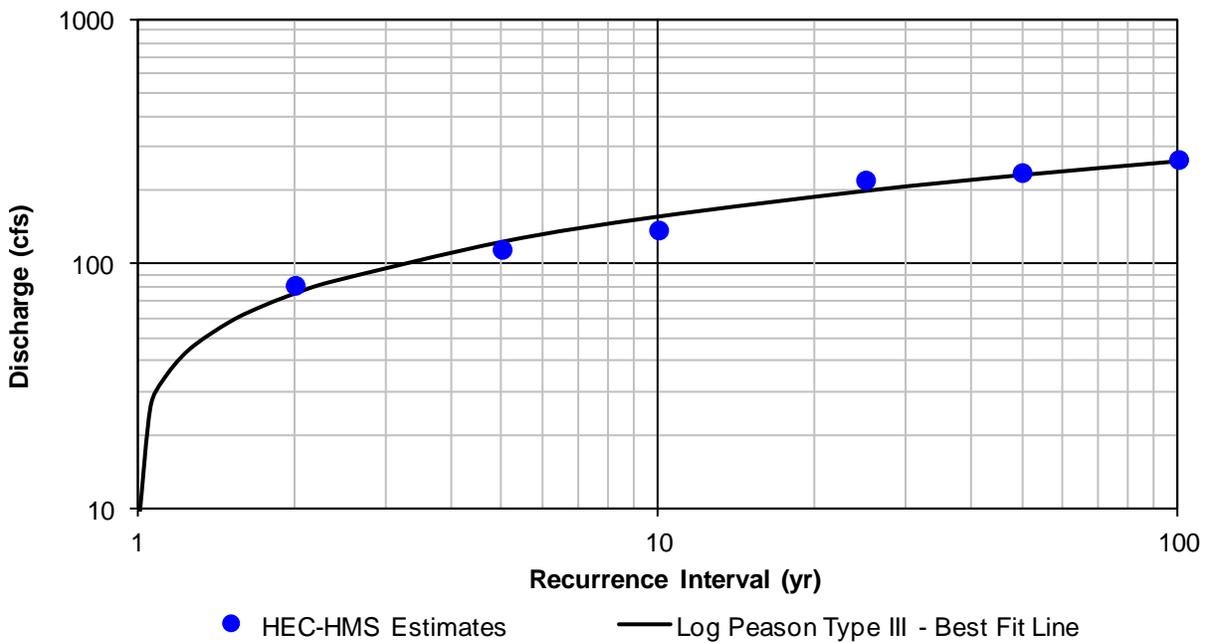
Figure 7: Log Pearson Type III fitted curve to the HEC-HMS 2, 5, 10, 25, 50 and 100-yr peak flood discharge estimates.

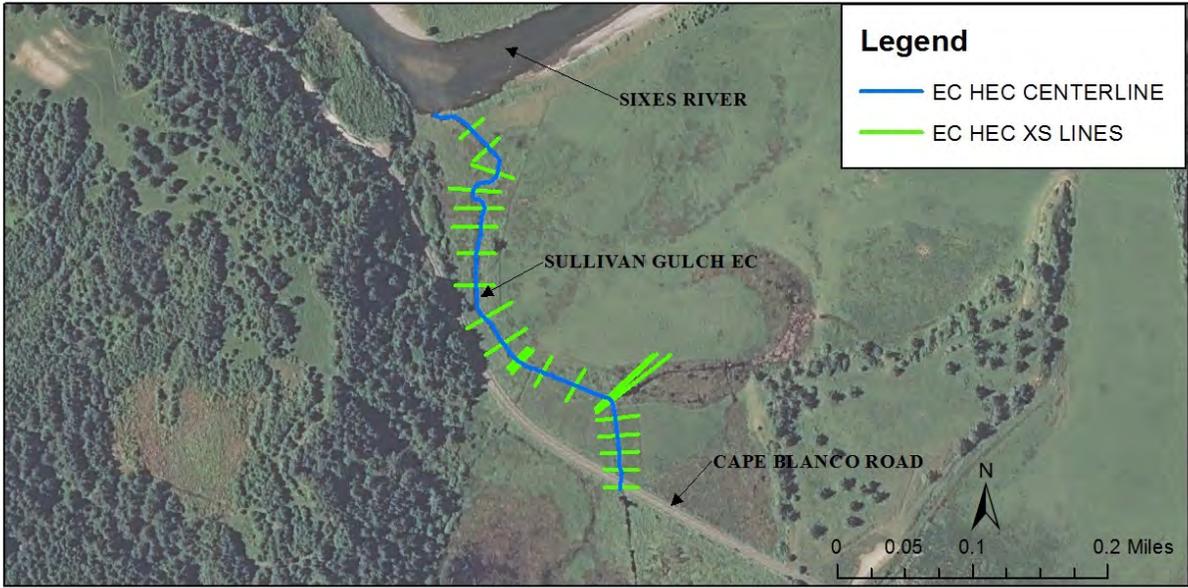
Figure 7: Draft Sullivan Gulch existing condition hydraulic model extent.

The existing condition hydraulic model (EC model) includes the existing Sullivan Gulch channel, beaver dams, and the Cape Blanco Road culvert crossing (Figure 7). The EC model includes approximately 1,850 ft of lower Sullivan Gulch represented by 23 cross-sections,

extracted from the Project DEM using ArcGIS and the HEC-GeoRAS extension. Cape Blanco Road and crossing defines the upstream end of the modeling domain. Currently, field surveys of the existing channel upstream of Cape Blanco Road have not been incorporated into the EC model. The one upstream cross-section in the EC model was based on downstream channel conditions and modified based on field observations.

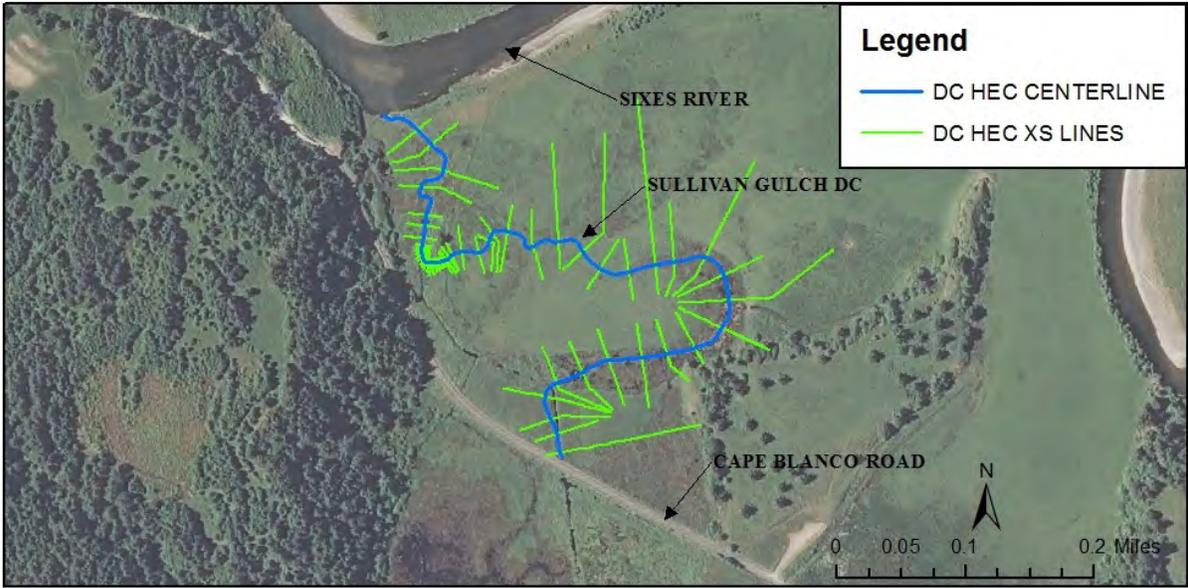
Figure 8: Draft Sullivan Gulch design condition hydraulic model extent.

A design condition hydraulic model (DC model) was developed to represent the proposed project elements for the Sullivan Gulch Restoration Project based on the 60% design surface (Figure 8). The DC model was extracted from the design Project surface using ArcGIS and HEC-GeoRAS, and starts and ends at the same location in Sullivan Gulch as the EC model. The DC model includes 56 cross-sections over approximately 3,500 feet of existing and design Sullivan Gulch channel. The proposed Sullivan Gulch Project adds approximately 1,700 feet of new channel length. The one upstream cross-section in the DC model is the same cross-section used in the EC model. The primary project elements currently incorporated into the preliminary DC model include:

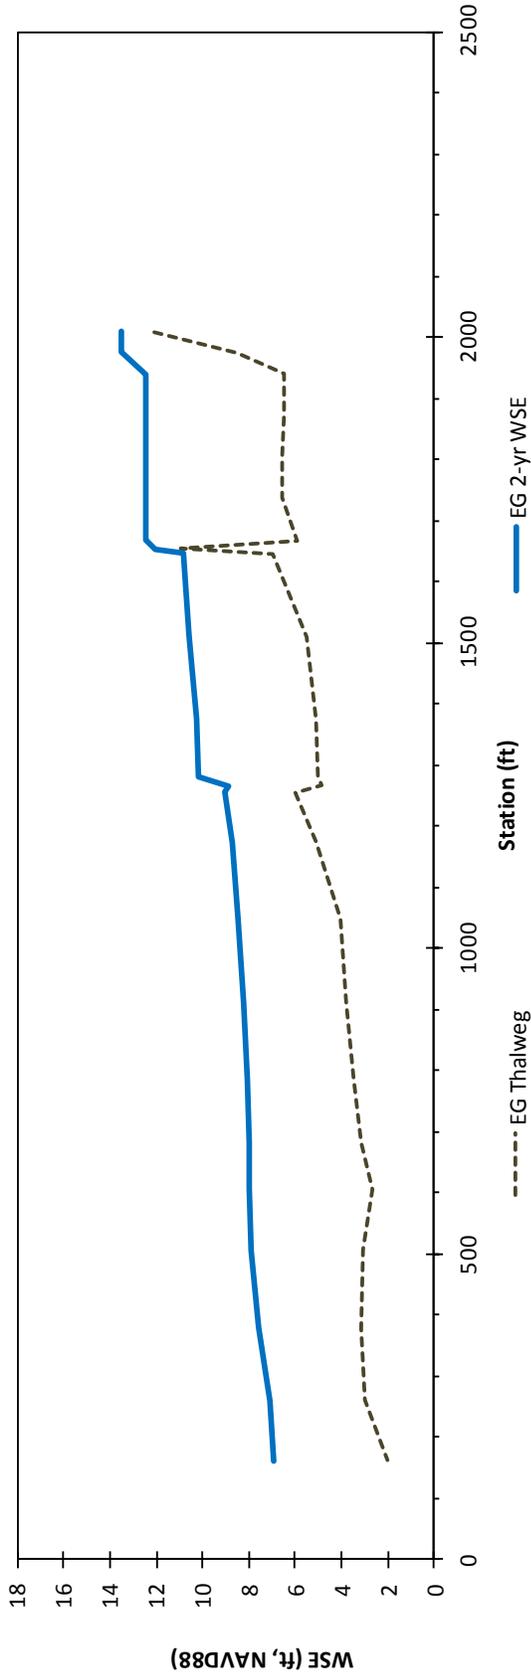
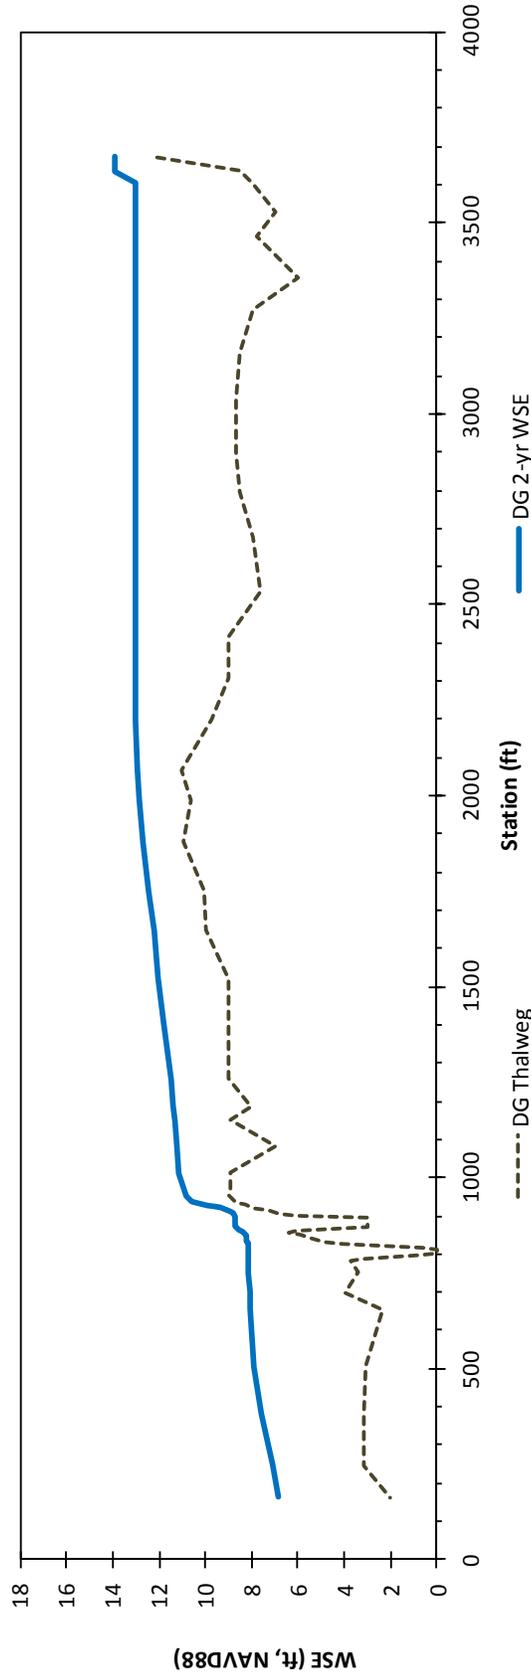
Figure 9: Sullivan Gulch preliminary hydraulic model steady state 2-yr peak water surface elevations for existing conditions (top figure) and design conditions (bottom figure).

Results from the draft EC and DC modeling show that the proposed Sullivan Gulch Restoration Project design elements raise water surface elevations for peak flood events over most of the channel design, which is caused by raising the base channel elevation above the drop structure, and the increased channel length and reduced velocities associated with reconnecting the oxbow. Table 3 lists the water surface elevations at the cross-section immediately downstream of Cape Blanco Road for EC and DC conditions. Figures 9 and 10 show modeled EC and DC water surface elevations for the 2-year and 100-year peak floods, respectively.

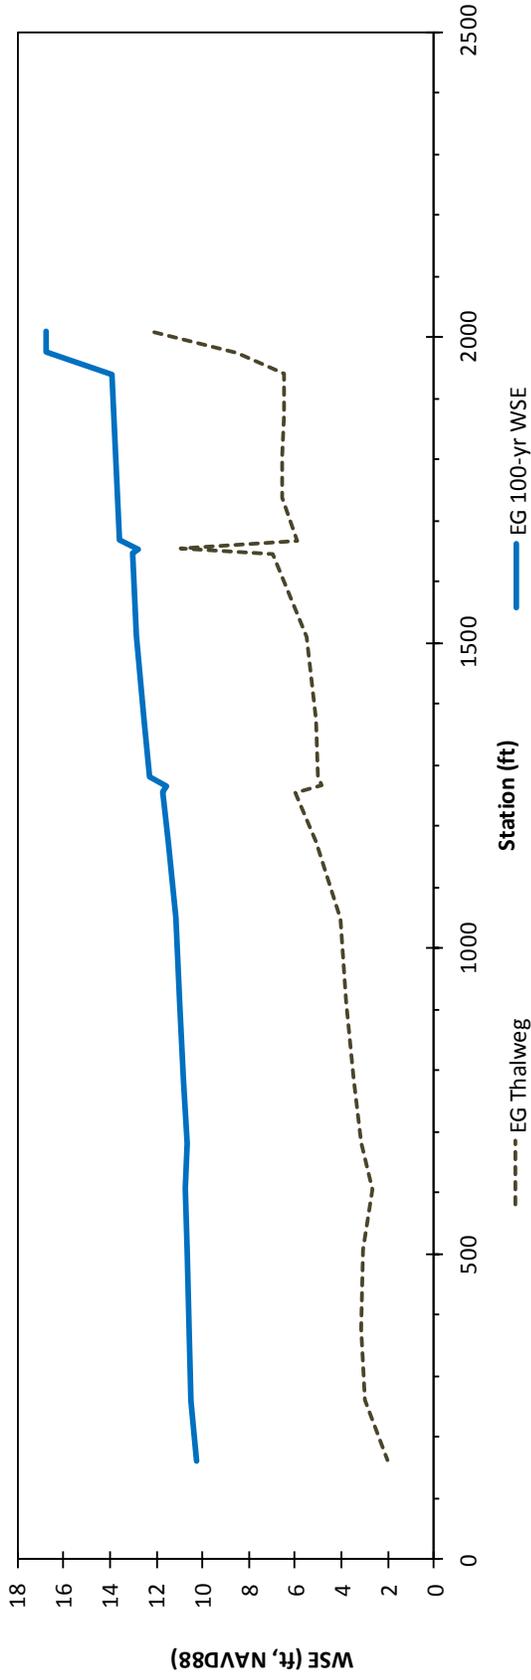
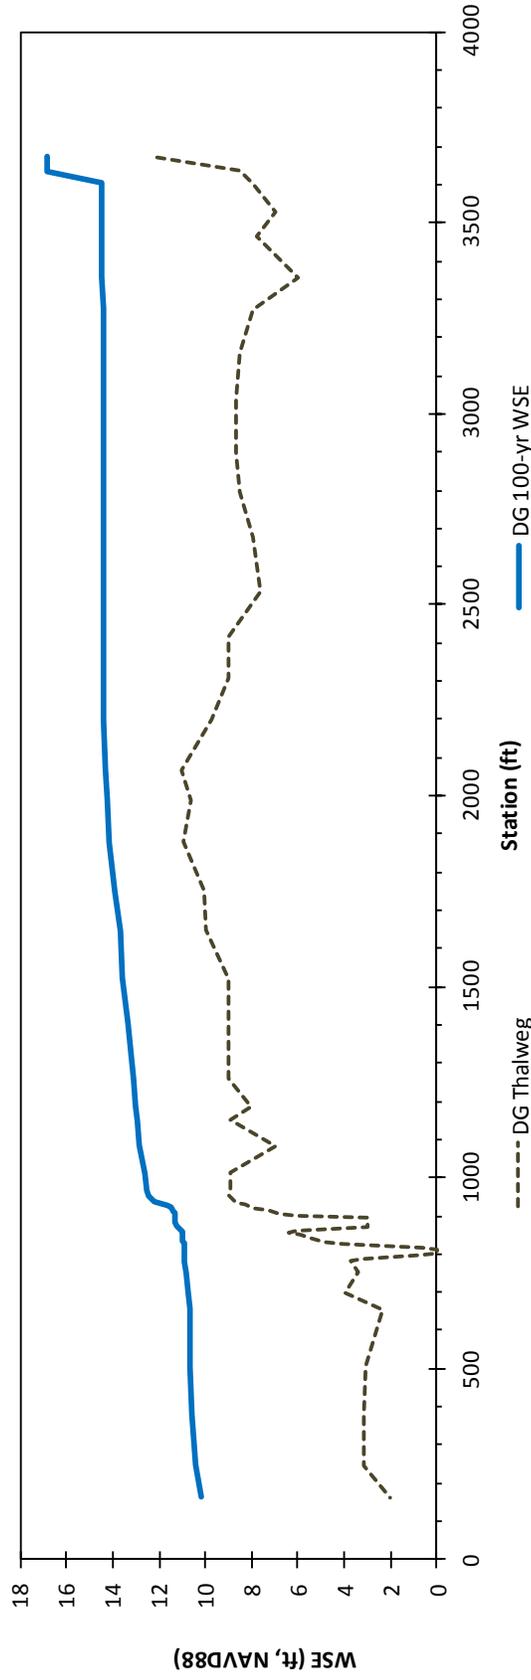
Figure 10: Sullivan Gulch preliminary hydraulic model steady state 100-yr peak water surface elevations for existing conditions (top figure) and design conditions (bottom figure).

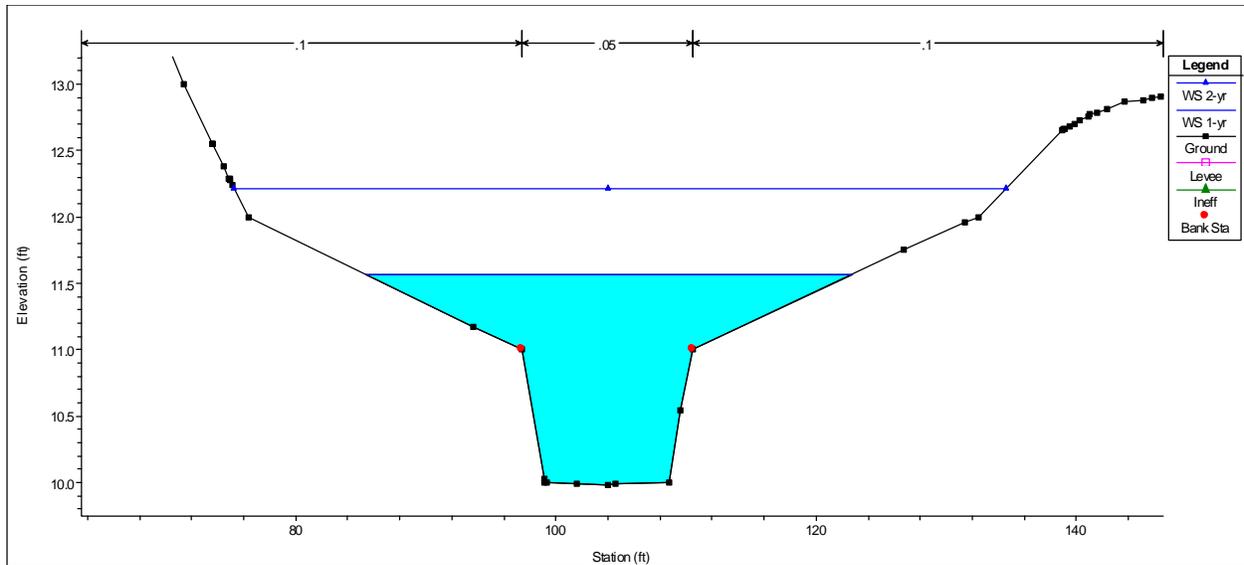
Figure 11: Preliminary Sullivan Gulch floodplain and channel design typical cross-section (DG model XS 1646.371) showing the water surface elevation at the 40 cfs design flow (approximately 1.11 to 1.25-yr event) which is depicted as the blue filled water level and denoted 1-yr, and the 82 cfs flow (2-yr event) water surface elevation which is shown as the blue line with triangle symbols.

2. The design channel side slopes have been changed to 1:1.5. It should be noted that the design channel bank full capacity is approximately 40 cfs, which is lower than the estimated 2-yr flood flow of 82 cfs.
