R & E Grant Application 13 Biennium

Project #:
13-085

Sullivan Gulch Bottomland Restoration

DRAFT
Sullivan Gulch Restoration Project
90% Design Report

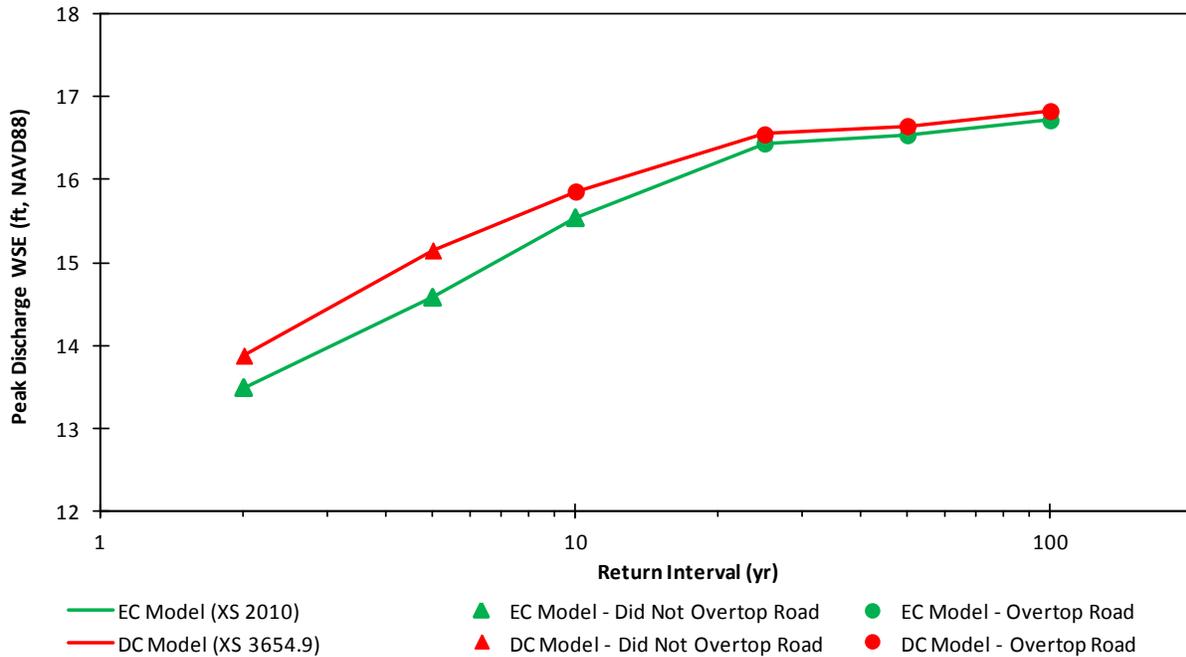
Figure 12: Sullivan Gulch hydraulic model steady state peak water surface elevations immediately upstream of existing Cape Blanco Road culvert for existing and design conditions.

Table 3: Existing and design condition water surface elevations at Cape Blanco Road estimated from the draft hydraulic models

Event	Existing Condition (ft, NAVD88)	Design Condition (ft, NAVD88)
2-year	12.48	13.03
5-year	12.78	13.38
10-year	12.97	13.60
25-year	13.58	14.21
50-year	13.68	14.31
100-year	13.88	14.50

The existing Sullivan Gulch crossing at Cape Blanco Road is a single 6 foot diameter corrugated metal pipe, which currently overtops the road during flood events. Currently State Parks is not interested in upgrading the existing culvert crossing. Based on draft modeling results the Sullivan Gulch Restoration Project will increase water surface elevations at the Cape Blanco Road culvert and the potential for overtopping the road (Figure 12). For the 10-yr event, modeling indicates that the proposed Project design causes the road to overtop whereas overtopping does not occur for existing conditions.

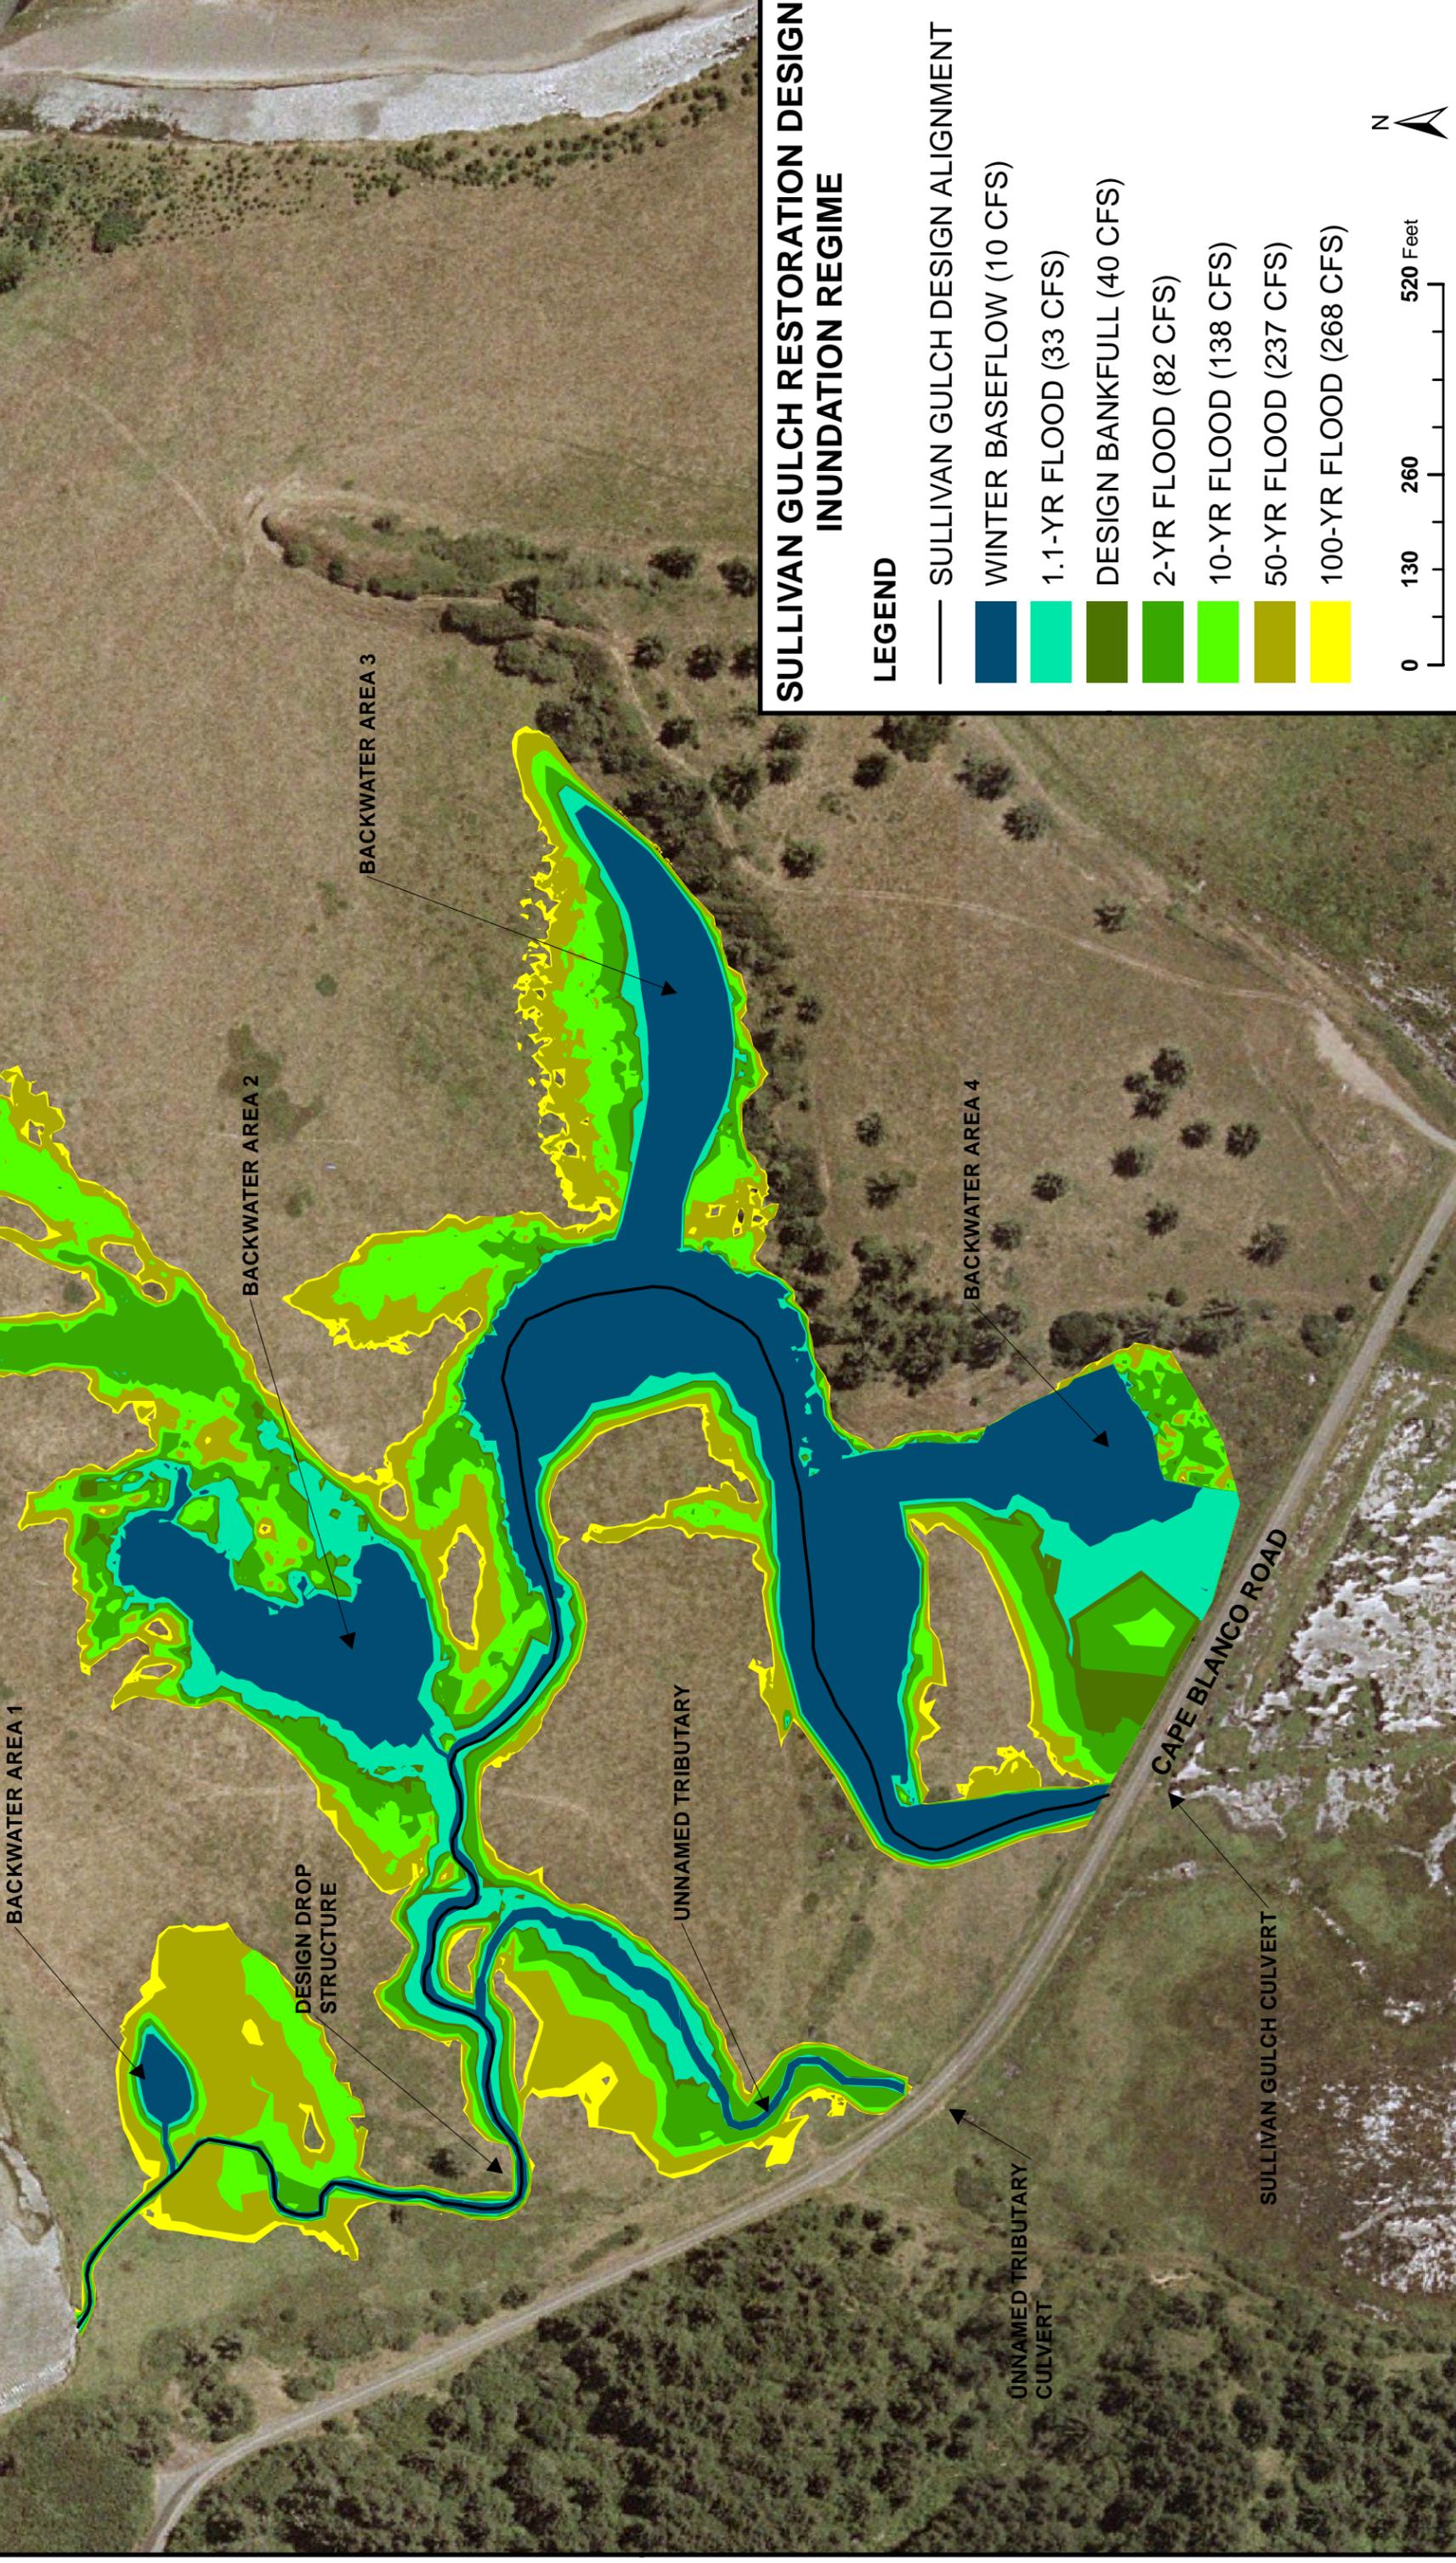
SULLIVAN GULCH RESTORATION DESIGN INUNDATION REGIME

NOTE: INUNDATION MAPPING FOR SULLIVAN GULCH RESTORATION DESIGNS ARE FROM THE NORTHERLY EDGE OF CAPE BLANCO ROAD TO TOP OF BANK OF SIXES RIVER. OTHER POTENTIALLY INUNDATED AREAS, FOR EXAMPLE SOUTH OF CAPE BLANCO ROAD, HAVE NOT BEEN ESTIMATED OR MAPPED.

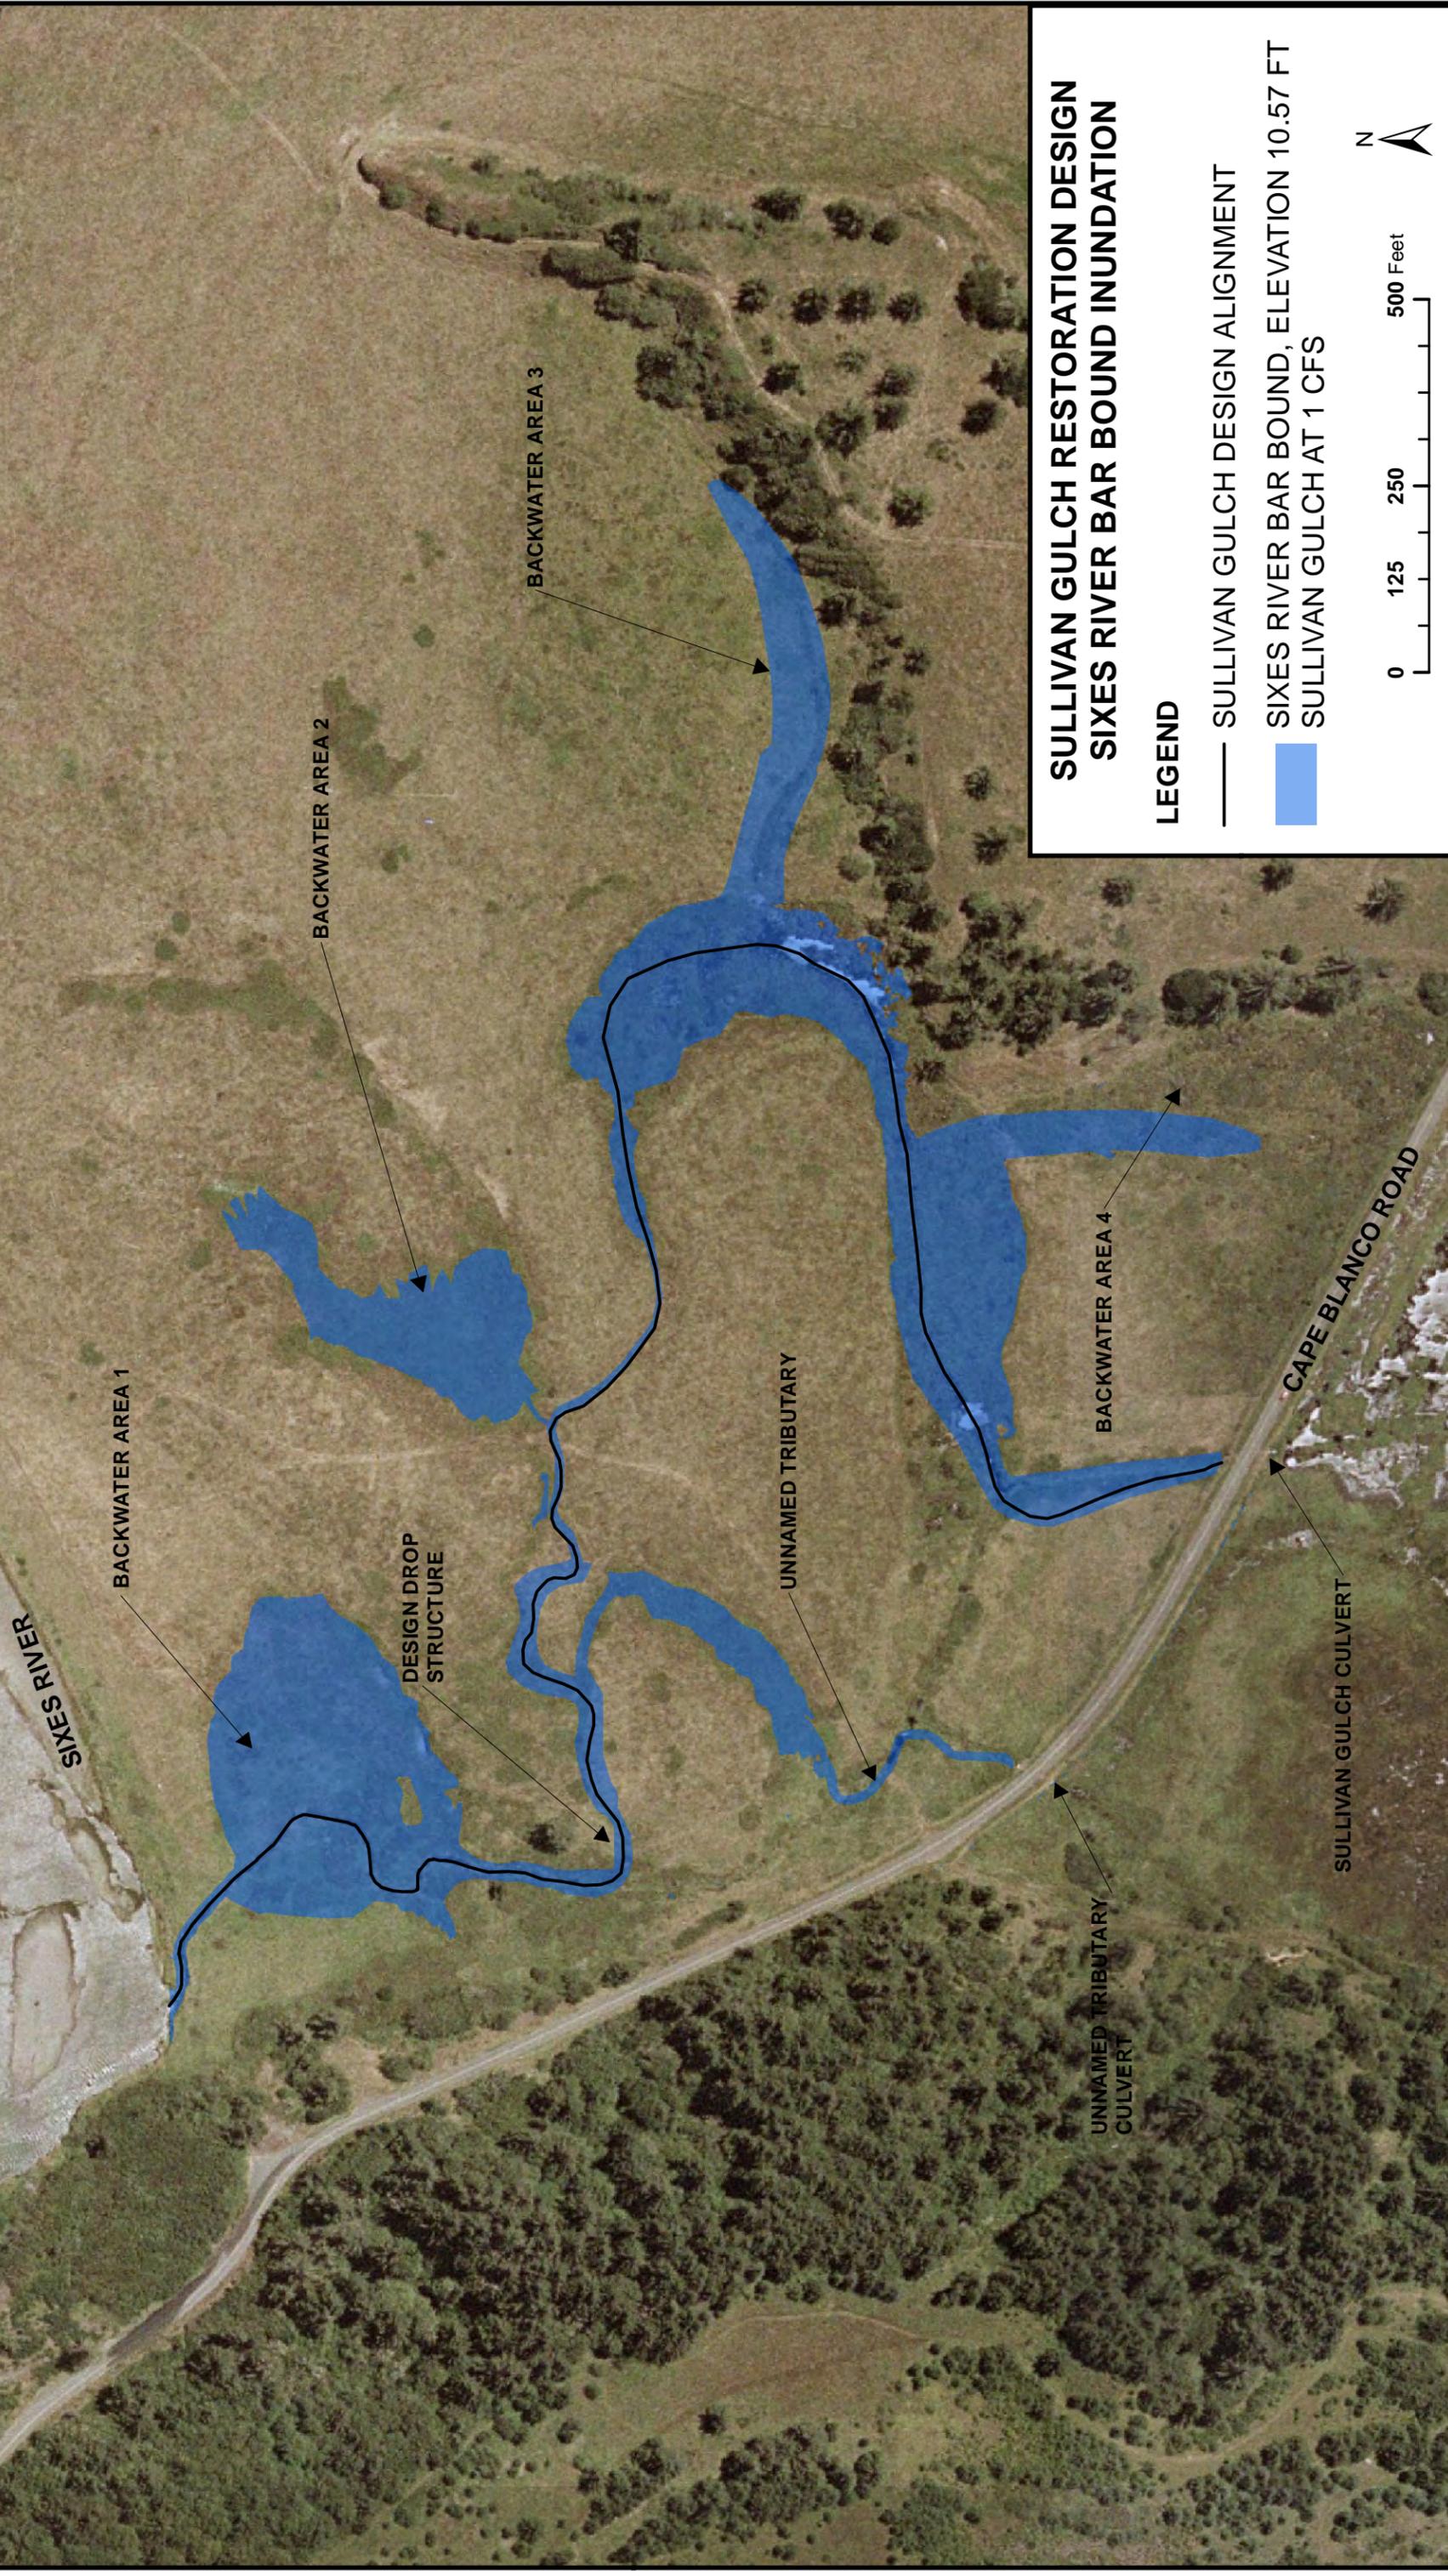
SULLIVAN GULCH RESTORATION DESIGN SIXES RIVER BAR BOUND INUNDATION

NOTE: INUNDATION MAPPING FOR SULLIVAN GULCH RESTORATION DESIGNS ARE FROM THE NORTHERLY EDGE OF CAPE BLANCO ROAD TO TOP OF BANK OF SIXES RIVER. OTHER POTENTIALLY INUNDATED AREAS, FOR EXAMPLE SOUTH OF CAPE BLANCO ROAD, HAVE NOT BEEN ESTIMATED OR MAPPED.
