# North Fork Walla Walla River RM 4.3-6.3 Floodplain Restoration

*Private Forest Accord Grant - Fall 2023  
Solicitation*

## ***Walla Walla Basin Watershed Council***

# FollowUp Form

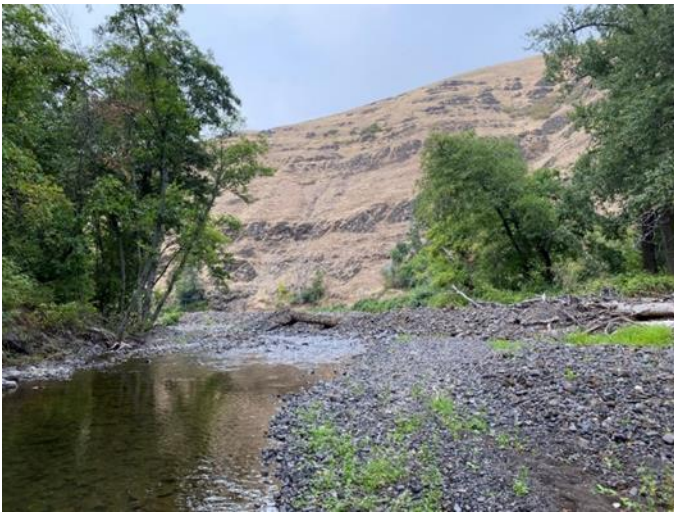
Figure 2. Anthropogenic change resulted in several areas within the project reach being leveed in response to flooding.

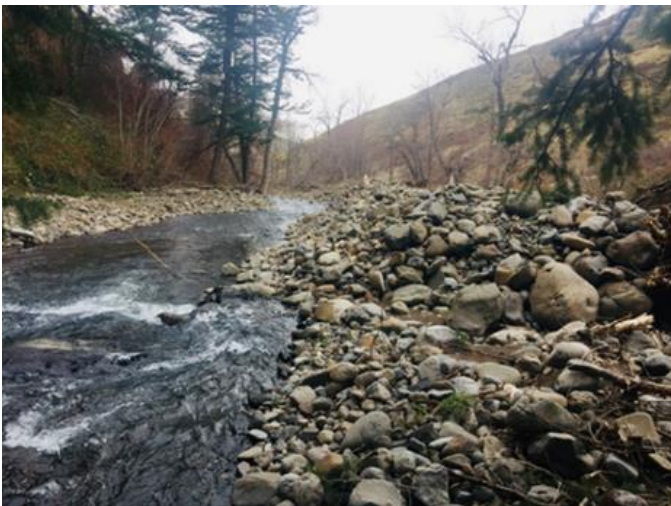
Figure 3. Push up levees to be perforated and/or setback in RM 4.3-5.2 reach.

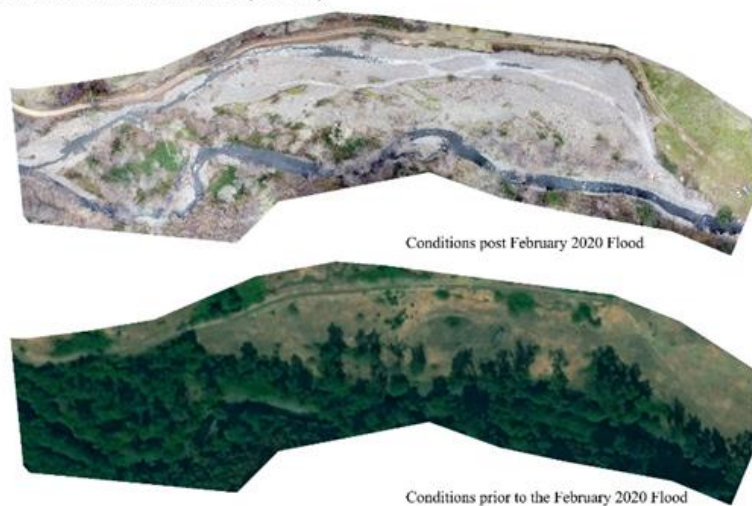
North Fork Walla Walla River (RM 5.3)

Figure 4. Post 2020 flood response footprint remains evident throughout the project area.

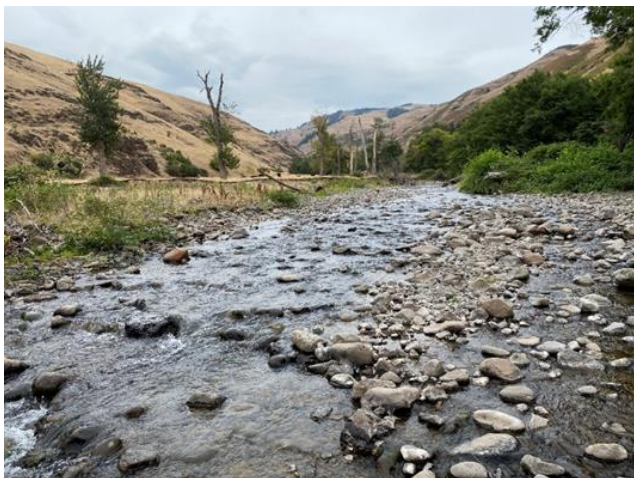
Figure 6. Habitat simplification resulted in several areas within the project reach.

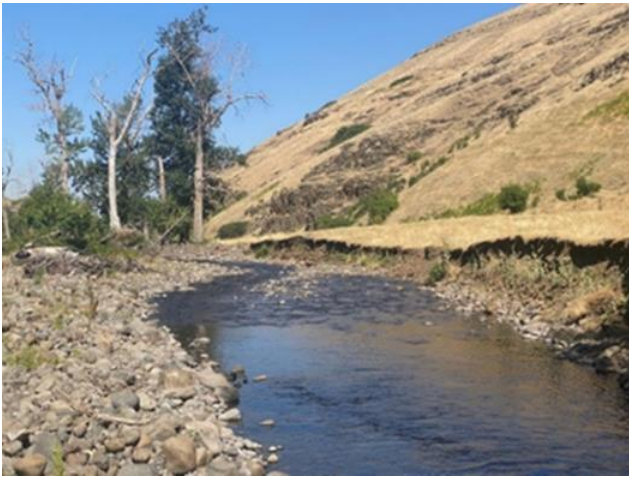
Figure 7. North Fork Walla Walla River RM 4.9 actively eroding bank and down-cutting incision

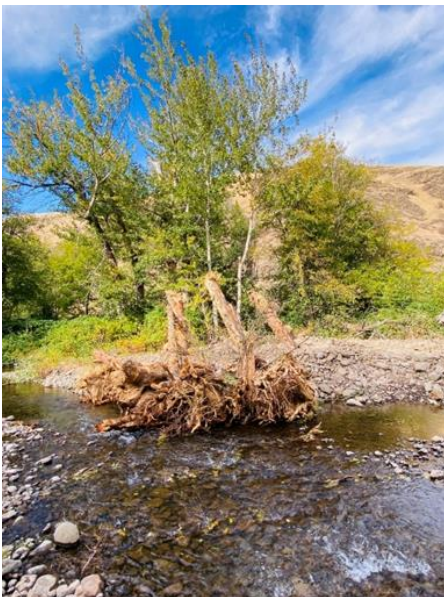
Figure 8. Rectification bank treatment and overhead cover implemented 2024, RM 5.0.

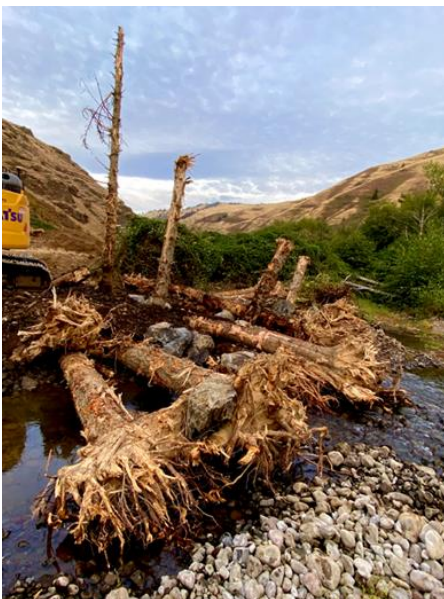
Figure 9. Rectification bank treatment and overhead cover implemented 2024, RM 5.2.

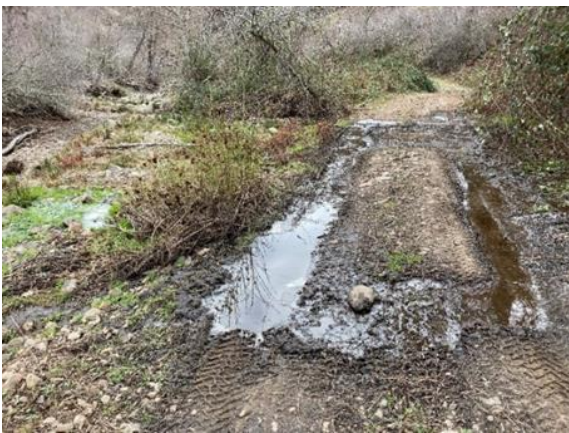
Figure 11. Turbidity, sedimentation, and elevated water temperature impacts associated with road prism.

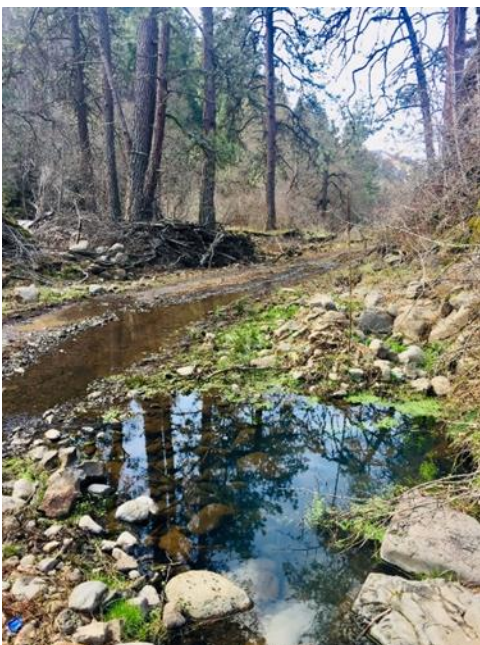
Figure 12. Unprotected springs were vulnerable to vehicle traffic and potential take of salmonids.

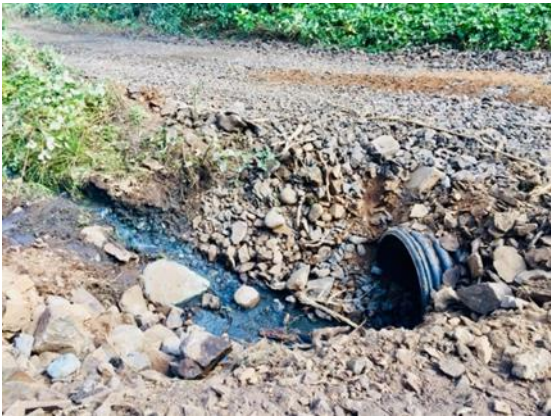
Figure 13. Culvert crossings were installed at the largest spring locations to provide juvenile habitat.

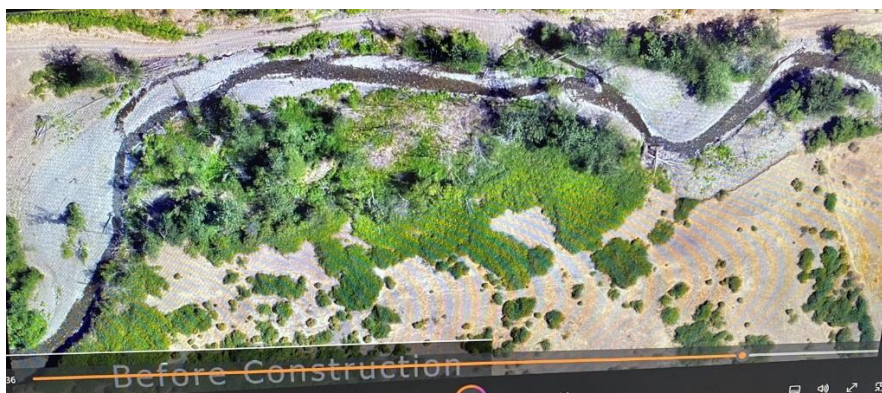
Figure 15. Phase 2 RM 3.6-3.8 before restoration.

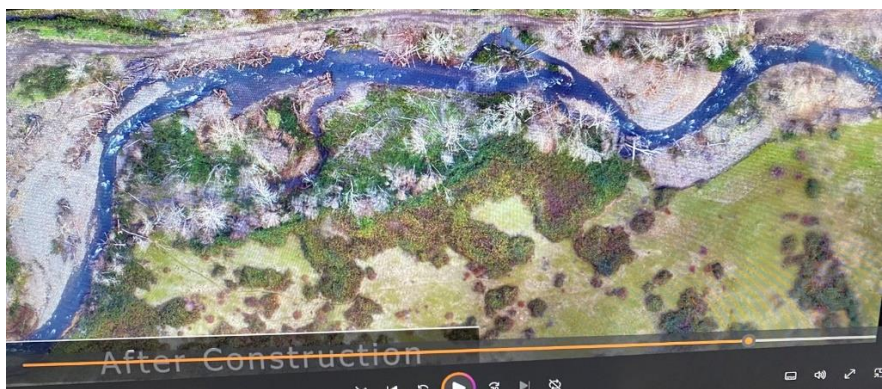
Figure 16. Phase 2 RM 3.6-3.8 after restoration.

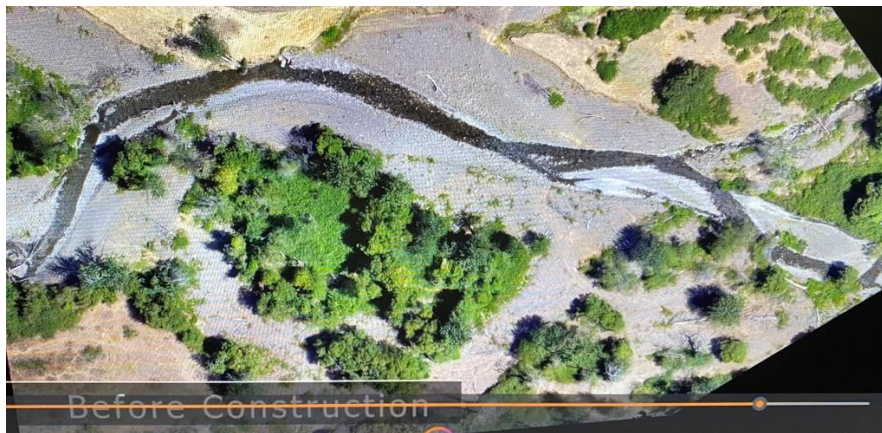
Figure 17. Phase 2 RM 4.1-4.3 before restoration.

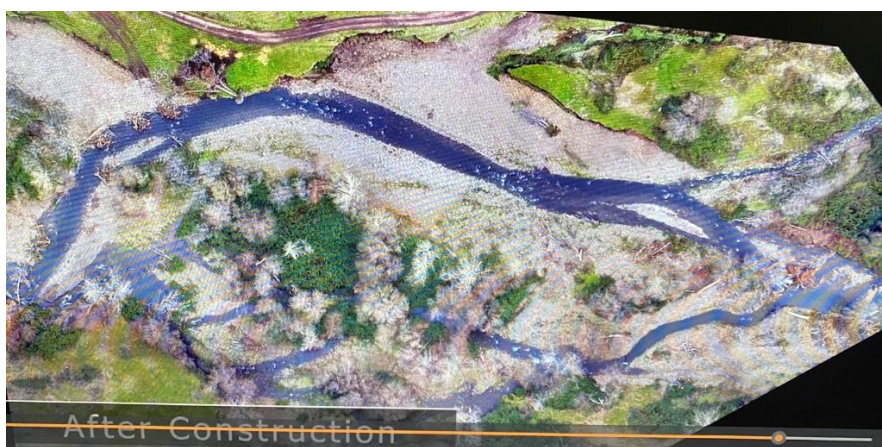
Figure 18. Phase 2 RM 4.1-4.3 after restoration.

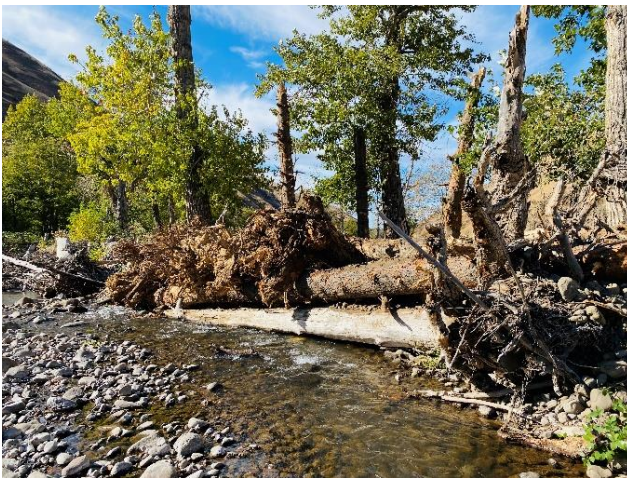
Figure 26. The intrusion of root wads into the wetted channel margin provides overhead cover for fish.

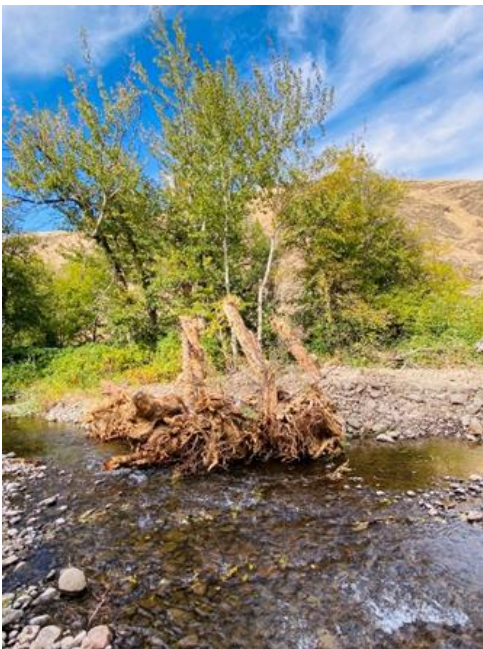
Figure 27. ELJ Bank Structure near RM 4.1 provided quality fish habitat uplift.

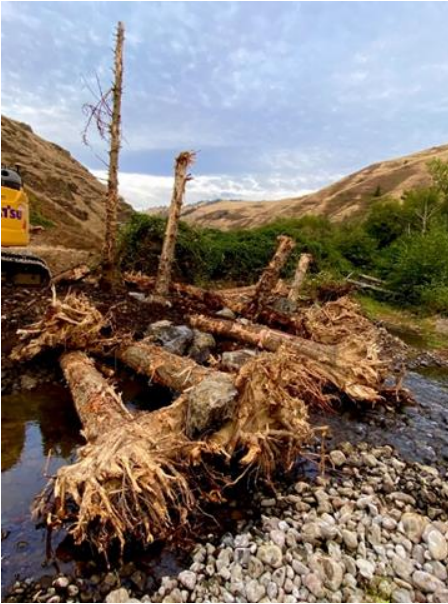
Figure 28. ELJ Bank Structure near RM 5.2 provided quality fish habitat uplift.

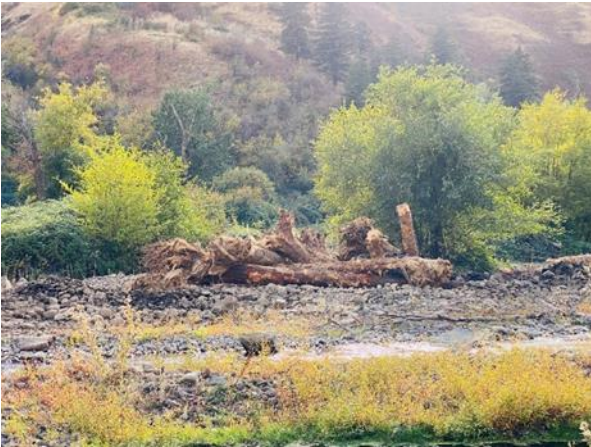
Figure 29. ELJ configurations were strategically constructed to reduce buoyancy and remain intact during high flow events.

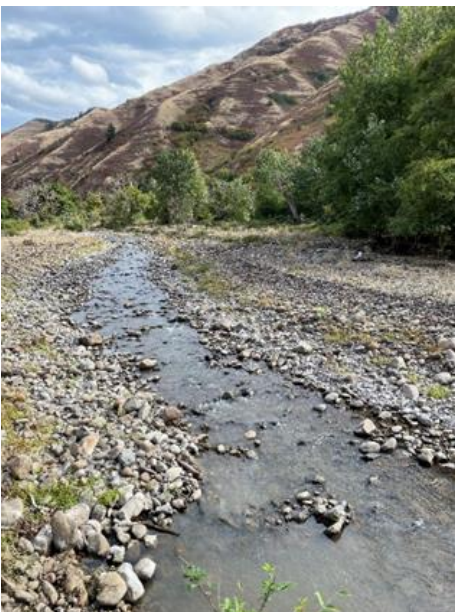
Figure 30. Before restoration RM 4.3.

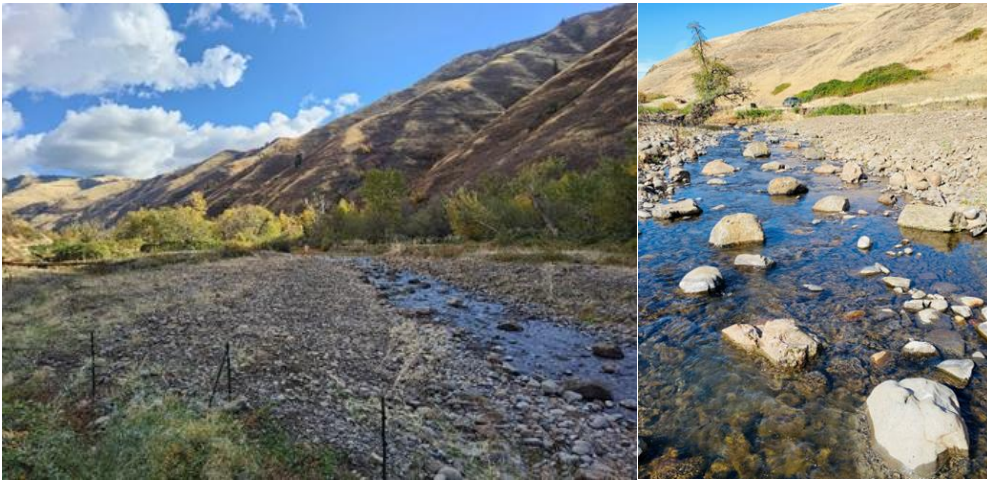
Figure 31. After restoration RM 4.3.

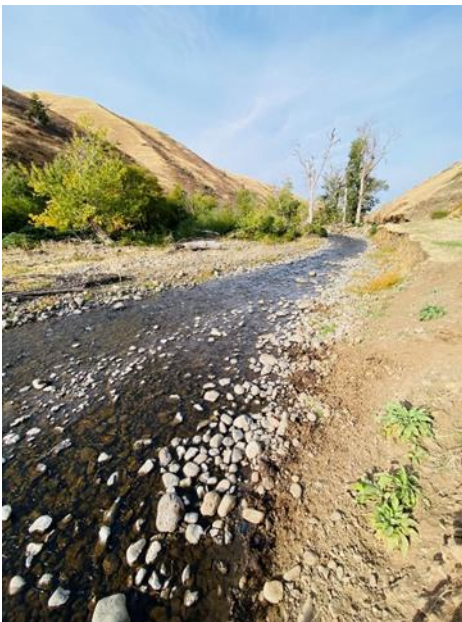
Figure 32. North Fork Walla Walla River RM 4.9 before construction condition.

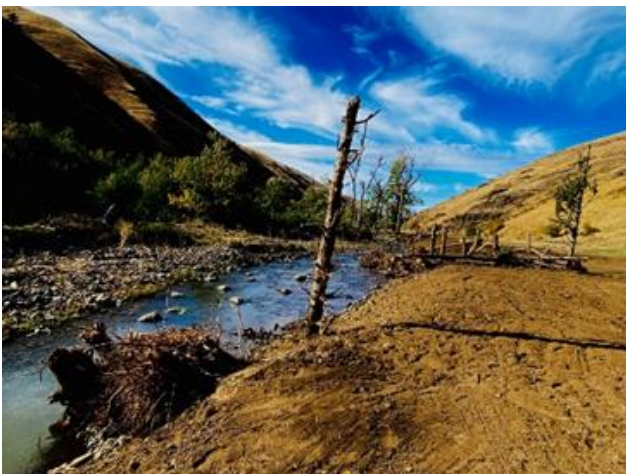
Figure 33. North Fork Walla Walla River RM 4.9 before construction condition.

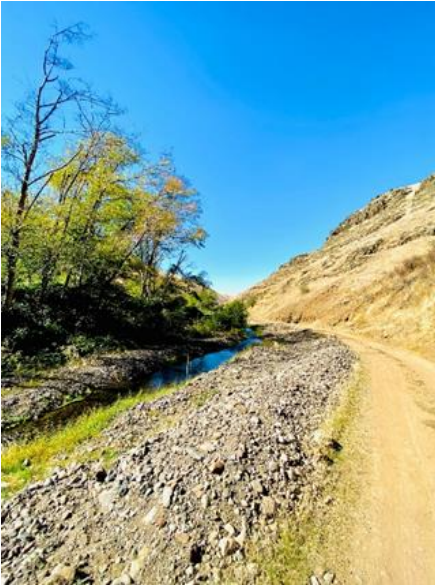
Figure 34. NFWWR RM 5.1 side channel before construction.

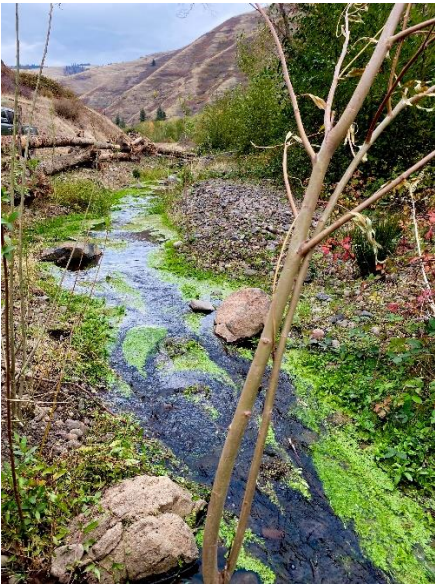
Figure 35. NFWWR RM 5.1 side channel following construction.

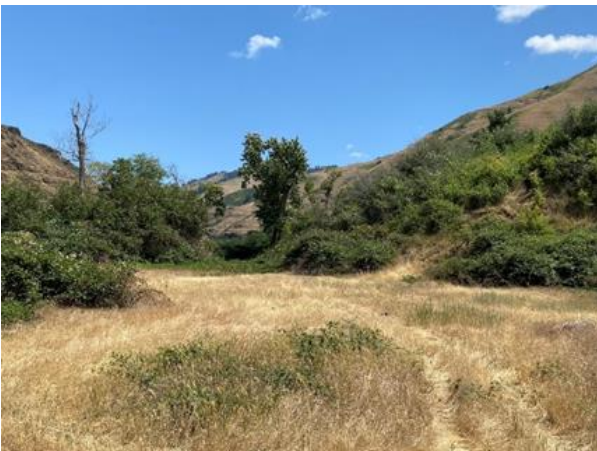
Figure 36. NFWWR RM 5.2 prior to restoration.

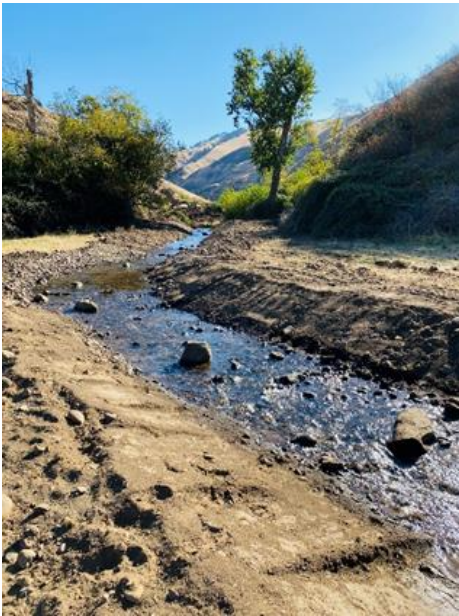
Figure 37. North Fork Walla Walla River RM 5.2 after implementation.

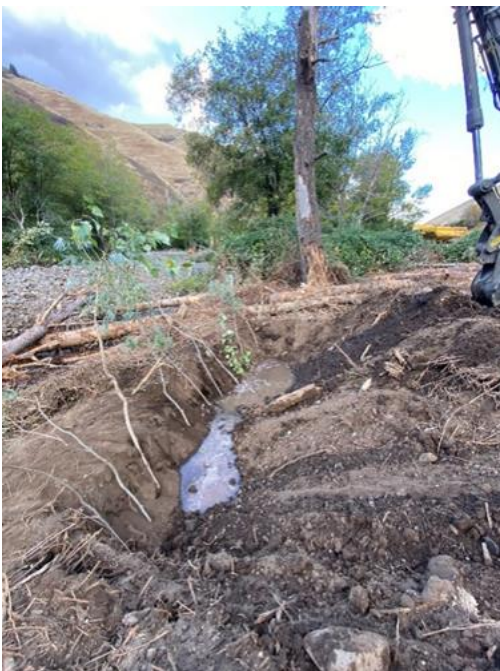
Figure 38. Trenching technique for planting willow and cottonwood cuttings in contact with water table.

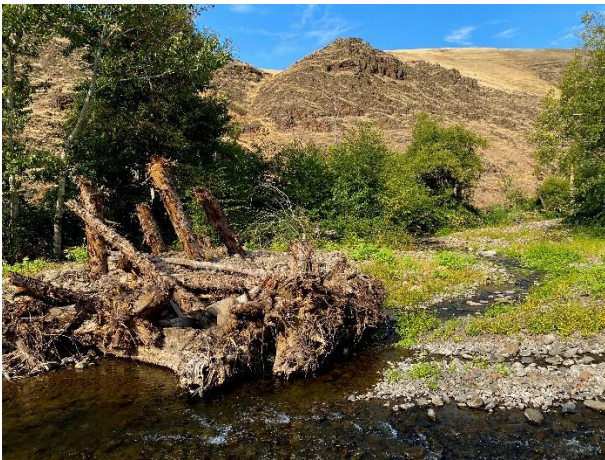
Figure 42. Roughness elements added to barren gravel bars to promote retention of fine sediments, point bar development, and riparian recovery.

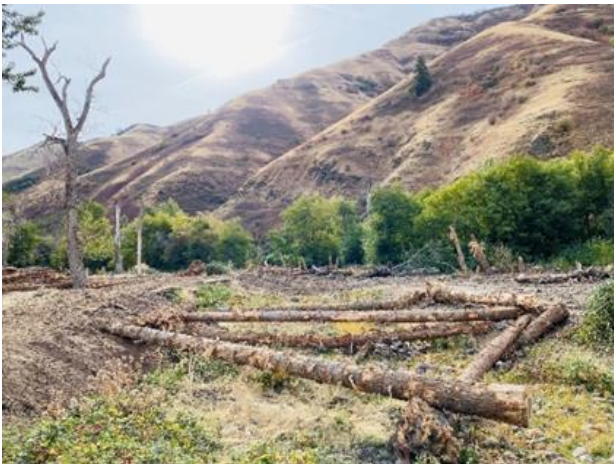
Figure 43. Whole trees and wooden fence enclosures decreased grazing of delicate, vibrant vegetation.

Protecting excessive grazing of sensitive spring seep and planted vegetation was accomplished with the installation of several restrictive barriers made of natural wood materials (Figures 43-45) as well as traditional wire strand fencing in combination with solar panels to provide electric boundary establishment (Figures 46-47), or in combination of the two methods (Figure 48). The function of temporary grazing enclosures is to reduce detrimental grazing impacts during vulnerable stages of vegetation development in effort to optimize long-term survival and establishment of vegetation. Enclosures are intended to protect vegetation from both domestic cattle and big game impacts. Protective measures will continue to be taken to ensure sensitive wetland and tree regeneration areas are established to buffer effects of global warming impacts as forecasts project a 33% reduction in spring flow and increase of 2.4 degrees Fahrenheit over the next several decades.

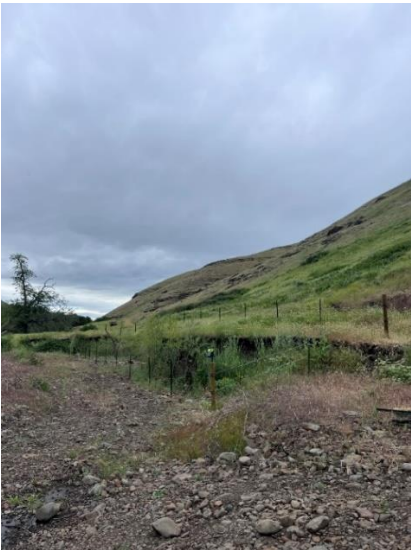
Figure 46. Temporary electric fence for protecting trenched vegetation planted during implementation.

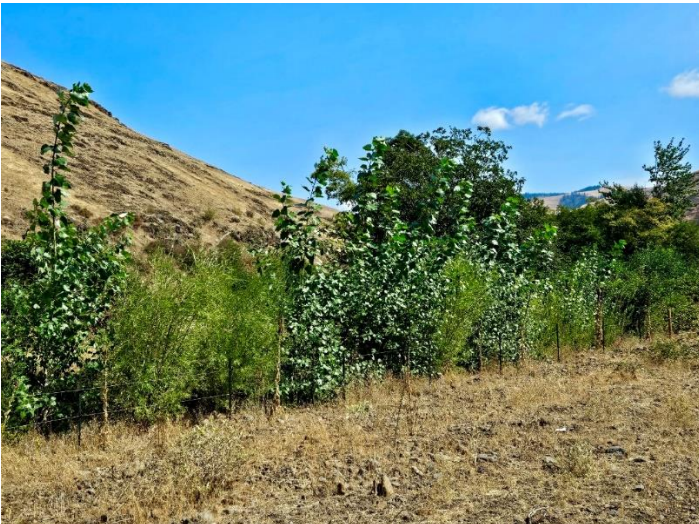
Figure 47. Effectiveness of solar electric grazing deterrent protecting trenched trees.

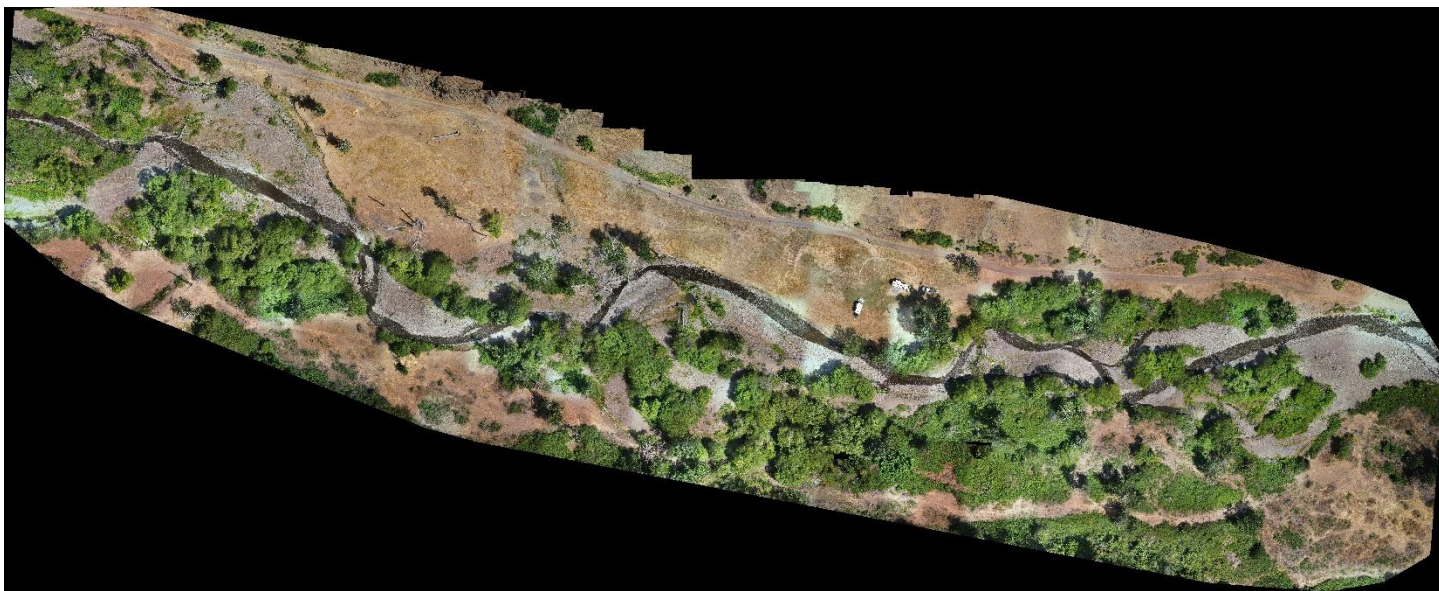
Figure 51. RM 4.5-4.8 pre-construction imagery taken during low September 2025 showing habitat simplification.

Results from the completed phases of the project show significant improvements regarding salmonid habitat suitability (Figures 49-54). Habitat uplift has translated to use of the project reach by adult steelhead trout for spawning (Figure 55), as well as juvenile abundance where results showed up to an 11-fold increase in presence of juvenile salmonids in treated versus adjacent untreated river sections (Figure 56). The cooperative efforts of all project partners working together in an area of the watershed identified in numerous regional natural resource guideline managerial documents have translated to award winning results (Figure 57).

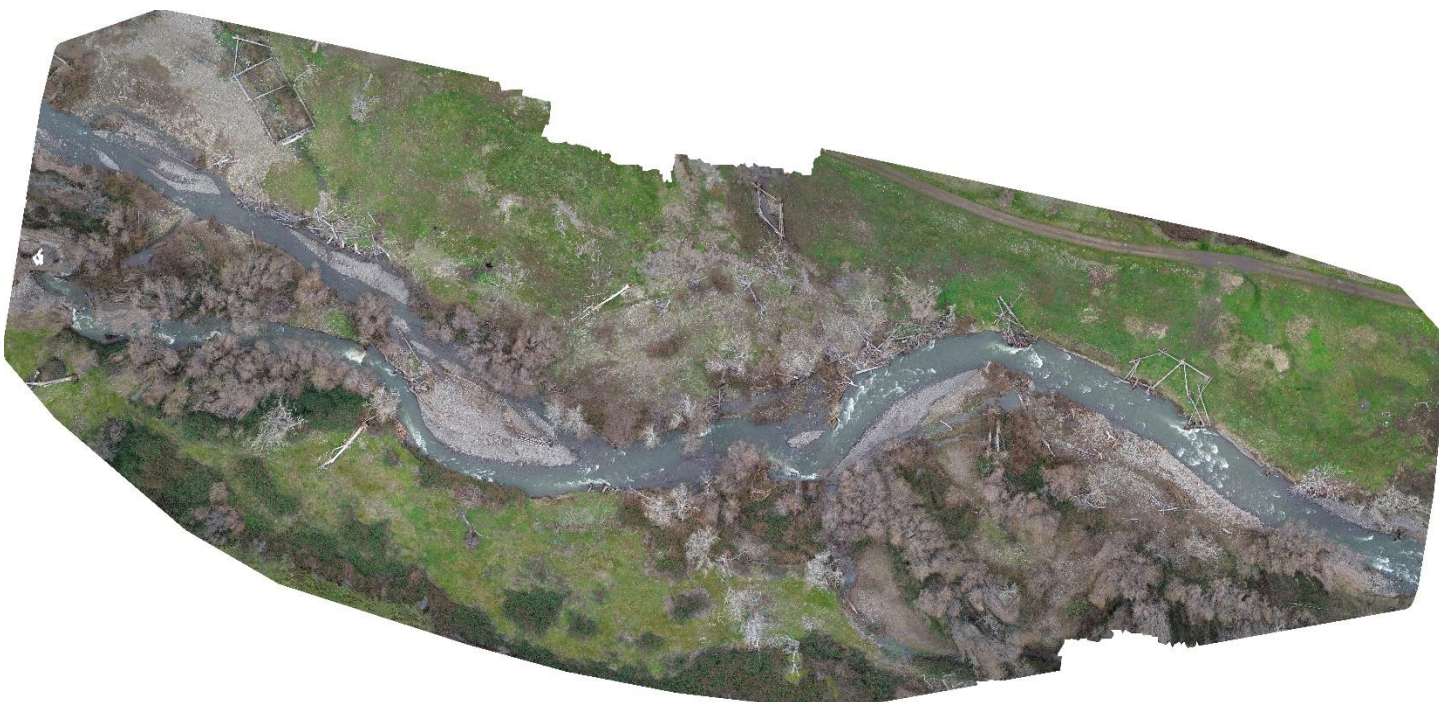
Figure 52. RM 4.5-4.8 post-implementation imagery taken during high flow event, March 2026 showing multi-channel diversity.

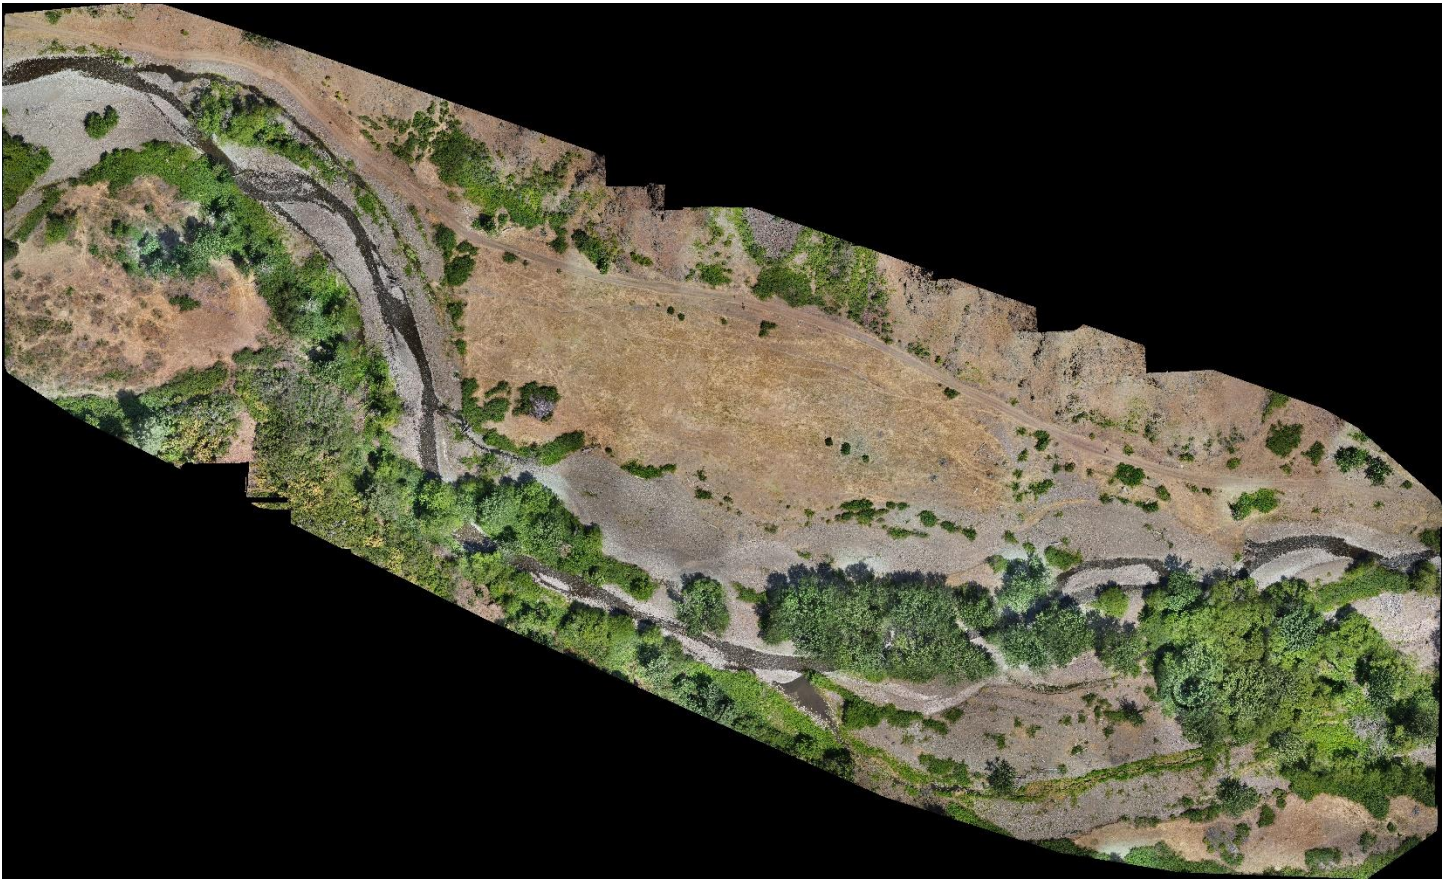
Figure 53. RM 4.9.5.2 pre-construction imagery taken during low September 2025 showing habitat simplification.

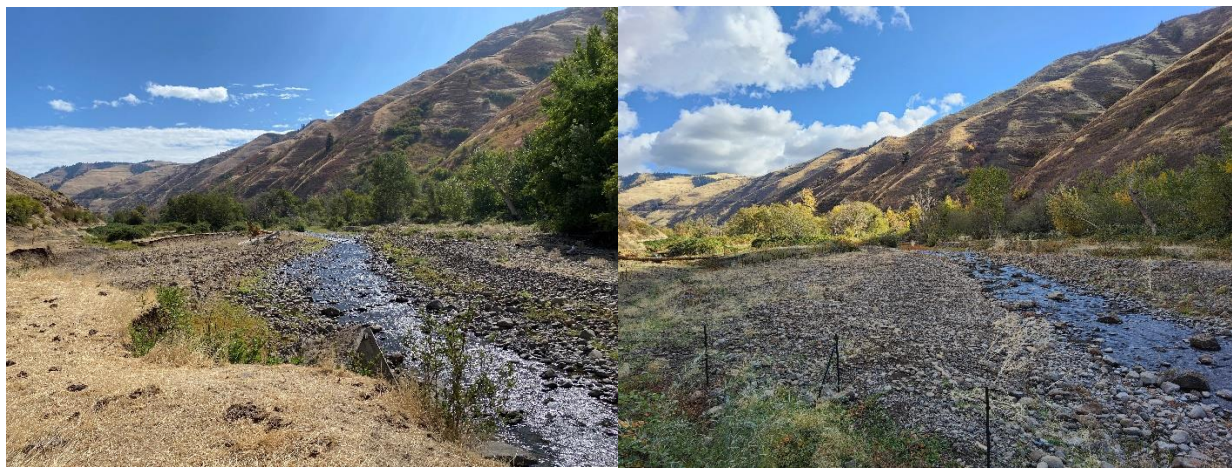
RM 4.4

Figure 5. Pictures before and after restoration of the project area from downstream to upstream, RM 4.4, 4.9, 5.1, 5.2.
