Oregon Department of Transportation Culvert Repair Programmatic Agreement Pilot Project Final Report 2018-2022

Final ODFW Report

Prepared by Pete Baki – ODFW-ODOT Fish Passage Liaison

June 30 2023

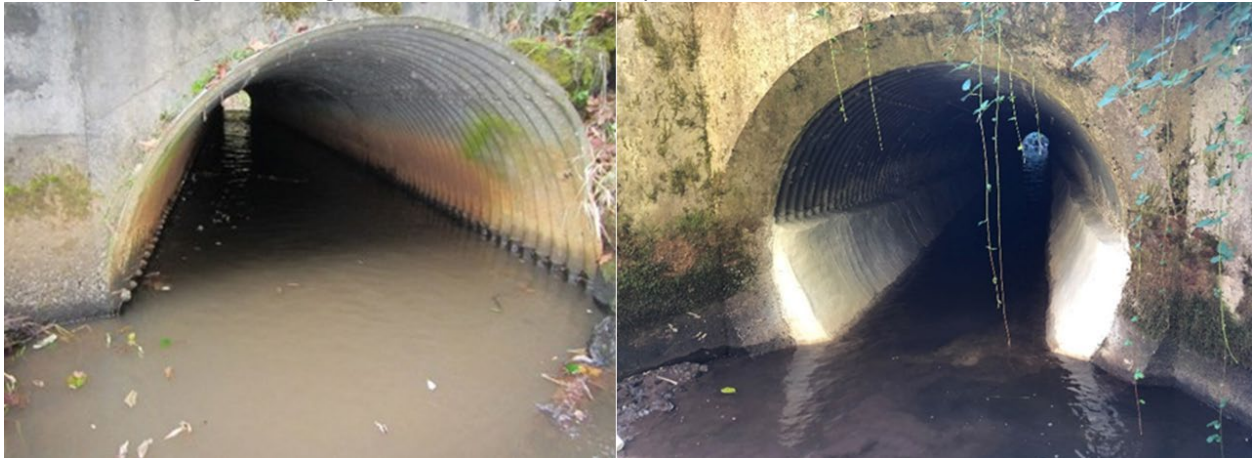
Figure 23: Pass Creek Culvert Repair Before and After

This project on Pass Creek is part of a series of culvert improvements done along a two-mile stretch of I-5. Culverts at mile points 165.90, 165.79, 166.69, and 167.04 were repaired under the CRPA in 2017, 2018, 2018, and 2019; respectively. Pass Creek flows south along I-5. Therefore, the increasing mile points correspond to movement upstream in the Pass Creek watershed. The amount of potential habitat above individual culverts is reported in each CRPA report, and the amount of potential habitat above the furthest downstream culvert repaired under the CRPA (MP 165.90) is 4.89 miles.

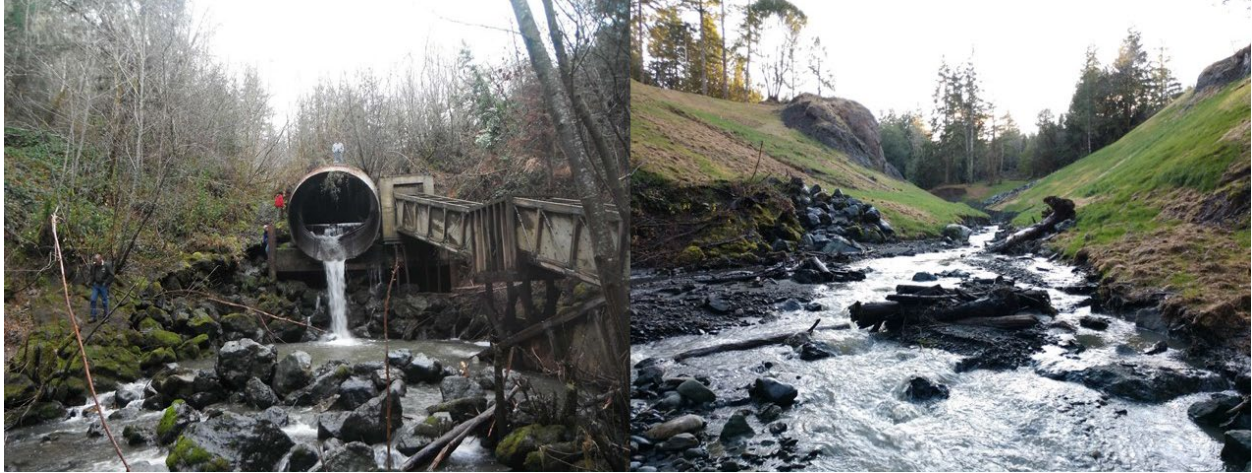
Figure 39: Baker Creek before (left) and after barrier removal (right).

The Baker Creek project removed a 12' by 250' long culvert that was perched 18' feet above the channel. This project was in Group 10 of the ODFW Statewide Fish Passage Priority list. A wooden fish ladder was installed in the past, but it wasn't very effective in getting fish into the culvert. Removing this barrier provided volitional fish passage to 2 miles of habitat. Baker Creek is an important cold water refugia in the South Fork Coquille River and many juvenile coho have been observed in Baker Creek below the culvert during summer and late fall months.

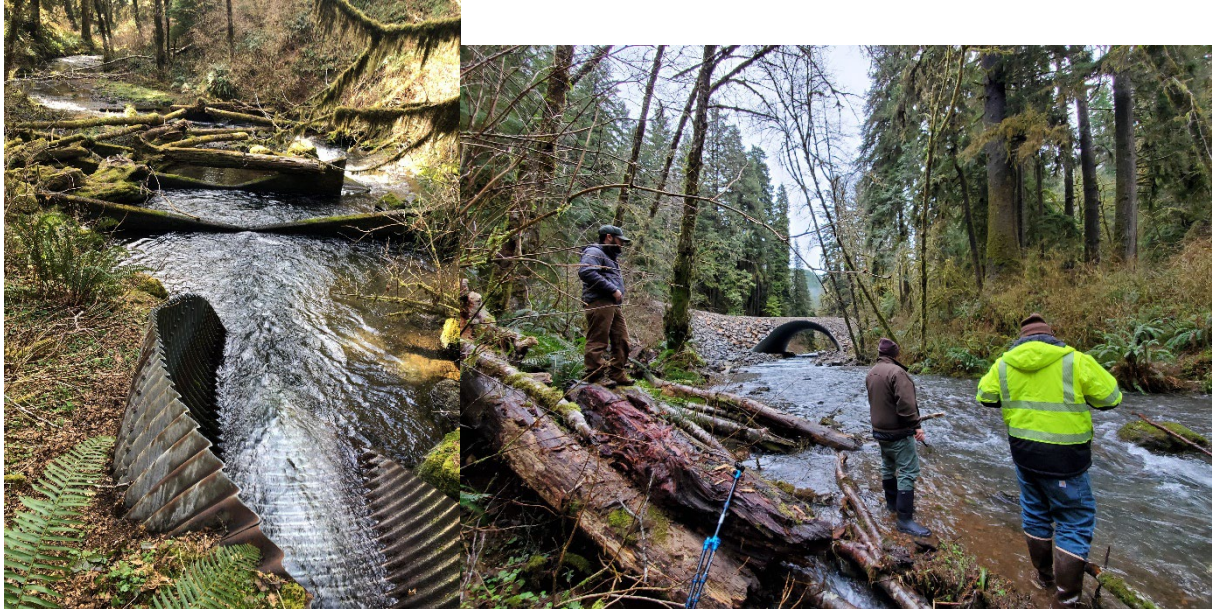
Figure 40. North Creek before (left) and after (right) culvert replacement.

The North Creek project replaced a perched undersized 12' culvert with an 50' engineered arch culvert. The pre-project culvert was undersized creating velocity barriers, and along with the perch, very few adult salmonids were able to pass. North Creek is a tributary of Drift Creek in the Siletz basin. North Creek provides spawning habitat and cold water refugia rearing habitat. Restoring volitional fish at this site provides access to 13 miles of habitat for coastal resident and searun cutthroat trout, 5.4 miles of winter steelhead habitat, 3.4 miles of Coho habitat and some additional habitat for fall chinook. Pacific lamprey also occupy North Creek. Many adult fish have been observed above the culvert since its replacement.

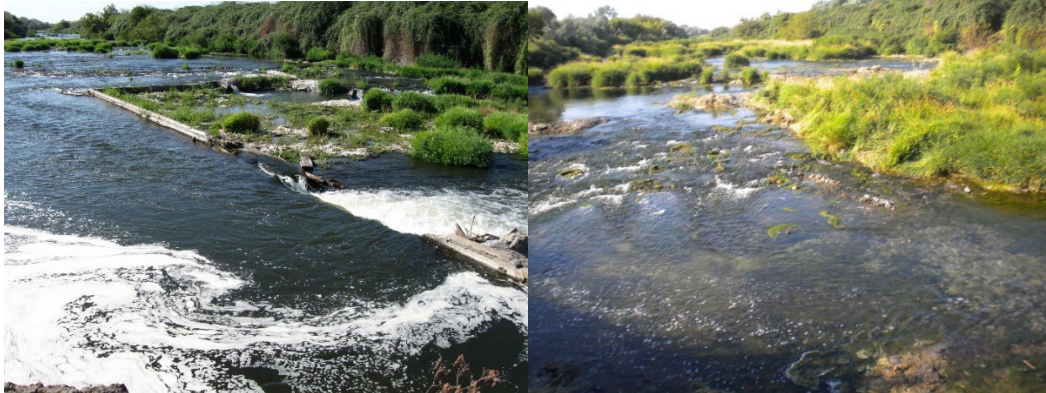
Figure 41. Brownell Dam before (left) and after (right)

Brownell dam is located at river mile 2.5 on the Umatilla River and is the first barrier migrating fish encounter on their way upstream to spawning grounds. The dam was no longer in use and a notch was removed to improve passage in the past, but the structure still caused delay in passage and created greater predation for out-migrating fish. The dam has been removed, providing volitional fish passage for native migratory fish and reducing upstream delays at this structure.

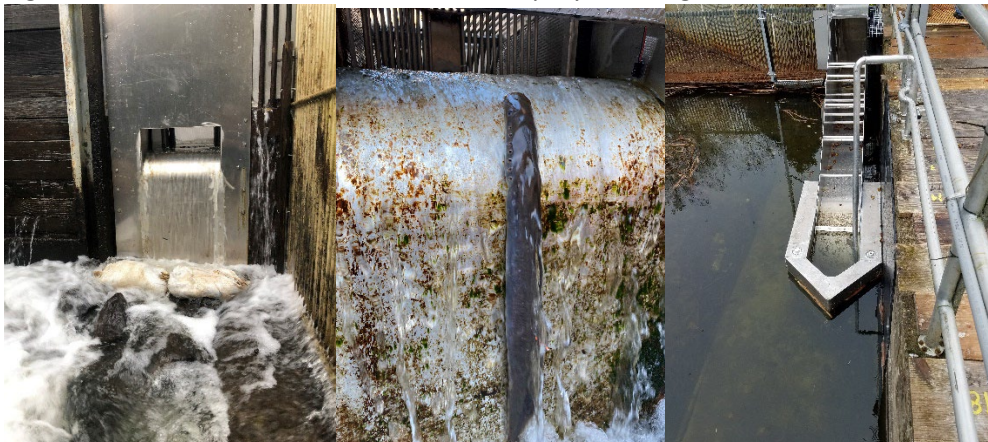
Figure 42: Eel Creek ladder, adult Pacific lamprey climbing

The outlet of Eel Lake has a cement dam with an existing fish ladder that provides passage for anadromous salmonid species. Lamprey are not able to use the fish ladder. A lamprey ramp was installed to provide passage for Pacific lamprey to provide access to the lake and its tributaries. Providing passage here provides an additional four miles of high quality spawning habitat and the project is on the 2013 ODFW Fish Passage Priority List. This project had significant financial and maintenance contributions from the Coos, Lower Umpqua and Siuslaw tribes.

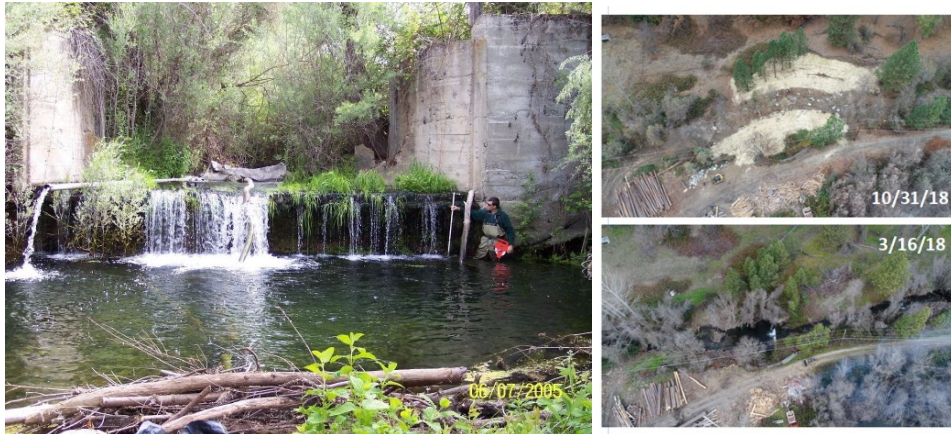
Figure 43. Before and after

The Forest Creek Dam removal project removed a full channel spanning five foot tall dam on Forest Creek, a tributary of the Applegate River in Jackson County. This dam has created an impediment to fish passage for over thirty years. A roughened riffle replaced the dam providing volitional fish passage to four miles of coho habitat and 6.4 miles of steelhead habitat. The habitat above the dam is high intrinsic quality habitat.

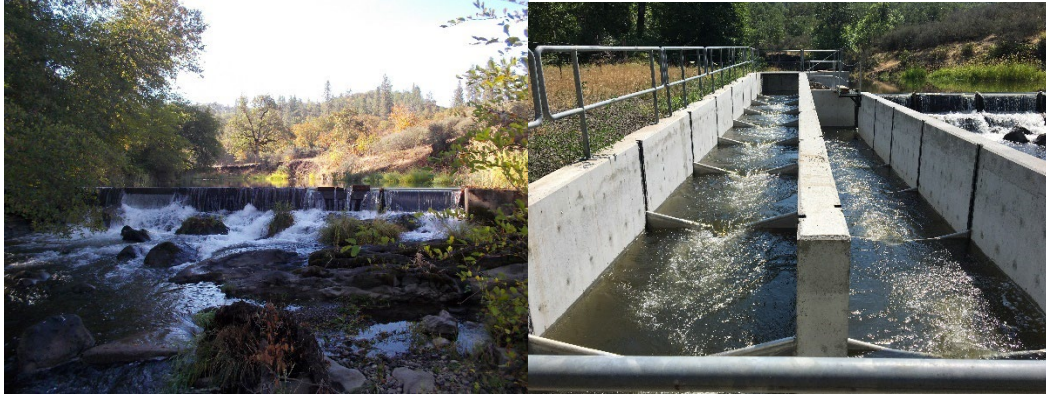
Figure 44: Salt Creek before and after.

Salt Creek is a tributary of Little Butte Creek near Eagle Point, Oregon and provides exceptional habitat for ESA listed coho salmon. This project removed two push up dams on Salt Creek which were in Group 9 of the 2013 Fish Passage Priority List. These push up dams were replaced by reprofiling existing irrigation ditches and retrofitting the existing fish screens and installing new head gates. This provided volitional fish passage to the lower 2.35 miles of Salt Creek.

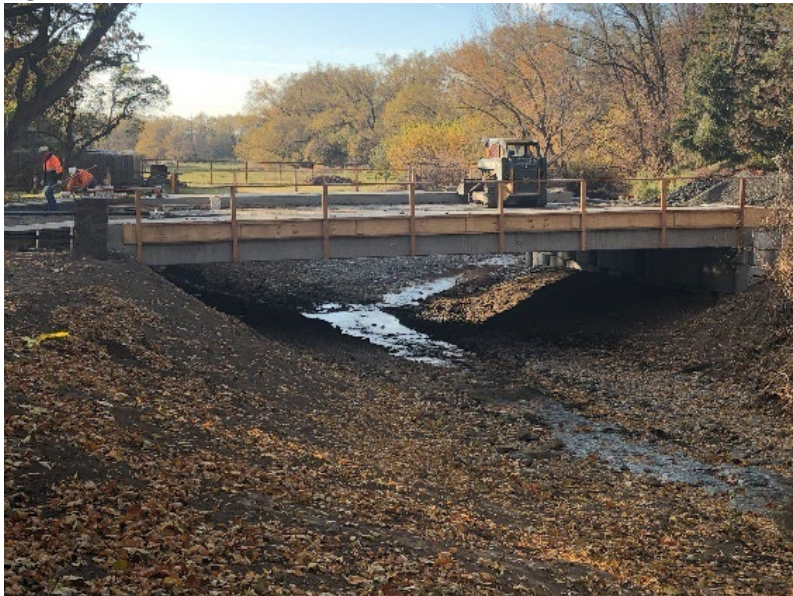
Figure 45: Wildhorse Creek after construction.

A channel spanning grade control structure in Athena, on Wildhorse Creek, tributary to the Umatilla River, completely blocked fish passage for native fish. To provide voluntary fish passage, the grade control structure was removed and a new bridge was installed at 3rd Street. Removing this barrier and restoring fish passage provides access to 15.4 miles of salmonid spawning and rearing habitat. This barrier was listed in the 2013 ODFW Statewide Fish Passage Priority List.

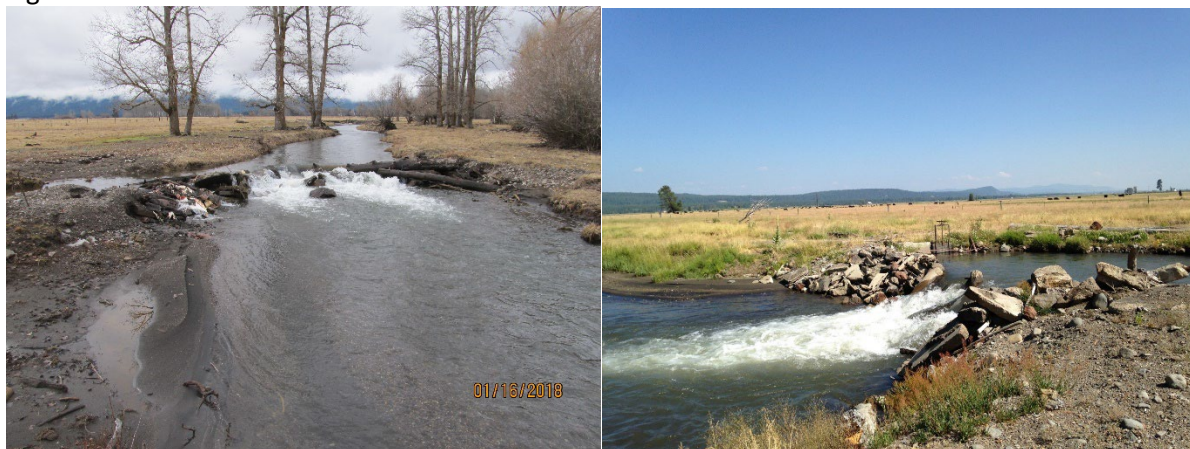
Figure 46. Annie Creek before and after.

This project provided volitional fish passage at two irrigation diversion pushup dams on Annie Creek, a tributary to the Wood River in the Upper Klamath Basin. Both barriers were removed and a roughened riffle was constructed to provide volitional fish passage. Both diversions were combined and a new criteria fish screen was installed to prevent the entrainment of juvenile fish. Removing these barriers allows upstream and downstream volitional passage in the lower five miles of Annie Creek.

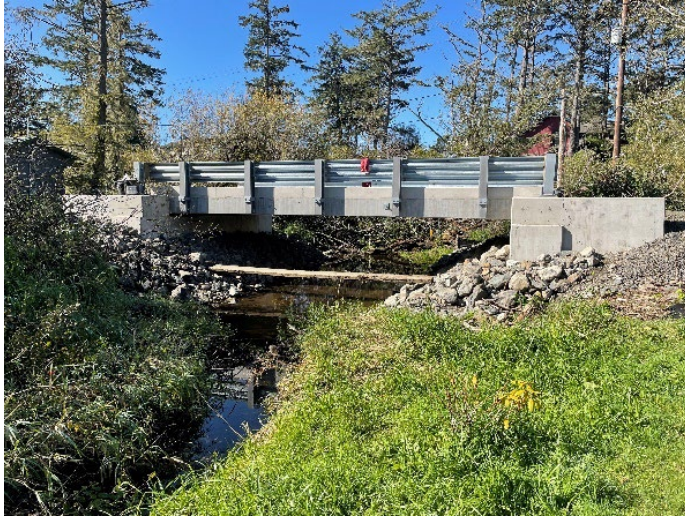
Figure 47. Butte Creek after removal of the tidegates.

This project is located in Neskowin, Oregon and is in Group 8 of the ODFW Statewide Fish Passage Priority List. This project removed two 42" top hinged tidegates on two 5' culverts and replaced them

with a 32' bridge on Butte Creek. Providing passage at this location provides native migratory fish 1.7 access to an additional 1.7 miles of habitat for spawning and rearing on Butte Creek.

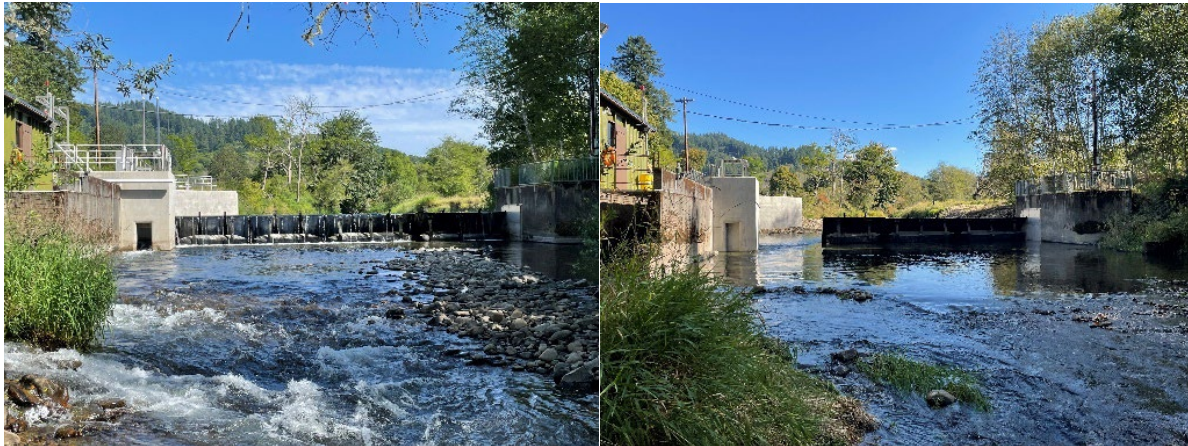
Figure 48: Cedar Creek before and after.

Cedar Creek Hatchery is approximately 1.5 miles east of Hebo and adjacent to Three Rivers, tributary to the Nestucca River. The hatchery, which was constructed in 1925, in order to meet hatchery and management goals used a hydraulically operated picket weir for collection of adult Chinook and Steelhead. This picket weir created a barrier to fish passage. The project removed the picket weir and replaced it with an Obermeyer weir which will only be operated during periods of hatchery fish collection. A new fishway was installed to provide juvenile and adult salmonid and lamprey passage as well as a new cylinder fish screen. This project provides improved access to 18 miles of habitat.

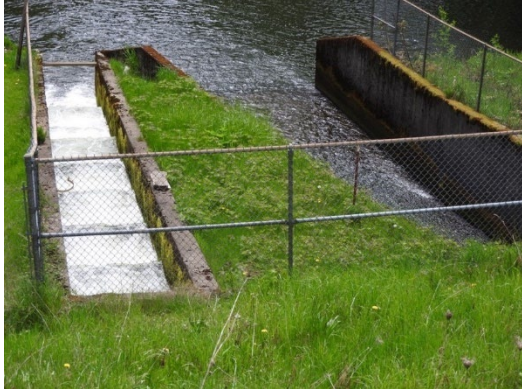
Figure 49: The old fish ladder at Fishhawk Lake.

Fishhawk Lake Dam is located on Fishhawk Creek, a tributary to the Nehalem River and has a ladder that does not meet the state's fish passage standards. This project is on the 2018 ODFW Statewide Fish Passage Priority List. The project is replacing the existing ladder with a new ladder that meets State Fish Passage Criteria. Providing passage at this location will benefit coastal cutthroat, coho and steelhead.

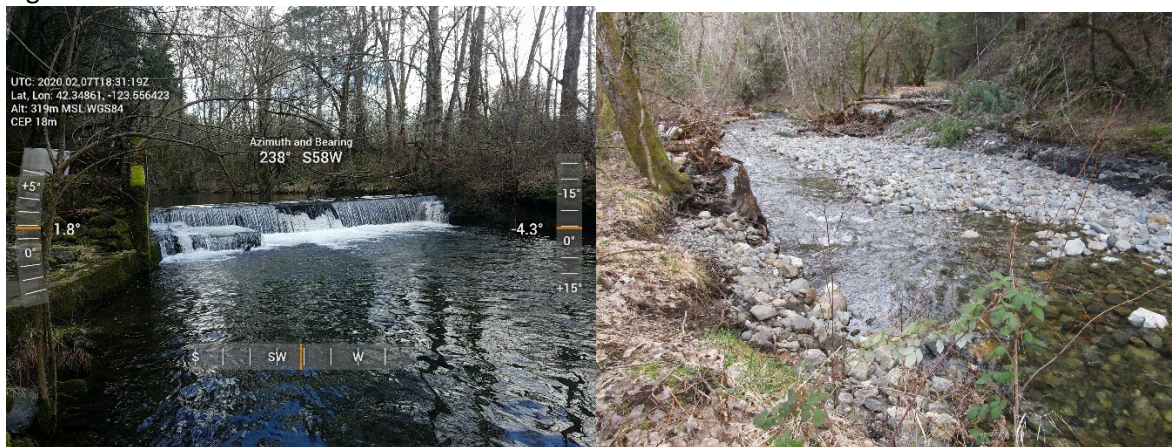
Figure 50: Harboldt Dam before and after.

This project removed the Harboldt Dam on Slate Creek and two unnamed dams on Welter Creek, both tributaries of the Applegate River in Josephine County. Harboldt Dam is listed at Group four on the ODFW Statewide Fish Passage Priority List. Additionally a new fish screen was installed to criteria to protect fish from entrainment into a water diversion. Removing these diversions provides volitional access to 15 miles of salmonid habitat.

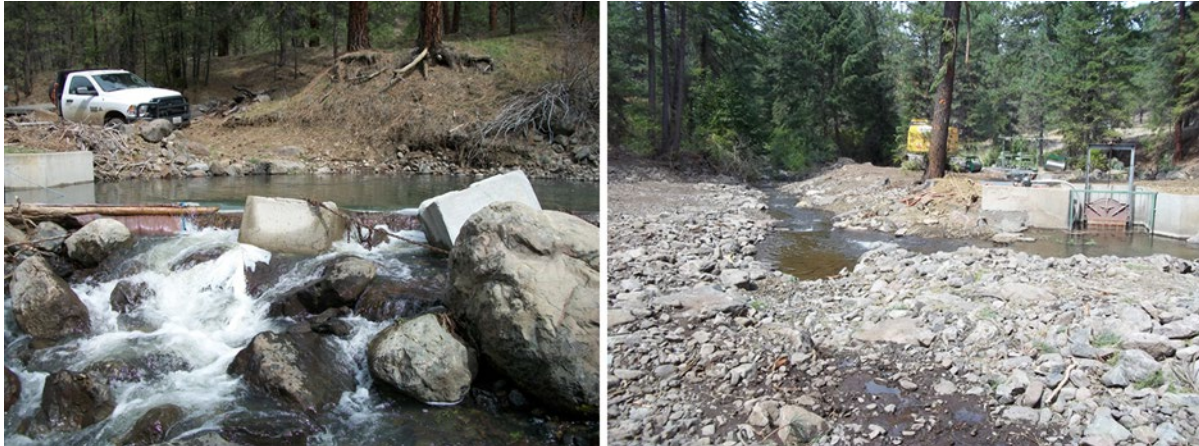
Figure 51: Rudio Creek before and after.

This project removed an existing channel spanning passage barrier at river mile 5.61 on Rudio Creek, a tributary of the John Day River. A criteria fish screen was also installed. This provided 11.18 miles of access to important habitat for ESA listed summer steelhead, spring chinook and redband trout.

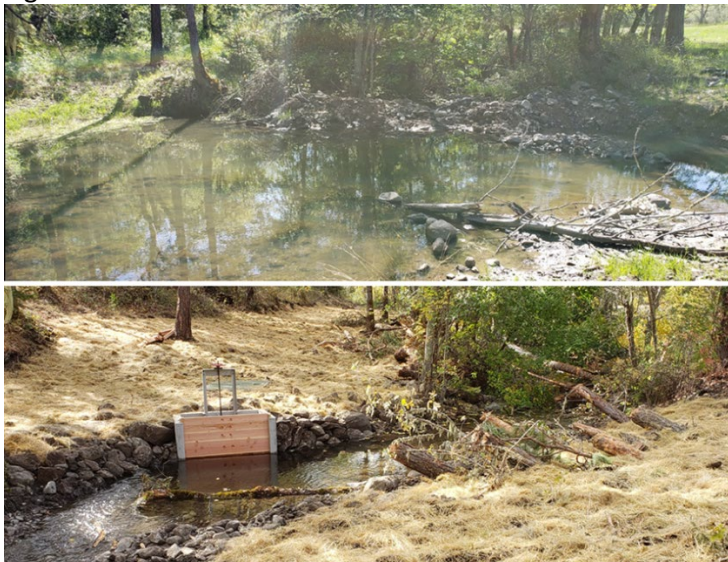
Figure 52: Salt Creek before and after.

This project removed two of Salt Creek's remaining five push up dams. New headgates and criteria fish screening were installed for the irrigation diversions. Salt Creek is a tributary of Little Butte Creek and provides habitat for steelhead, coho, Chinook and coastal cutthroat trout. Salt Creek maintains cold water temperatures over the summer months providing essential over summer rearing habitat for salmonids.

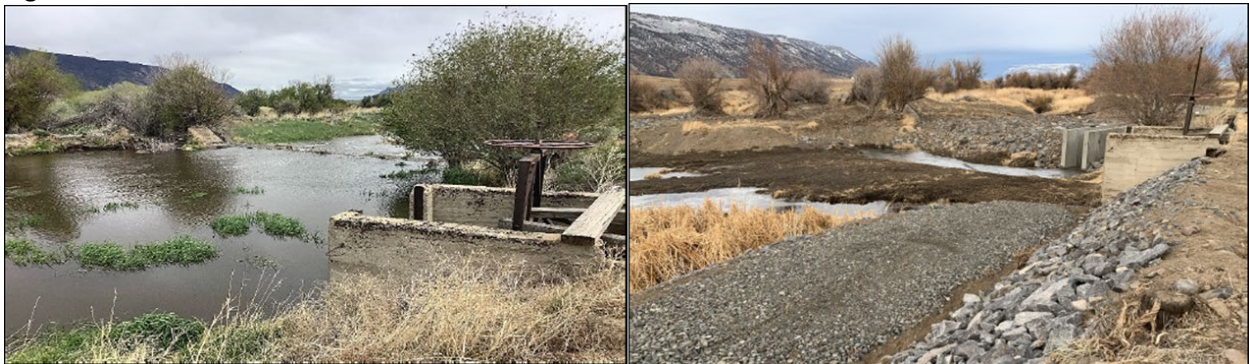
Figure 53: Thomas Creek before and after.

The Thomas Creek project, Group 8 on the Statewide Fish Passage Priority List, provides passage by providing a bypass channel around a diversion providing access to 35 miles of upstream native migratory fish habitat for Goose Lake redband trout, Goose Lake lamprey, Goose Lake sucker, Goose Lake tui chub, modoc sucker and pit roach. This project will re-establish opportunities for native fish to access cold water refugia during the warm summer months.

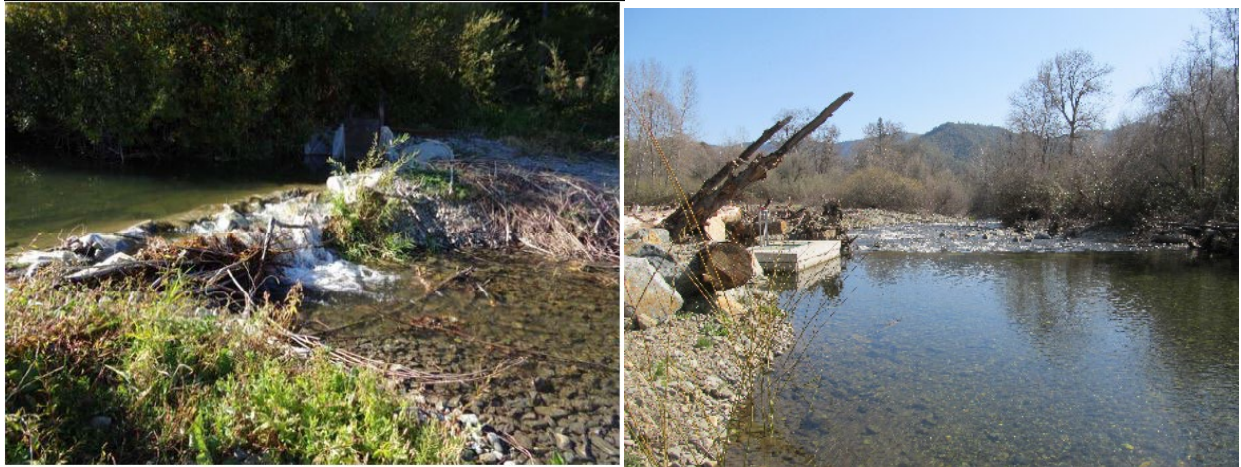
Figure 54: York Breeden Dam before and after.

This project on Williams Creek, a tributary of Applegate River, will remove a push up dam that limits fish passage and install a new headgate and fish screen for the water diversion. Removing this barrier will improve access to 11.5 miles of Pacific lamprey habitat, 13.1 miles of Chinook habitat, 24 miles of ESA listed coho habitat, 36.2 miles of steelhead habitat and 62.5 miles of cutthroat trout habitat. This dam is on the 2018 Statewide Fish Passage Priority List.

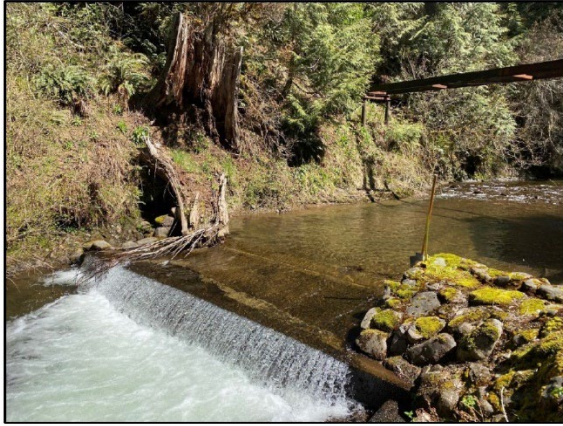
Figure 55: North Fork Eagle Creek Dam.

The North Fork Eagle Creek Project will restore full volitional fish passage to eight miles of high quality spawning and rearing habitat for ESA listed winter steelhead, coho and spring chinook. This project is listed in the ODFW Statewide Fish Passage Priority List. This 8' high channel spanning dam on has impaired passage since the 1970's. The project will also restore side channel connectivity at a second location nearby.

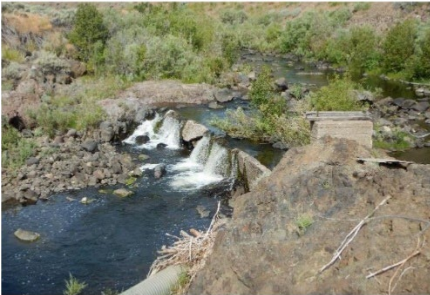
Figure 56: Deep Creek Middle Diversion.

The Middle Diversion on Deep Creek, tributary to Crump Lake, has been operating for at least 100 years. This diversion impedes fish passage for Warner sucker and Warner Lakes redband trout. This project will remove the Middle Diversion weir. Three lower diversions on Deep Creek have already been addressed with 2 additional upstream barriers that will need future work. When passage is improved at all six diversions, 9.5 miles of habitat will be connected.

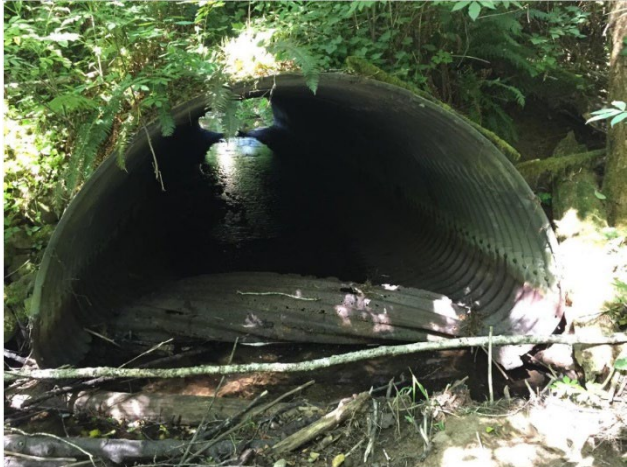
Figure 57: Cougar Creek Culvert

This project will replace an undersized and damaged culvert with a full spanning bridge on Cougar Creek, a tributary of Five Rivers in the Alsea basin. This project is in Group 11 of the Statewide Fish Passage Priority list. Providing improved passage at this location will allow access to four miles of upstream habitat for Chinook, Coho, steelhead, Pacific lamprey and cutthroat trout.

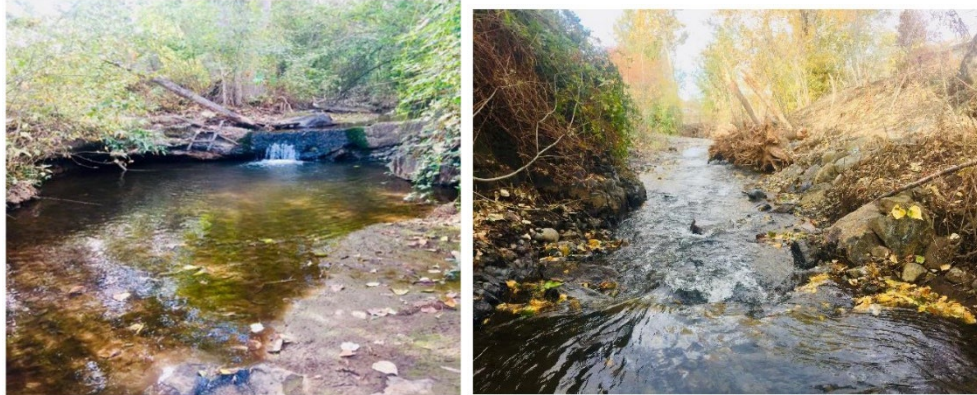
Figure 58: Couse Creek before and after.

Couse Creek is a tributary of the Walla Walla River near Milton Freewater. This project removed a 2 foot tall irrigation dam and installed a roughened riffle to provide passage. This project is on the 2019 Statewide Fish Passage Priority List in group 13. This was the last known barrier in the Couse watershed. Removing the dam provided volitional access to 11 miles of habitat for ESA listed steelhead and bull trout as well as redband and spring chinook.

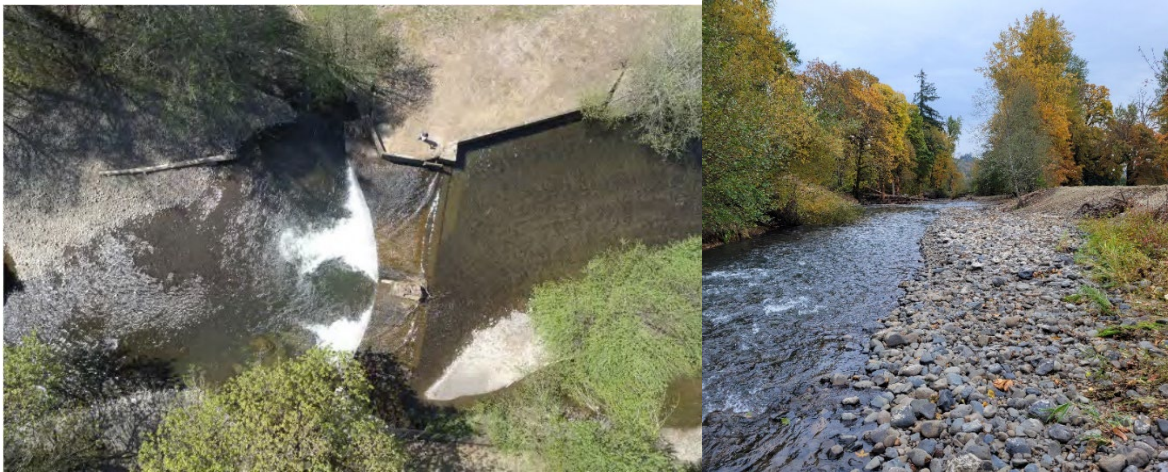
Figure 59: Balm Grove before and after.

This project will remove the Balm Grove Dam on Gales Creek, a tributary of the Tualatin River. This channel spanning dam is in Group 4 of the ODFW 2019 Statewide Fish Passage Barrier List and providing full fish passage here improves access to 87 miles of native migratory fish habitat. The dam has been in place for almost 100 years. Instream habitat improvements were completed along with the dam removal.
