# Culvert Repair Programmatic Agreement (CRPA) Annual Report 2016

**Report Prepared by**  
**William Warncke, ODOT**  
**Art Martin, ODFW**  
**February 3, 2017**

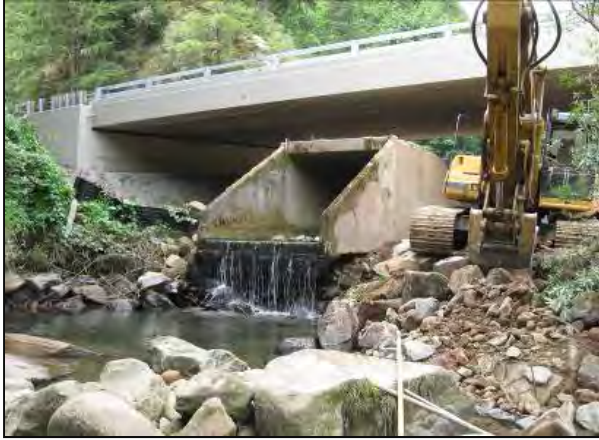
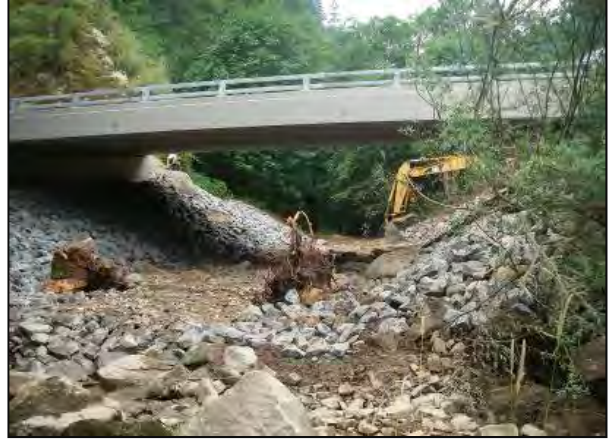
The Charlotte Creek culvert replacement project (photos below), completed by the ODOT Fish Passage Program, is one example of ODOT’s commitment to improving fish passage and supporting the Oregon Plan for Salmon and Watersheds. The project replaced an undersized culvert with a channel spanning bridge. The project opened two miles of high value habitat for salmon and steelhead at a cost of \$2 million.

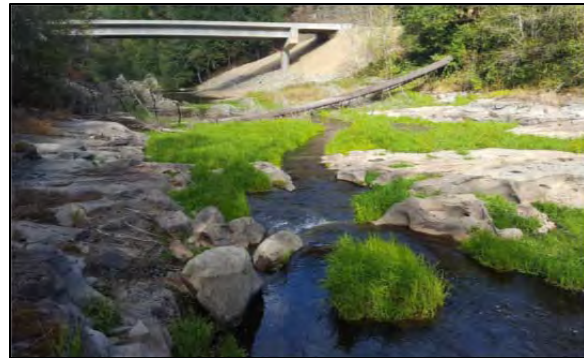
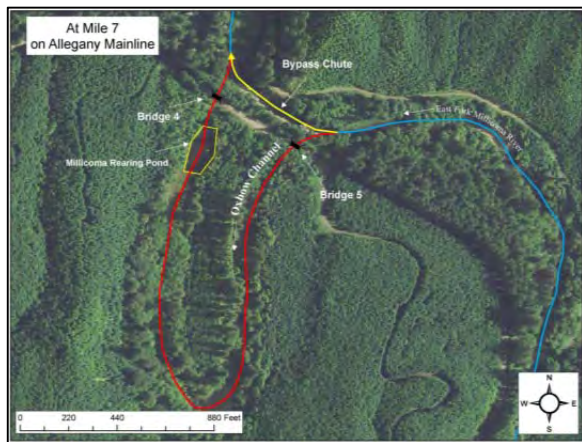
### East Fork Millicoma River (completed 2016)

The East Fork Millicoma River (EFMR) is the largest tributary to the Millicoma River and is near Coos Bay, Oregon. The EFMR has the potential to provide important habitat to Chinook, chum, and Coho salmon and steelhead trout and Pacific lamprey. In 1958, two bridges crossing the East Fork Millicoma River were filled in, forming an artificial oxbow. Fill material was excavated from a ridge at the narrow point of the old meander, creating a steep bypass chute that is the current river location. The bypass chute was a velocity barrier prior to the project for all adult and juvenile salmonids, especially Chinook; limiting access to over 16 miles of potential habitat.

The restoration proposal reversed this severe alteration to the EFMR. The project installed bridges at the two historic oxbow crossings. Fill material from the bridge locations was returned to the existing bypass chute (shown in yellow on map to left) creating a diversion dam that returned all flows back through the oxbow, reconnecting the river's original course (shown in red on map to left). The end result is significantly improved passage for all salmonids and reclaiming 0.6 miles of abandoned river channel. This project is part of a larger project to restore the entire EFMR watershed; whose goals are: 1)

reconnect the EFMR Oxbow; 2) restore over 16 miles of degraded streams upstream from the Oxbow; and 3) reduce fine sediment inputs throughout the EFMR sub-watershed. This barrier was the highest ranked barrier on the southern Oregon coast and in the Coos-Coquille District.

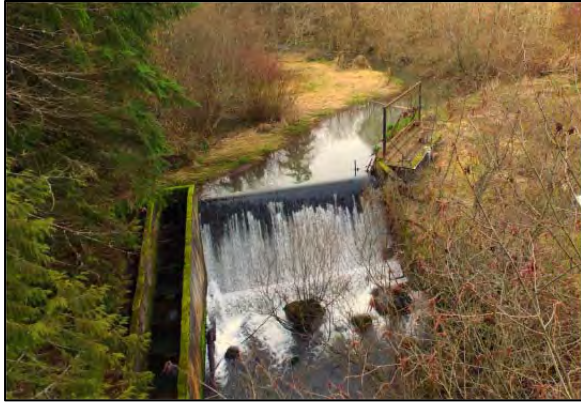
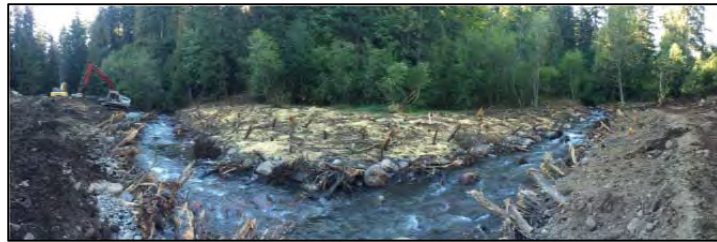
### Odell Creek (Completed 2016)

Odell Creek is a non-glacial tributary that joins the Hood River at RM 5.6. This project removed a 12 foot high concrete dam near the mouth of the creek, which restored year-round fish passage and improved important rearing habitat for threatened winter steelhead and resident trout. The dam included a fish ladder that was considered a complete barrier; it was in disrepair and included jump heights in excess of one foot. The lower Hood River's winter steelhead population is considered both a core and genetic

The project removed the dam and fish ladder, and reconstructed the stream channel, banks, and floodplain. The stream was restored to its original location. A portion of the sediment stored behind the dam, estimated at 1,200 yd<sup>3</sup>, was removed and placed at an onsite, upland location. A new fish screen for an irrigation water diversion was installed and the riparian area was restored.

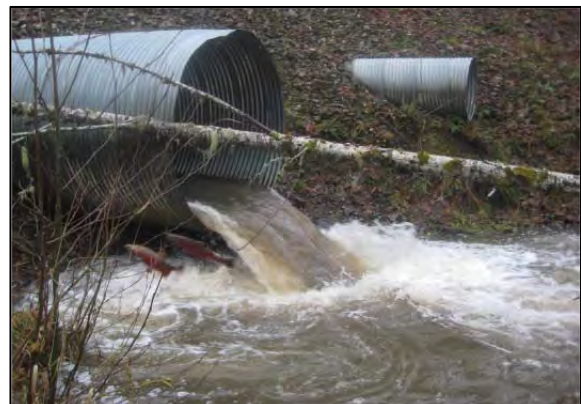
### Oak Ranch Creek (Scheduled for 2107)

This project will restore anadromous and resident fish passage and natural stream functions underneath Apiary Road (Columbia County) at mile post 15.7 at river mile 3.5 of Oak Ranch Creek. Replacing the 8' diameter x 120' long corrugated metal pipe with an open bottom 11.6'H x 39.0'W x 115.0'L concrete box culvert will make 9.5 miles of productive aquatic mainstream and tributary habitat accessible. ESA listed Coho salmon are the primary species of interest. Oak Ranch Creek also supports summer/fall run Chinook, winter steelhead, coastal cutthroat trout, and lamprey. Upstream of the culvert barrier a series of well-established Beaver complexes and healthy riparian areas occur on ODF lands and in Camp Wilkerson increasing habitat quality, quantity and production potential.

Restoring fish passage at this location will complete the basin wide effort to restore fish passage throughout the Oak Ranch Creek basin. Removal of the remaining barrier will provide full access to the entire Oak Ranch system including highly productive headwater reaches containing some of the best Coho salmon rearing habitat in the Upper Nehalem watershed. Oak Ranch Creek also provides significant rearing/refuge for juvenile salmon to escape lethal temperatures known to occur in the mainstream in the Nehalem River in the summer months.
