OREGON DEPARTMENT OF FISH AND WILDLIFE

Fish Passage WAIVER Application

Phase 9 Fish Passage Waiver Application
 FFO – US20 PME: UPRR-Eddyville Project
 Yaquina Turnkey Mitigation
 Lincoln County, Oregon

ODOT US20 PME TURNKEY MITIGATION PROJECT LINCOLN COUNTY, OREGON

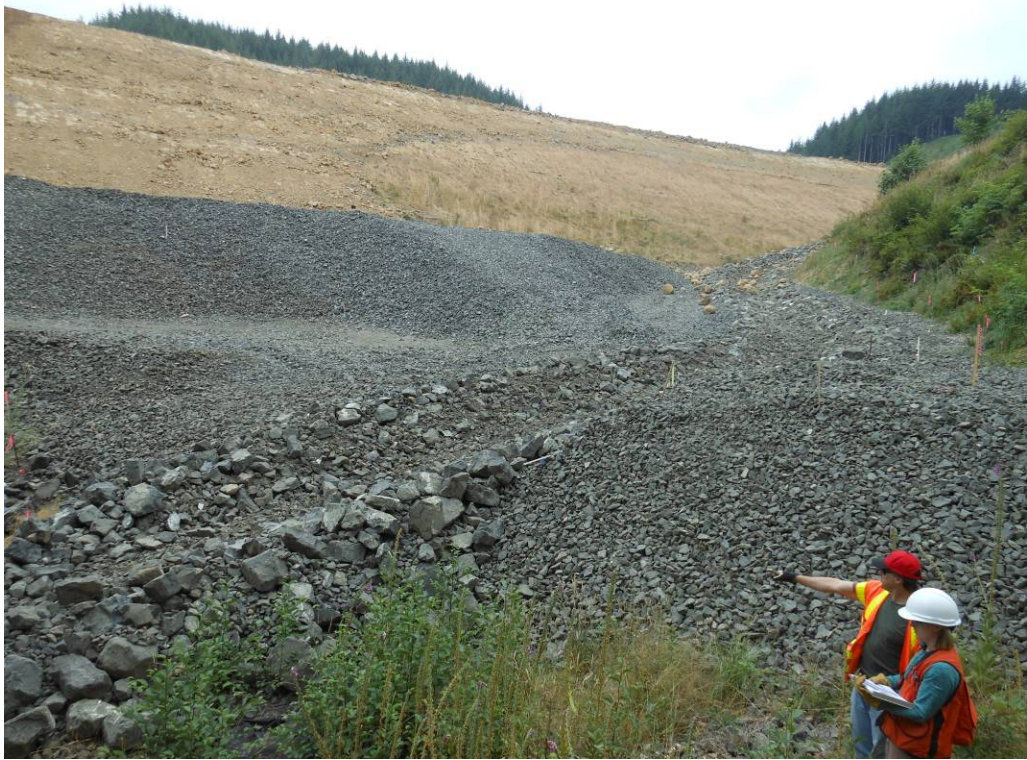
1

1. View of the existing rock butress on Eddy Creek C. The tributary is located in a pipe below the rock channel.
2. View of the Eddy Creek C rock butress culvert outlet. The proposed rock butress extension will extend the existing butress 216 feet downstream beyond this point.

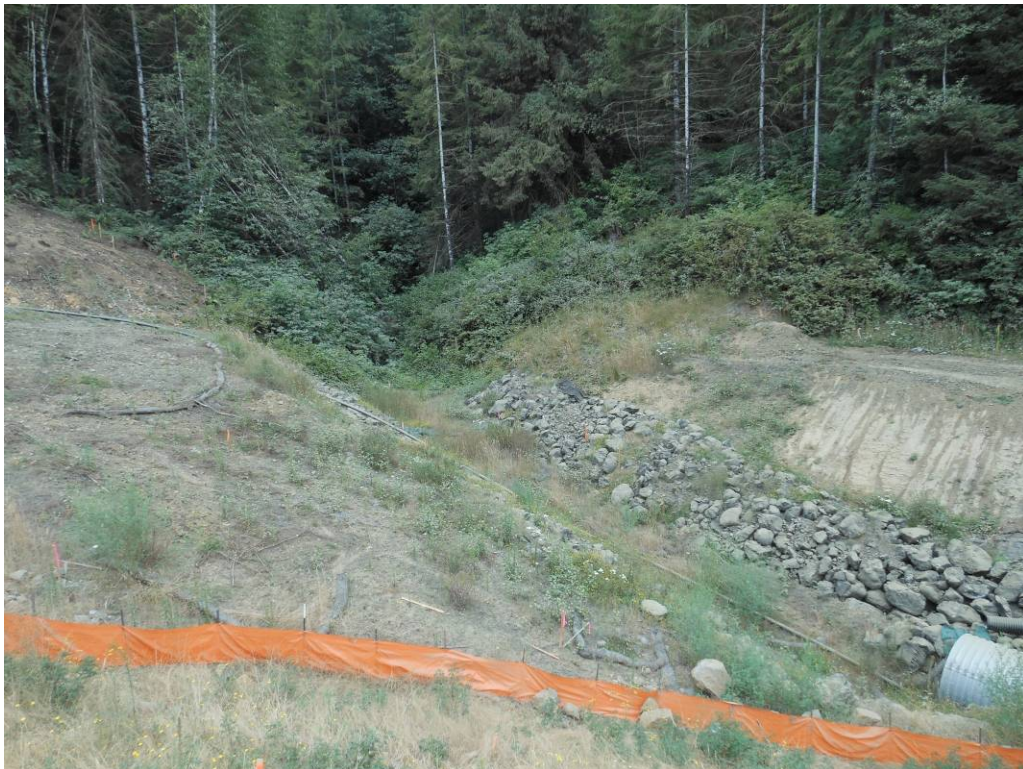
6

5. View of a portion of Eddy Creek C drainage proposed to be filled by the rock butress extension.
6. View of the downslope extent of the existing rock butress at Cougar Creek and butress drainage pipe. This pipe does not drain Cougar Creek; Cougar Creek is located in the riparian area in the photo background.

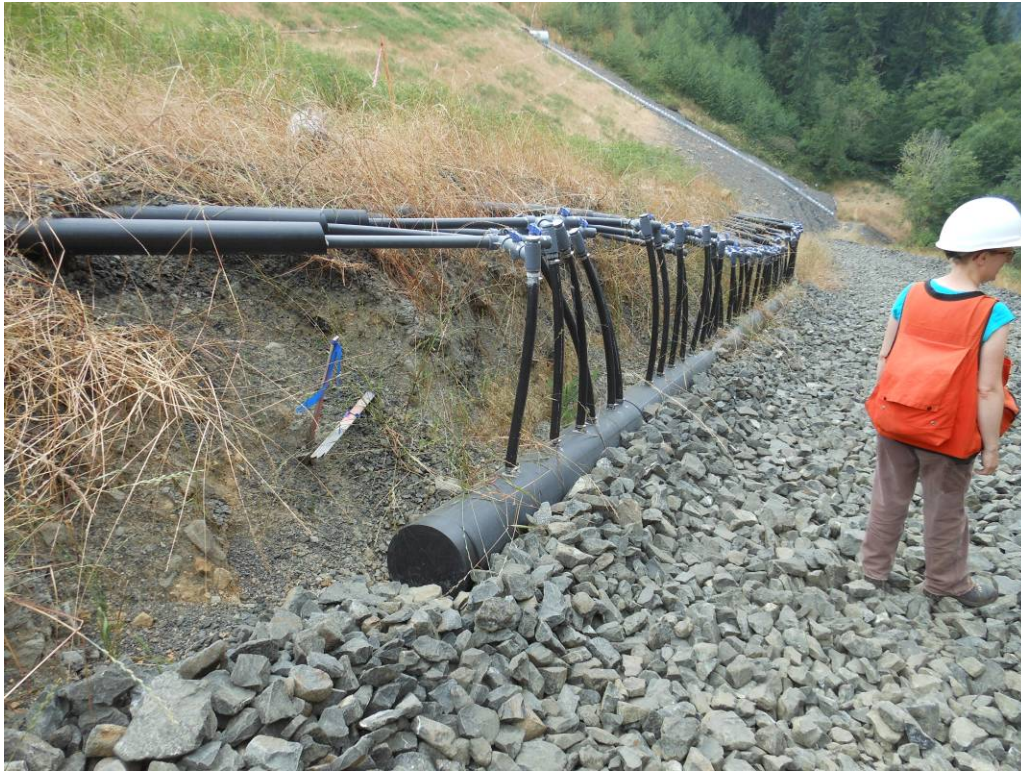
7

7. View of existing Cougar Creek rock buttress drainage features. These features drain to the pipe shown in Photo 6.
8. View of the portion of the Cougar Creek drainage proposed for additional rock buttress construction.

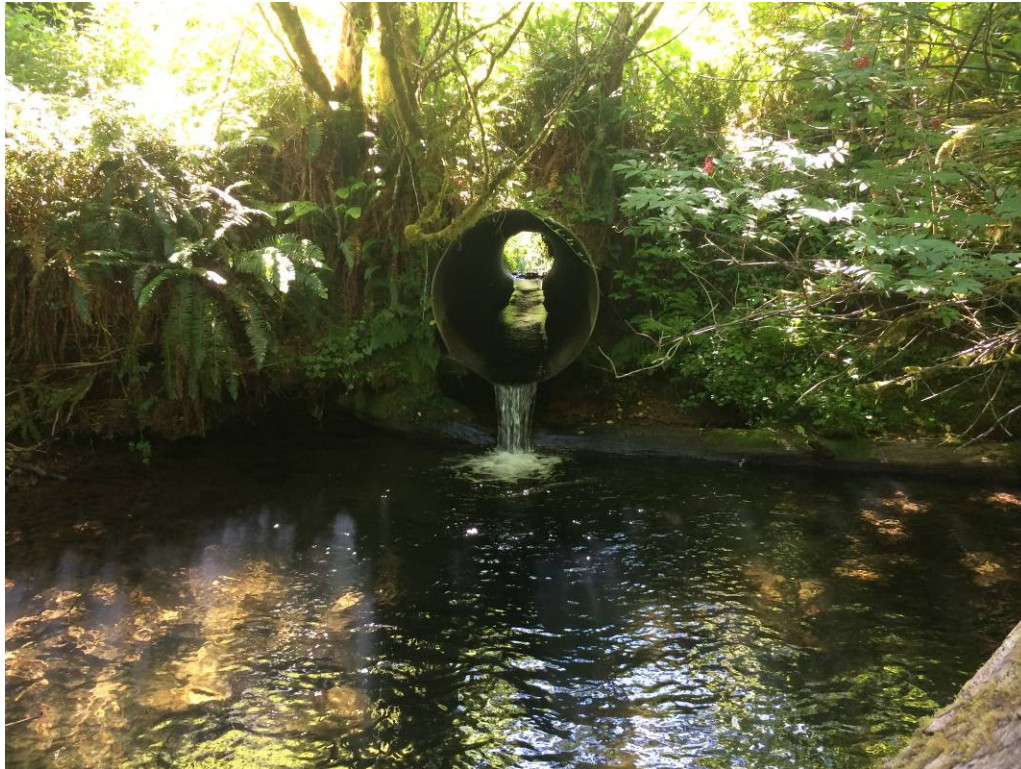
11

- 11. View of the existing Bull Creek culvert and outlet pool.
- 12. View of the existing Bull Creek culvert and outlet pool.

feet below the culvert outlet, the culvert is a complete upstream barrier. When flows are high and the scour pool raises to the height of the culvert outlet upstream passage is possible; however, flow velocities in and exiting the culvert could prevent upstream passage for some species and/or life forms.	
Water Quality	The 2003 and 2009 ODFW Rapid Bioassessment report for Bull Creek discusses Bull Creek having very favorable water temperatures for supporting salmonid life histories. The favorable water quality conditions are linked to the high level of coho salmon production in the system per the ODFW report. The creek is well shaded by a dense riparian canopy and the lack of disturbance in the upper watershed (i.e., no road infrastructure or timber harvesting) results in favorable water quality conditions downstream and upstream of the culvert proposed for removal. The road network downstream of the culvert is denser than upstream of the culvert. As such, it is reasonable to expect that a higher level of sediment loading may at times occur in the reaches downstream of the culvert compared to upstream of the structure.	The lack of development and recent timber extraction upstream of the culvert provides extremely high water quality conditions in Bull Creek upstream of the culvert and supports favorable water quality conditions downstream of the culvert.

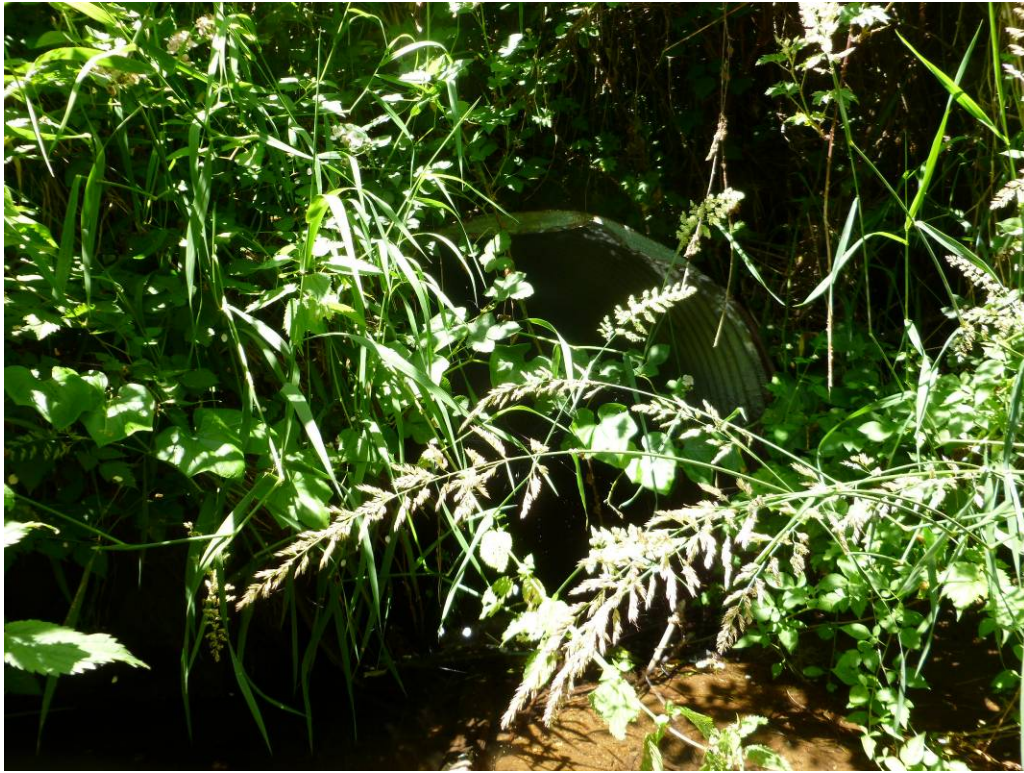
13

- 13. View of the existing Bull Creek culvert inlet.
- 14. View of Bull Creek road and the Bull Creek crossing (at red arrow).

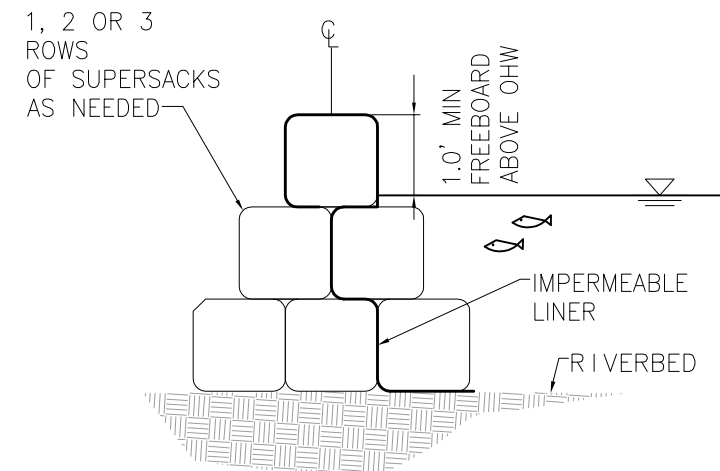
2 **SANDBAG BARRIER**
NTS

NOTE: THIS BARRIER WILL NOT PREVENT SUBSURFACE FLOW FROM ENTERING WORKING ZONE. CONTINUED PUMPING MAY BE REQUIRED IF ISOLATED WORK AREA NEEDS TO BE DEWATERED.

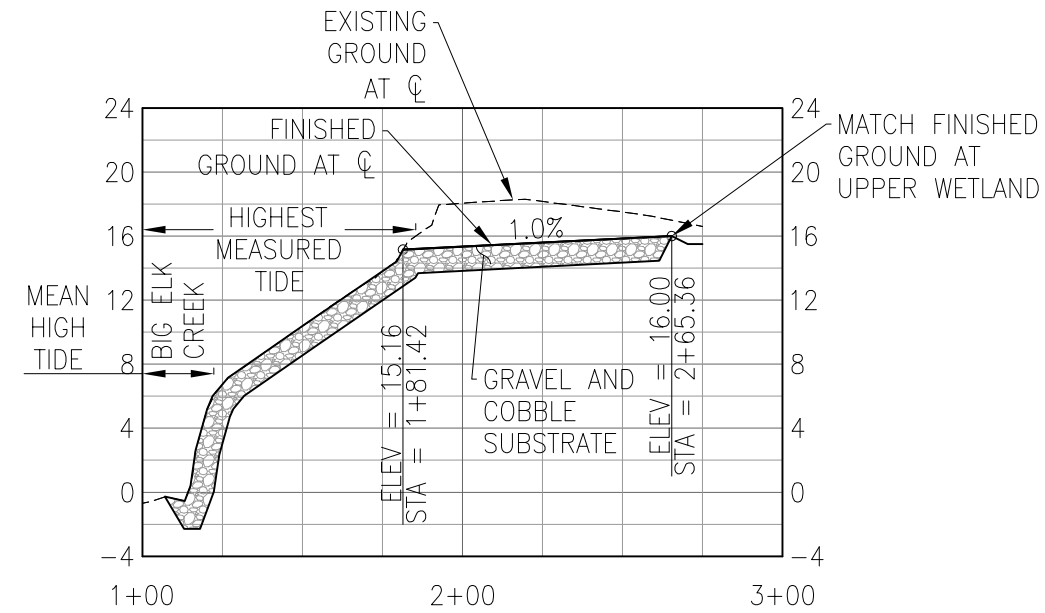
WEST OVERFLOW CHANNEL PROFILE
 HORIZ. 1" = 30'
 VERT. 1" = 6'

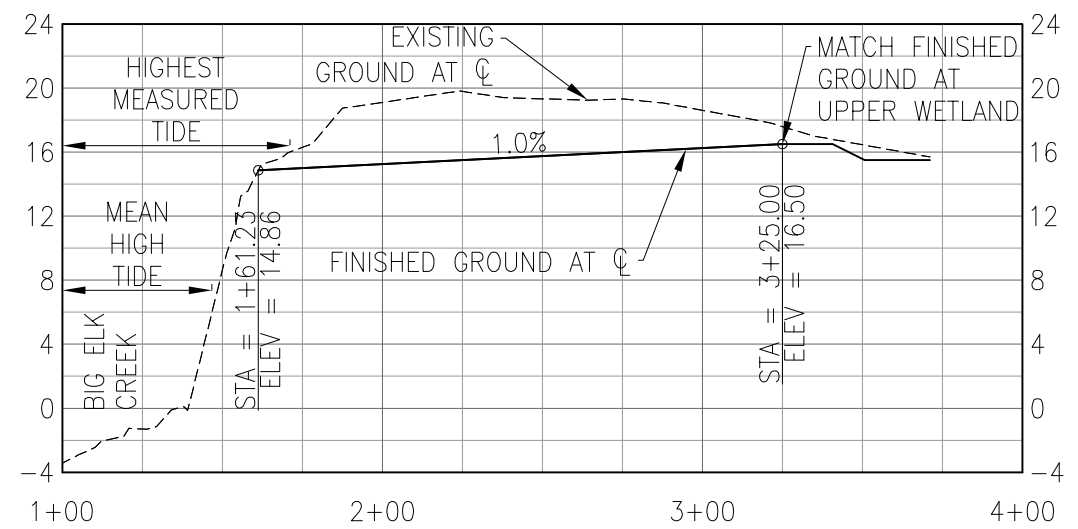
NORTH OVERFLOW CHANNEL PROFILE
 HORIZ. 1" = 30'
 VERT. 1" = 6'

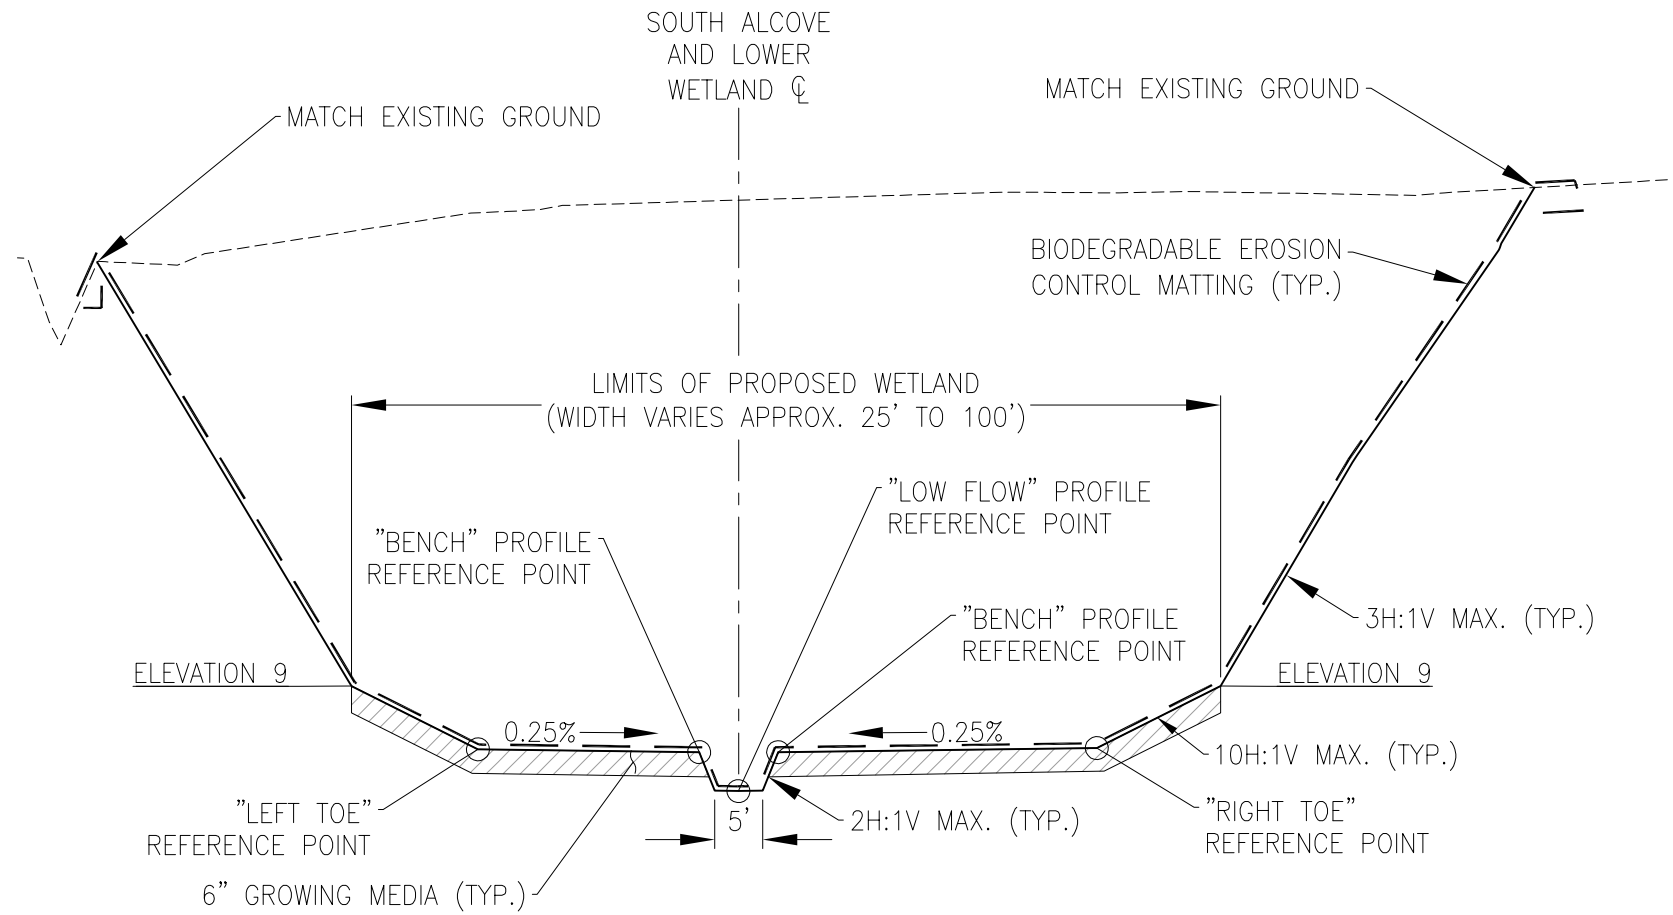
A **TYPICAL SOUTH ALCOVE AND LOWER WETLAND SECTION**
 NOT TO SCALE, VERTICALLY EXAGGERATED

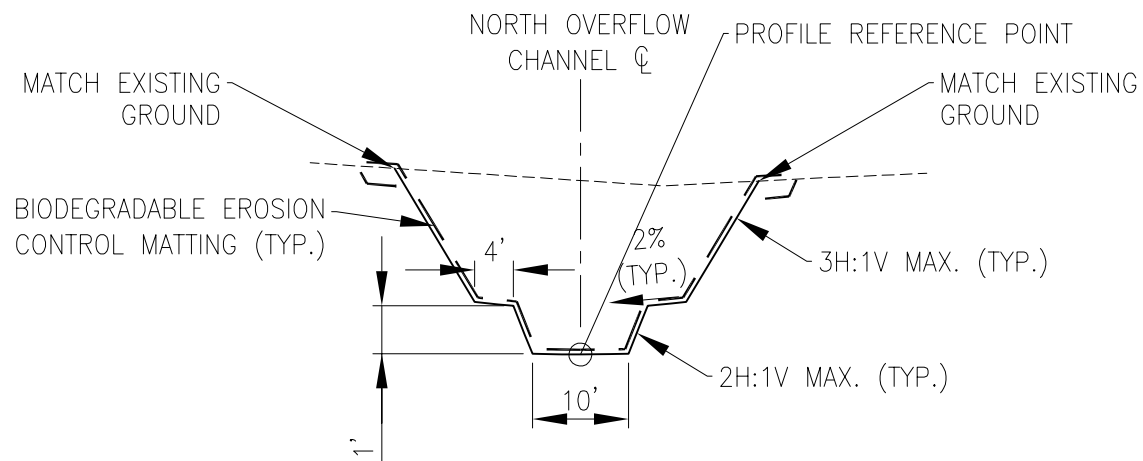
E TYPICAL NORTH OVERFLOW CHANNEL SECTION
NOT TO SCALE, VERTICALLY EXAGGERATED

- ① INSTALL WORK AREA ISOLATION AND EROSION CONTROL MEASURES.
- ② CONSTRUCT UPPER WETLAND (SEE TYPICAL SECTION D ON SHEET BE06).
- ③ CONSTRUCT NORTH OVERFLOW CHANNEL (SEE PROFILE ON SHEET BE04 AND TYPICAL SECTION E ON SHEET BE06).
- ④ CONSTRUCT LARGE WOOD ASSEMBLAGE TO INCREASE HABITAT DIVERSITY AND PROVIDE HYDRAULIC COMPLEXITY.
- ⑤ STABILIZE SITE WITH NATIVE VEGETATION (SEE REVEGETATION PLANS).
