Memorandum

Oregon Department of Fish and Wildlife

SUBJECT: Net Benefit Analysis for proposed barrier on headwaters of Mill Creek (South Santiam Basin) Fish Passage Exemption Request

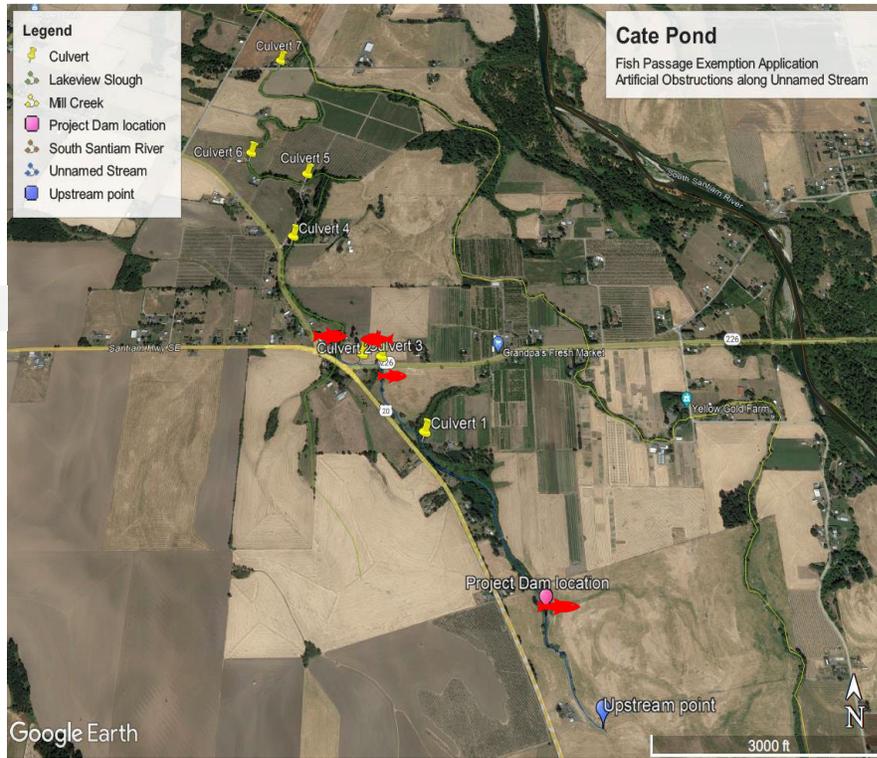
Sampling locations

ODFW sampling with a back-pack electro-shocker occurred at three sites above and below Culvert

2 and 3 (approximately one mile below the proposed barrier site, as well as at the proposed barrier site itself. The only fish species encountered or observed were *Gambusia affinis* (Western Mosquitofish) and Three-spine Stickleback. These two species are not NMF as per OAR 635-412-0005(32) and the state's fish passage rules and regulations to not apply. Many amphibians were also collected or observed, including bullfrog (tadpoles and adults) and Northwestern Salamander. Below is a description of the sampling habitat and what was found at each location with relevant observations, starting with the lowest most section and moving upstream.
